# SERVICE BULLETIN

## SERVICE BULLETIN NO. 1

EQUIPMENT TYPE: 30L-1 R-F LINEAR AMPLIFIER

SUBJECT: WIRING CHANGE REQUIRED BEFORE CONVERSION FROM 115 TO 230-VOLT OPERATION IS MADE, USE OF 8-AMPERE LINE FUSES, AND CORRECTION TO INSTRUCTION BOOK DRAWINGS.

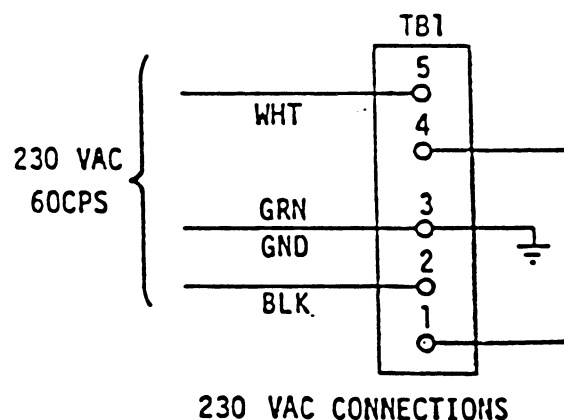
Figure 1

The procedure and schematic for converting operation of the unit from 115 to 230-volts, as detailed in the 5th edition of the 30L-1 R-F Linear Amplifier Instruction Book, dated 15 June 1962, is in error. These errors are corrected in the 6th edition of the above referenced instruction book, dated 15 June 1964. Before conversion is attempted the wiring changes detailed below must be made. After these changes have been made, the conversion can be made by changing the jumper wires on TB1 as shown in figure 1.

Termination of AC Power Cord at Terminal Strip TB1

1. Remove a-c power cord from the primary power source.
2. Lift the cabinet lid and remove the two Phillips-head screws located on the front panel rim.
3. Remove the four feet and the Phillips-head screw that is located between the rear feet.
4. Remove amplifier chassis from cabinet. The easiest way to do this is to place amplifier panel down on a padded surface.
5. Remove the screws from the bottom panel and both end panels of the amplifier. Lift out the bottom shield.
6. Move the white wire from the power cord from terminal 1 to terminal 2 on terminal strip TB1.
7. Move the lead of capacitor C4 from terminal 1 to terminal 2 of TB1.
8. Reassemble unit and return to operation. (Conversion from 115 to 230-volt operation and vice versa now can be made by connecting the jumper units on terminal strip TB1 as shown in figure 1.)
