BC-610-() TRANSFORMER REPAIRS

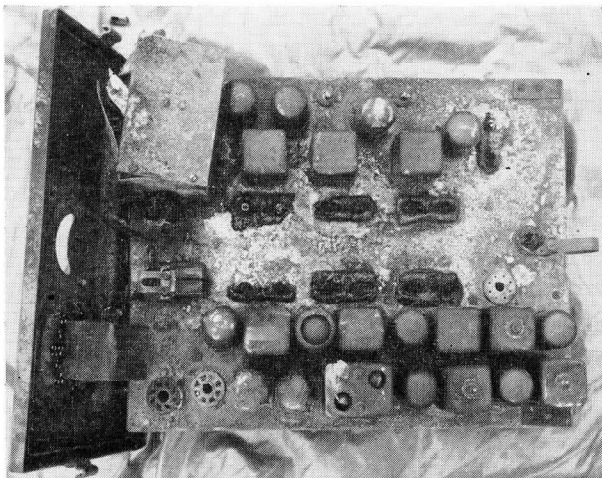
EFFECTS OF SALT SPRAY ON A SIGNAL CORPS RADIO SET.

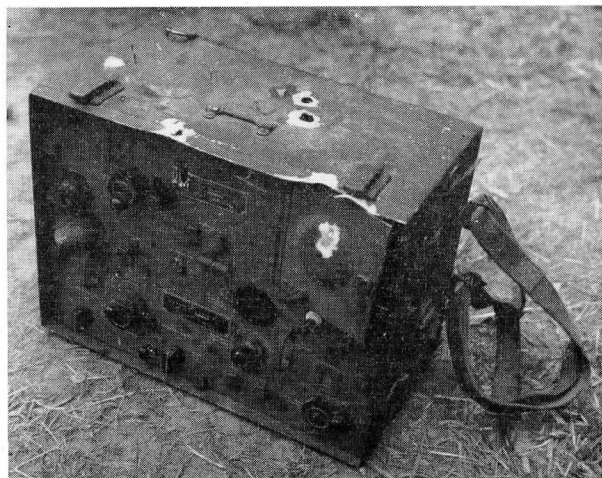
THE BC-654—A DAMAGED BY ENEMY RIFLE FIRE.
