KWS-1 Capacitor Replacement List
1/31/96

SERVICE BULLETIN NO.1

EQUIPMENT TYPE: KWS-1 TRANSMITTER

SUBJECT: PREVENT OFF FREQUENCY OSCILLATION APPEARING ON THE OUTPUT

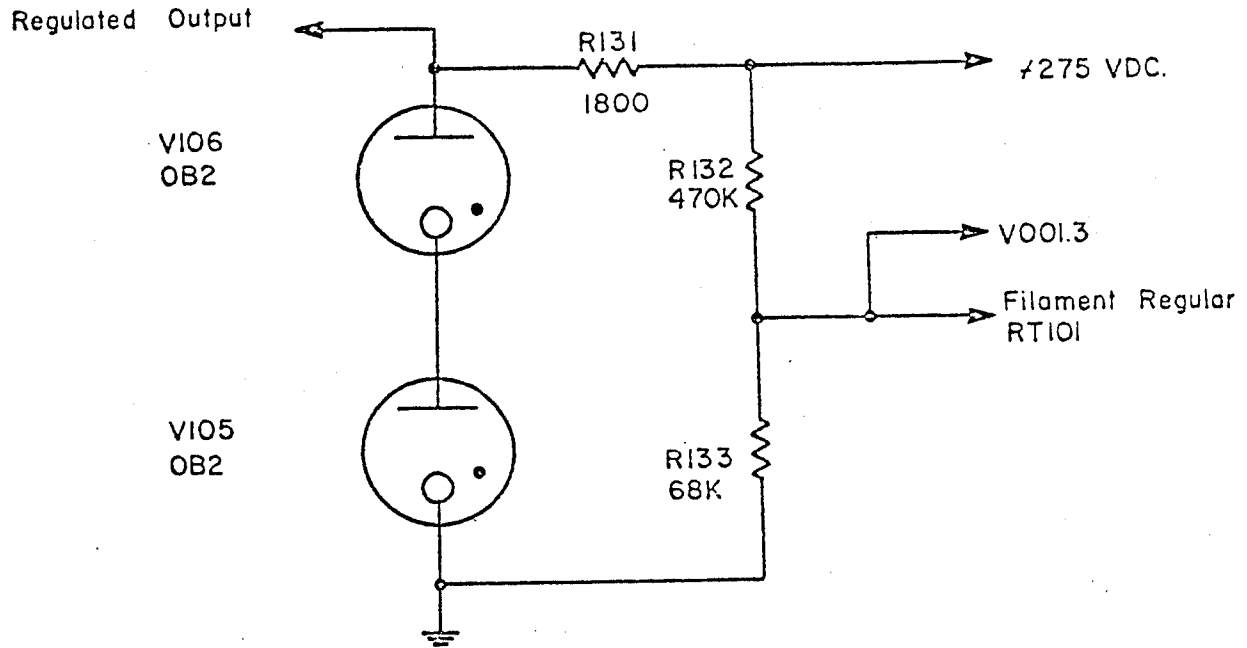
BEFORE MODIFICATION

It has been determined that the current through the voltage regulator tubes V105 and V106 is exceeding the tube ratings and has caused an oscillation to appear on the output approximately 15KCs removed from the operating frequency. This condition can be eliminated by the insertion of a 1000 ohm resistor in series with the input of the VR tubes which reduces the current drain.

In production units with serial number 372 and above this modification is accomplished by changing the value of R131 from 1800 ohm to 2700 ohms. The following procedure is recommended for field modification on serial numbers 371 and below.

1. Remove bottom cover from Exciter/Power Amplifier.
2. Remove the white lead with red tracer, coming from the oscillator housing assembly, from the B / insulated terminal beside the VOX relay.
3. Install an insulated terminal, CPN 306 0234 00, on the RF Chassis using the screw which holds the solder lugs to which the yellow coax shields are tied.
4. Connect a 1000 ohm 2 watt resistor, CPN 745 5652 00, between the B / terminal and the newly installed terminal.
5. Connect the white lead with read tracer removed in step 2 above to the newly installed terminal.
6. Replace bottom cover.
