Restoration of an RCA ACR-175: a mid-1930's 'Classic' – Gerry O'Hara

I was recently asked to work on a couple of mid-1930's RCA communication receivers: an ACR-111 (fairly rare) and an ACR-175 – the latter lower cost and hence more popular/common. The owner also has a much-rarer RCA AVC-11A to refurbish – that will make for an RCA communications set 'hat trick' this year! (and its only August...). The photo, above, shows the ACR-175 on the day it arrived at my workshop.

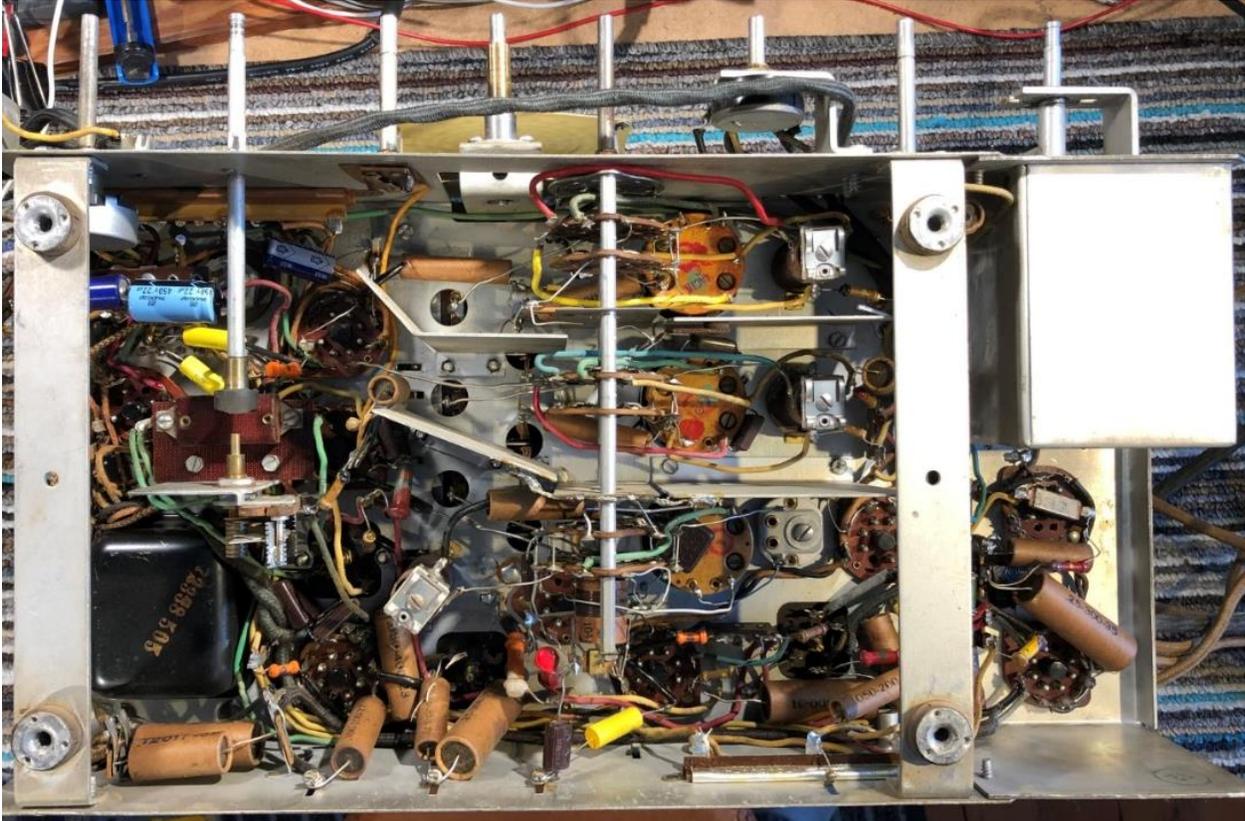
Preliminary inspection of the chassis showed that someone had done some recapping work previously - some electrolytics and a few paper capacitors have been replaced (photo, top of next page). The rubber isolation coupling on the crystal phasing control shaft was broken (photo, right) – easily fixed with a drop of Duco cement, but otherwise things looked in reasonable physical shape under the chassis. The speaker driver looked ok too, this being mounted on a simple wooden baffle stand, and is thought to be the original as supplied with the set.

- Reversing the 'obvious' repairs, eg. using re-stuffed capacitor shells recovered from the work on the ACR-111 chassis to install in place of the 'modern' replacements, and removal of the 'modern' under-chassis electrolytics and re-stuffing the original electrolytic capacitor cans;

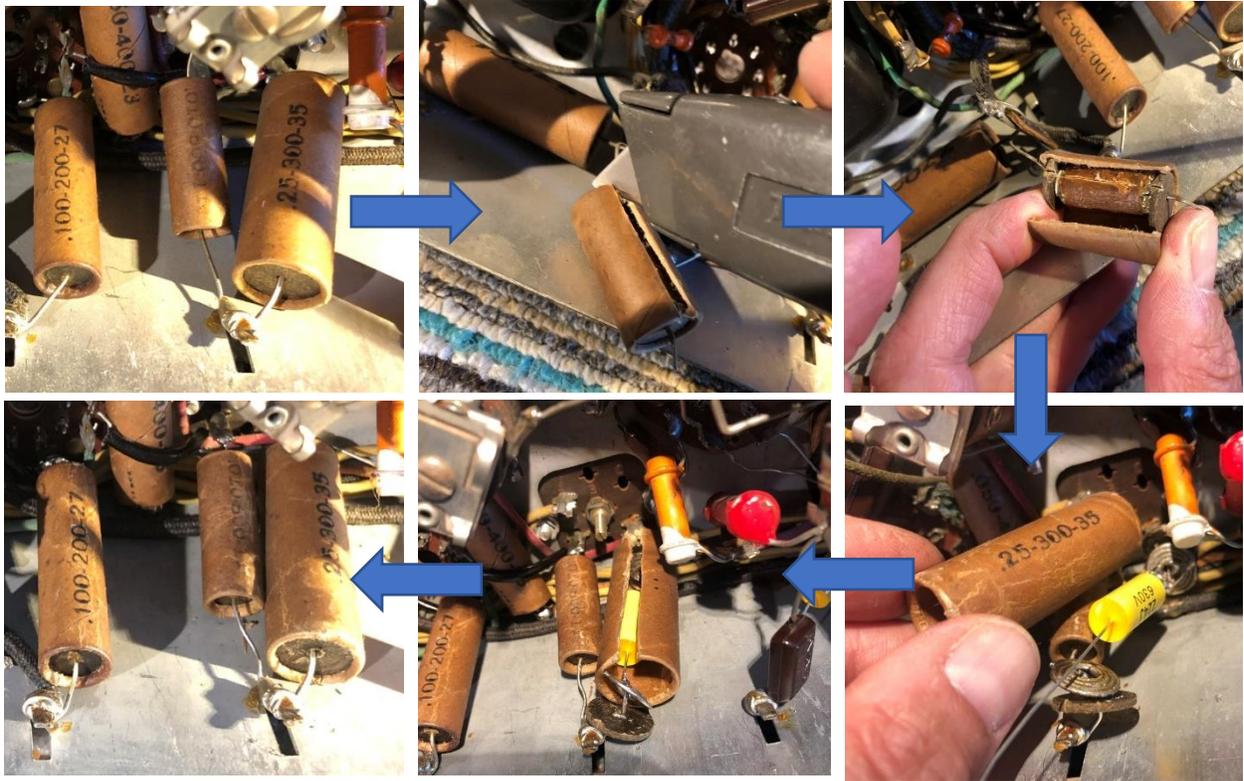
As an experiment, and to see if the technique would satisfy the owner's request, I tried an 'in-situ' re-stuff of one of the original tubular paper caps near the rear apron of the chassis. The sequence of this process is shown/explained in the sequence of six photos at the top of the next page. The technique was successful on the 'sample' capacitor, and the owner was pleased with the result, so I therefore planned to continue with this technique for the remainder of the original tubular paper capacitors. This part of the work comprised:

- Identifying a couple of cardboard capacitor 'shells' with '0.01uF' markings on them in the 'old parts' bag left over from working on the ACR-111 (it used the same type of cardboard tube capacitors, but these were not re-stuffed in that chassis), re-stuffing them, retaining the original leads, and installing them in place of the two previously replaced (yellow) caps in the BFO unit. Although these parts will not be seen when the BFO screening can is in place, the owner chose to have as 'all original' look as possible;

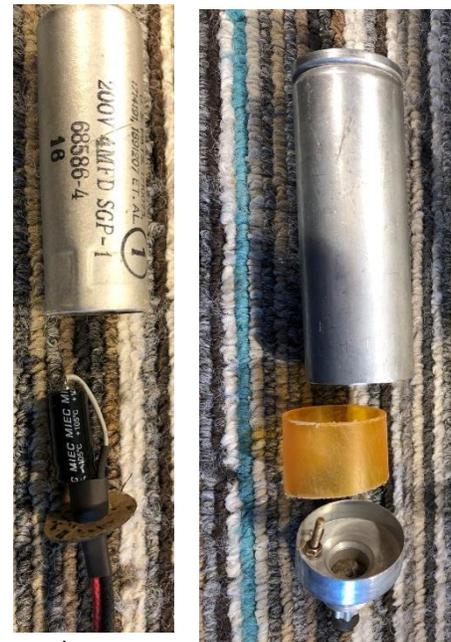
- Removal of a tagstrip someone had fitted to install replacement electrolytics, and the removal of all three replacement electrolytics. I then removed the three above-chassis capacitor cans (one is cardboard), re-stuffed them with fresh electrolytics (photos, right), and then re-installed them on the chassis. I had to change out one of the retaining nuts on one can capacitor spigot to one that could be soldered to as the large solder lug was missing - both of the metal can electrolytics are insulated from the chassis and their negative connections (cans) are connected together electrically;

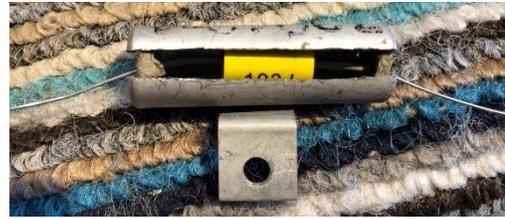
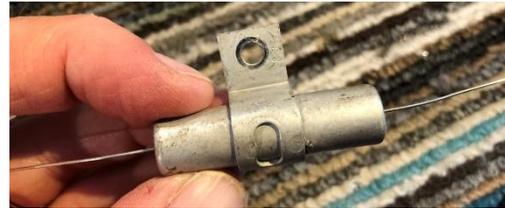
- On completion of the above, I found one last tubular paper cap lurking on the chassis – a metal clad one next to the volume control on the front apron. I removed it, cut the casing with a Dremel, re-stuffed it and re-mounted it so it looks completely original (photos, right);

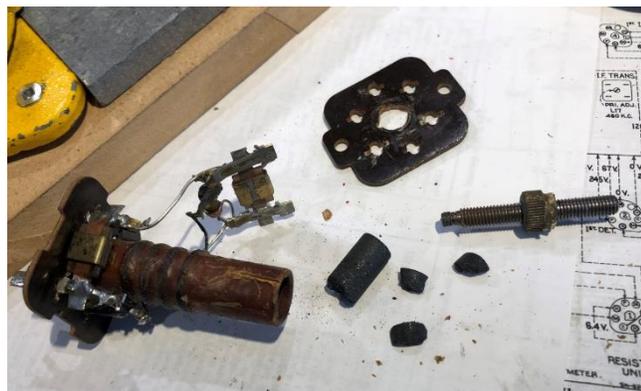
- I disassembled the BFO coil (not easy!) and sure enough, the adjustment screw had detached from the end of the slug, and part of the slug had disintegrated (photo, right);

- I used J-B weld to re-attach the slug to the adjustment screw, setting up a circular mould using masking tape (photos, right, show the masking tape mould (top), and repaired slug (bottom)).

Once the J-B Weld attaching the BFO adjustment screw and the powdered iron slug was set, I trimmed it up and epoxied the threaded brass bushing back into the end cap of the BFO coil former. I lubricated the adjusting screw with ROCOL Kilopoise high viscosity grease and it now had a nice smooth feel when rotated. I checked the 100Kohm resistor that is installed in the can and it was well within tolerance (within 1%!), so I left it in place. I then re-installed the coil assembly into the can and reconnected it into the circuit. It now worked well, with around +/-5kHz frequency swing, plenty of room for adjustment of centre frequency, and it has a good injection level.

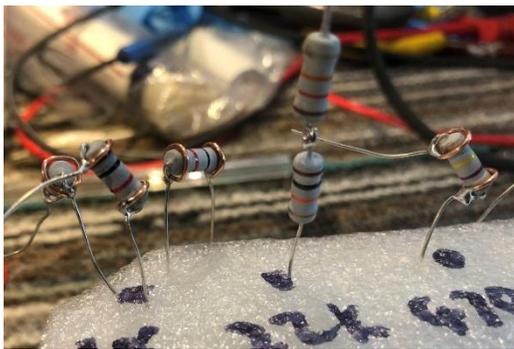
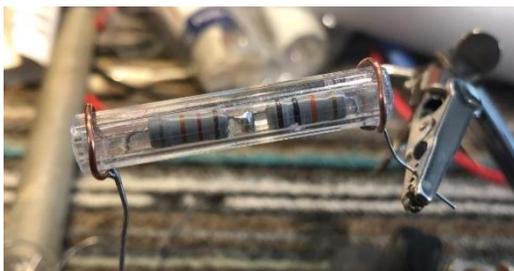
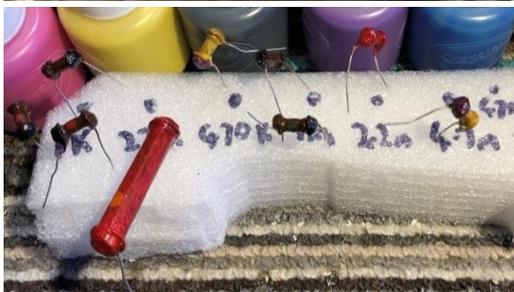
I checked all resistors (mostly in circuit, but with one leg detached where appropriate). I found that twelve were >20% (or very close to) tolerance and should be replaced. The resistor types are a mix of larger and very small dog bone types, and therefore can be reproduced reasonably well:

- The original resistors are a bit of a mix of styles, so rather than try to reproduce each one exactly, I made 10 of them a 'generic' dog bone

style with the wire-wrap ends, and two hex-body larger ones to match the two like them being replaced exactly (a 22Kohm and an 82Kohm part);

- The photos, left, show the fabrication of the wire-wrap dog bone style resistors: the leads were bent to 90 degrees, a loop of copper wire made and wrapped around each end of the resistors, and then soldered to each of the resistor leads to secure in place. The ends were then re-shaped using epoxy putty and then painted with the 'body-end-dot' colour code using acrylic paints. After painting the resistors, they were given a coat of amber shellac to give a semi-gloss 'aged' finish.

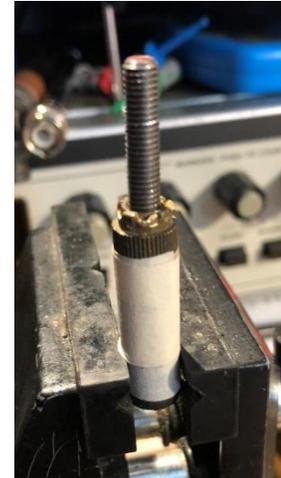
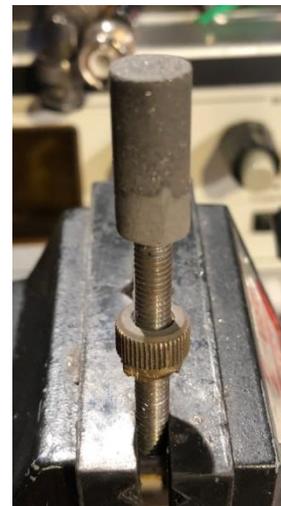
- Two of the 1Kohm resistors that measured out of tolerance were, when looked closely at the

originals, 1.2Kohm parts (different from the schematic) and so were actually well-within tolerance, so I left them in (they are plate load resistors and are not critical anyway);

- I then fitted the repro resistors in the chassis (I decided to use un-modified resistors in the tuning eye socket and 3rd IF can where they will not be seen);

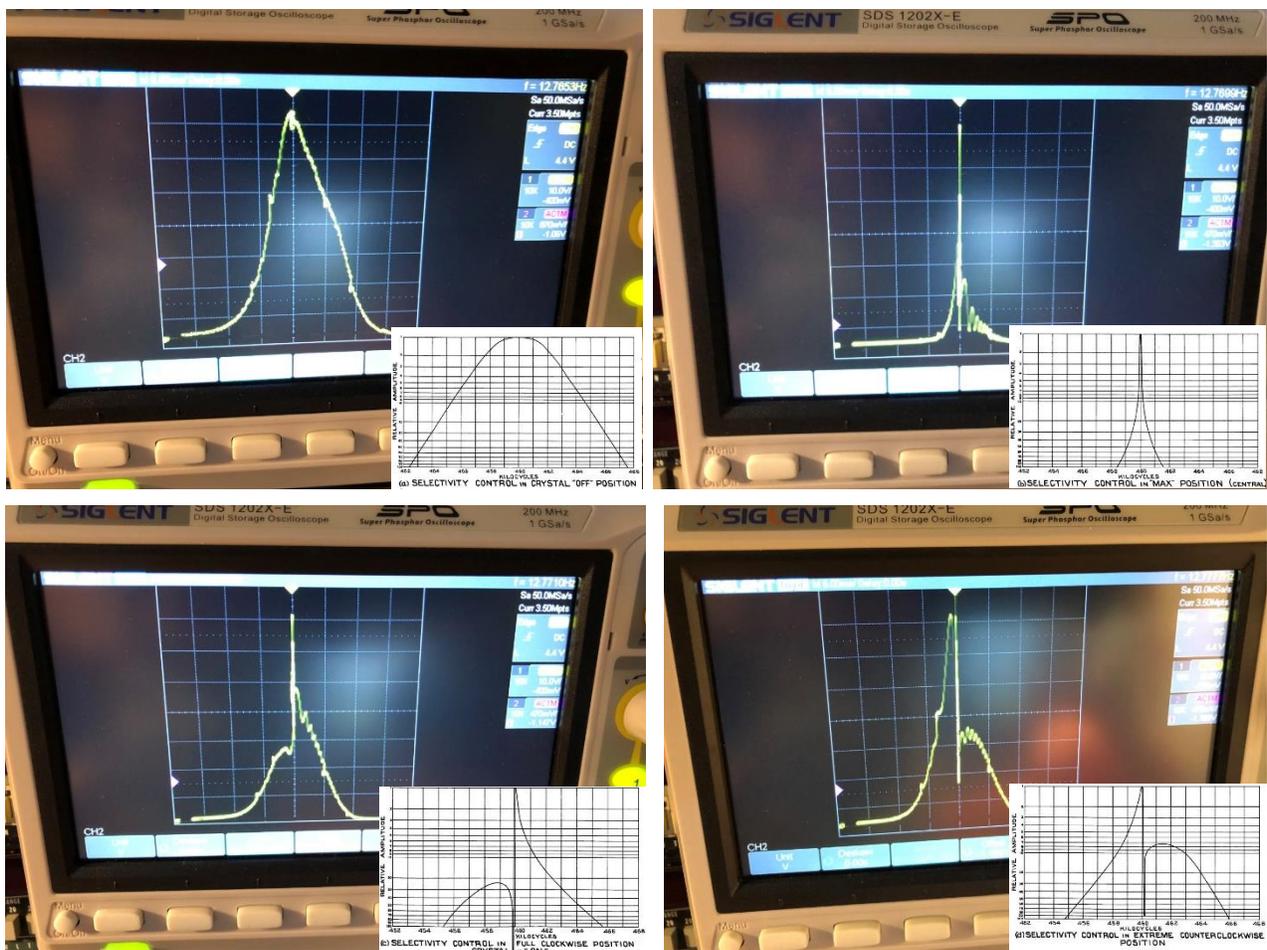
Above - photos of the IF response curves as follows: top left - without crystal filter (with and without 20KHz marker pips; top right - crystal filter in, phasing control centred ('max selectivity'); bottom left - crystal filter in, phasing control fully clockwise; and bottom right - crystal filter in, phasing control fully counter-clockwise. These closely match the 'ideal' response curves provided in the manual (shown on the inset figures above on each photo for comparison). With the crystal out of circuit the response is sharper than the manual shows, which, in my opinion, is much better-suited to a receiver intended for communications use

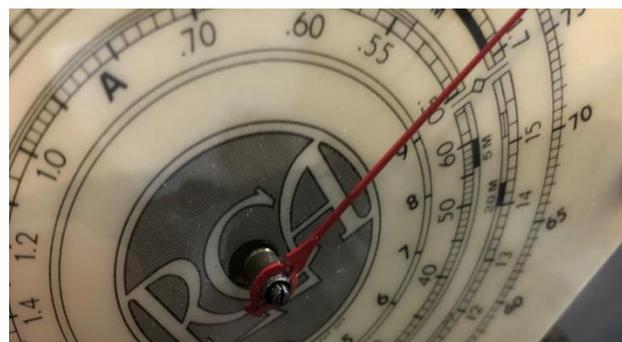
I cleaned and lubricated the tuning gang: there was a mechanical issue with the dial mechanism in that the logging scale pointer (the red one that should turn rapidly -photo, right) did not turn as the gears/pinion driving it were not engaging properly. This also made the main tuning feel 'lumpy', so needed to be fixed. To access these gears required the dial to be removed, and to do that, the pointers had to be removed first.

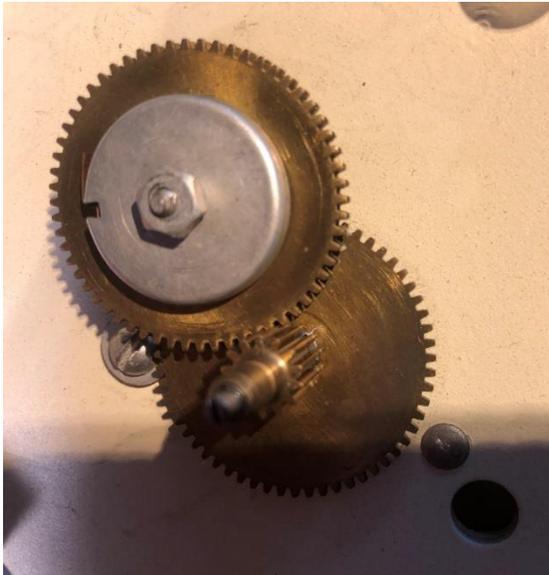
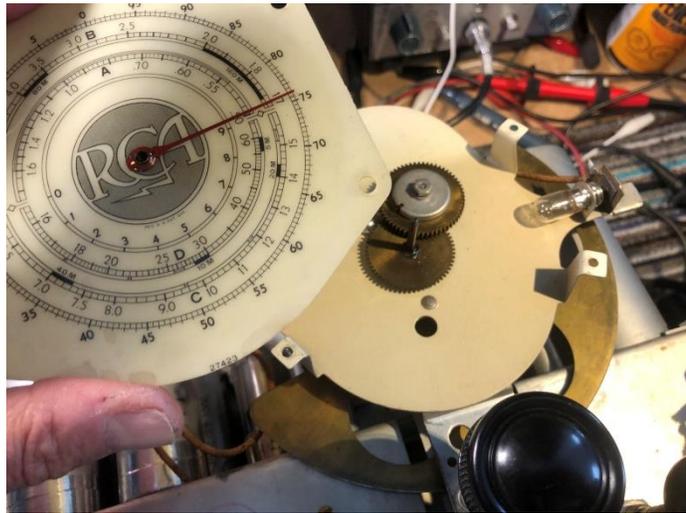
Unfortunately I found that I could not move the screw at the centre of the pointers to do this - it was really tight. I tried every 'watchmakers'

I next placed the chassis facing towards the ceiling with a few drops of penetrating oil placed on the pointer retaining screw hoping this would help to loosen the screw – I left it like this overnight. The screw would not budge the next morning – I then tried applying heat, cooling, tapping, etc as well. Nothing worked: and for good reason – its not a screw! It's actually the end of the tuning shaft, which is split and gives the appearance of a screw. The pointers are simply a friction push fit over the concentric shafts²! Anyway, once I realized this, I had the thing apart in minutes (photo, below right). The problem with the tuning was a mixture of wear and a loose anti-backlash spring housing bell. I had to bend the idler gear shaft slightly to ensure reliable mesh of the worn gear/pinion, engage and re-tension the spring, and use a new star washer to prevent its housing bell from rotating (photo, below left). I cleaned everything, lubricated it and it was then very smooth in operation. Instead of the split rivets that were falling apart, I mounted the dial (after cleaning) using screws. A short video of the fixed dial operating can be seen [here](#) (it looks a bit jerky on the video, but it's very smooth in reality).

² The clue was in an [ARF post from 2008](#). Yes, it pays to do your homework: ".....Eureka!! Paul with the RCA 143, take note. That was not a screw head. It is the top of the shaft. With all the liquid wrench, I was able to twist the pointer on the shaft. With a strong tug upward the pointer came off. The slot in the top of the shaft looked like a screw head, but was not. Appreciate all the advice, it kept me thinking. Thank goodness I gave it one more look before resorting to the file.....". I figured RCA may have used the same disguise on the ACR-175, and sure-enough, they had.

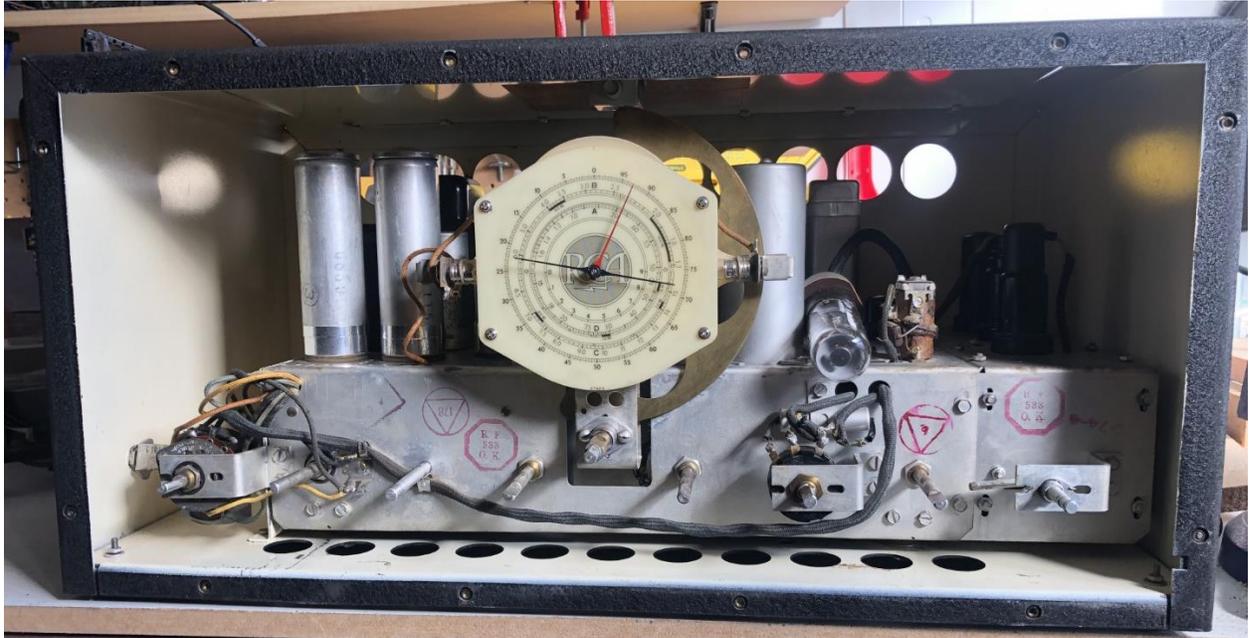
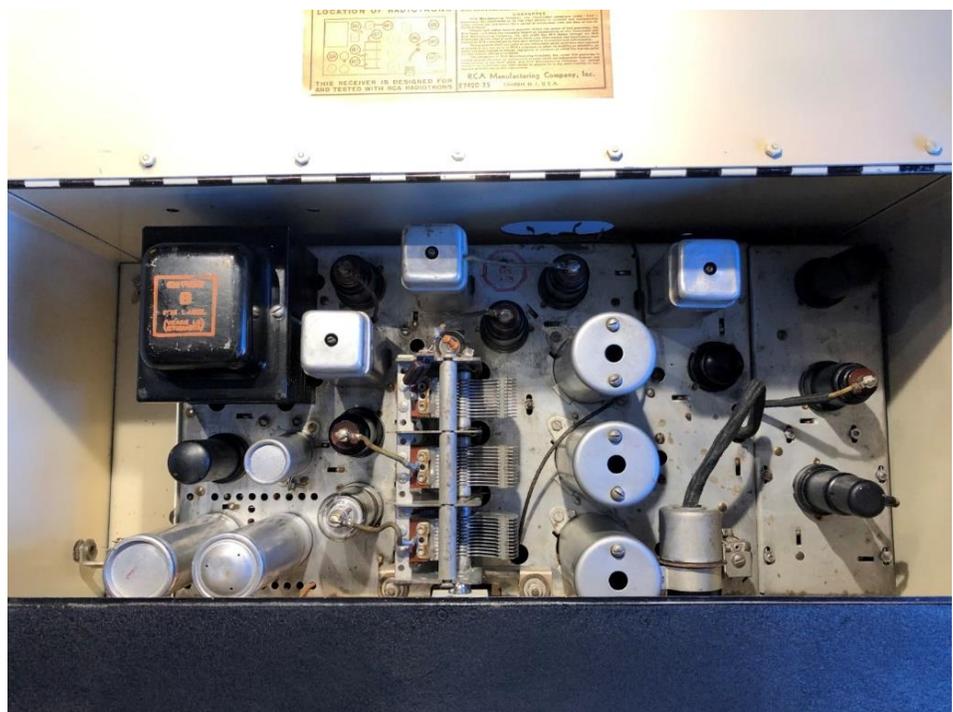
- Installing the chassis into the cabinet (photo, above – without the front panel fitted, photo, right – the chassis viewed through the cabinet lid): I noted that two of the front panel screws had been sheared-off sometime in the past and the threads are stuck in the

holes (and, of course, the heads were missing). I found a couple of similar-looking screws, sawed the heads off and epoxied the heads into the holes as 'dummy' screws, then painted them black to match the others;
