# The Kenwood MC-60A Desk Microphone Rebuild

The whole purpose of this page is to share what I learned to rebuild the Kenwood MC-60 Desk Microphone due to hours of search engine hunting turning up nothing.

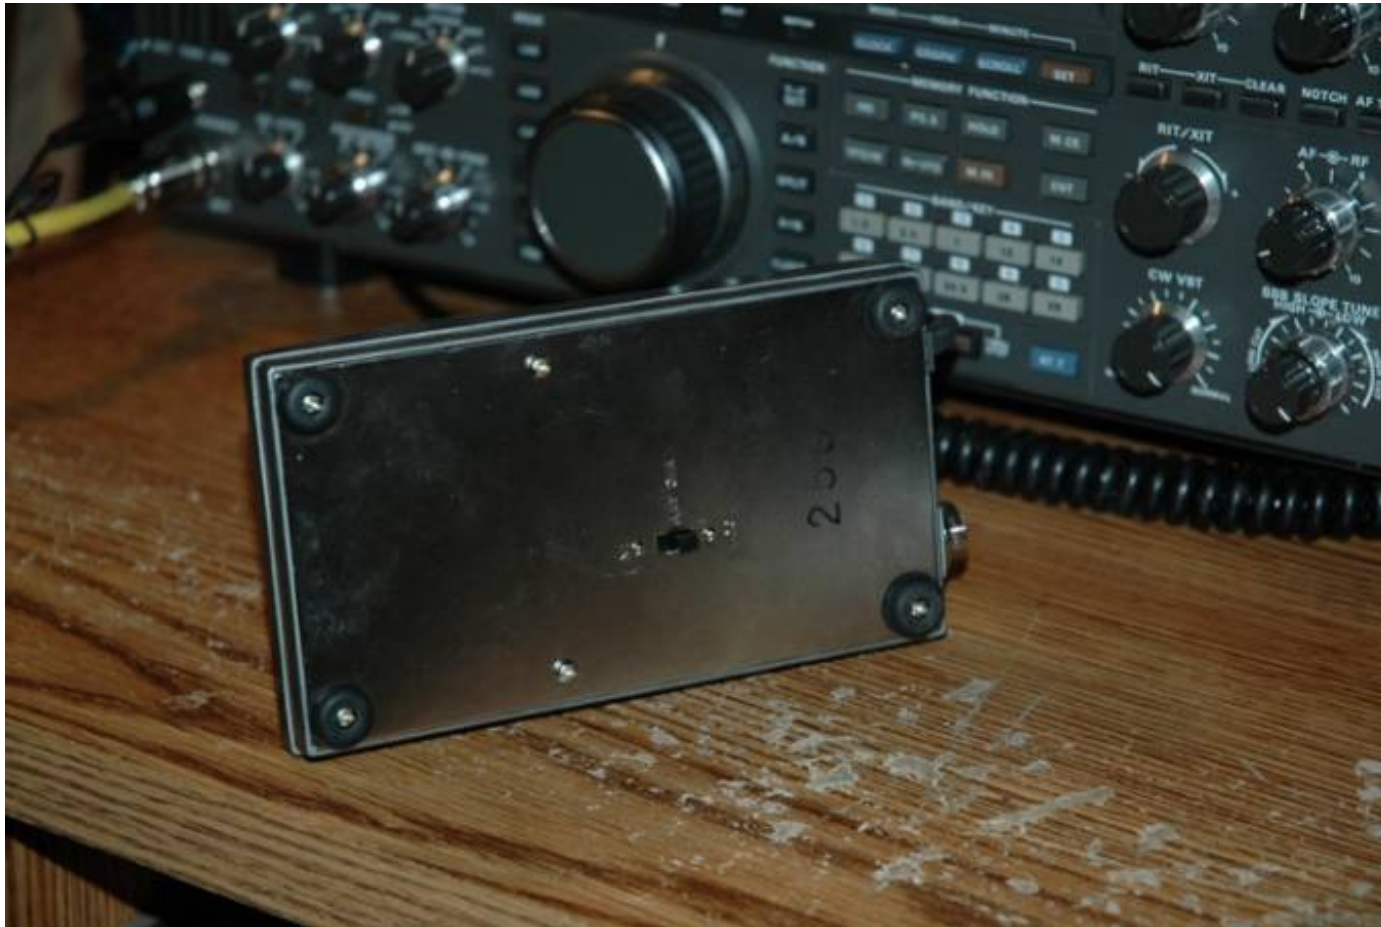
Bottom View- Shows Pre\_amp “In/Out” switch

The first step was to check the continuity of all the switches involved- P.T.T., Lock, and pre-amp “in/out”. The only one I found bad was the DPDT slider for the pre-amp “in/out”. Then I began to carefully unsolder all the components, except the resistors and the zener diode, which can be accurately checked while still soldered to the board. Use great care not to overheat as many of these components can be damaged by heat. Use of a heat-sink is a good idea.

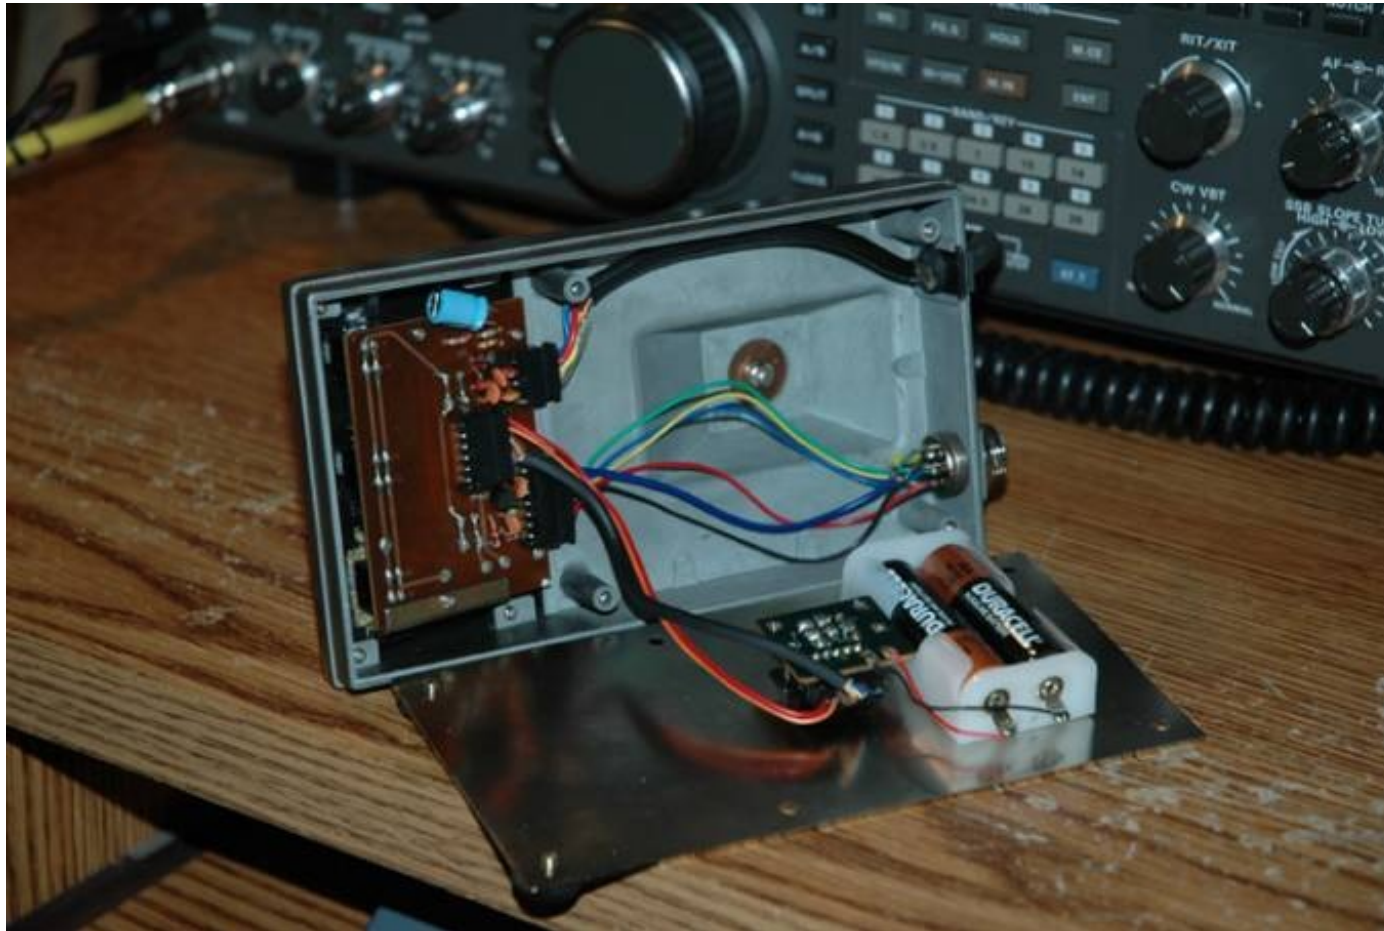
Open base- This is an after-repair photo- The electrolytic Capacitor here is rated at a higher voltage than the factory One, hence it's larger size

While I found that the tantalum capacitors, diode, transistors and resistors were all fine, I did have a couple bad disc capacitors and electrolytic capacitor. These were easily obtained at Radio-Shack, however the only 100microF electrolytic they had was rated at a higher voltage than the factory one, so it is a little larger, but didn't really pose a problem for fit. I figured that the price was right, and the time was right to replace all the capacitors except for the tantalum ones, and carefully, the components were all replaced into their respective positions on the boards. I say boards, because the pre-amp switch is soldered into the smaller board attached to the cover-plate.

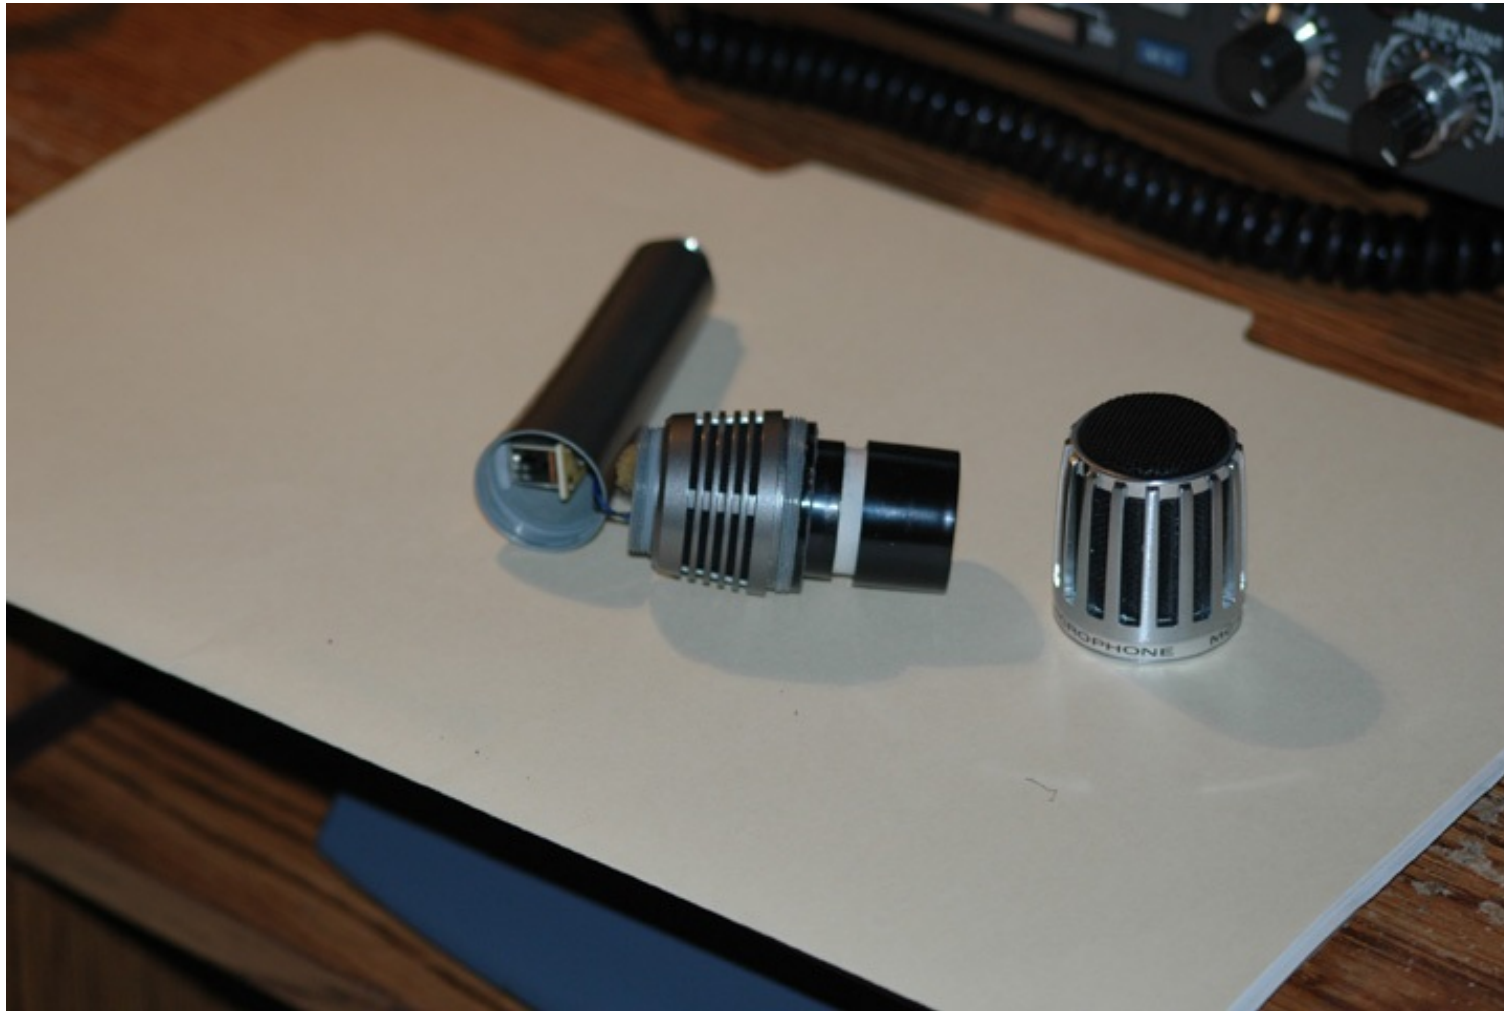
channel locks to disassemble it (it gets very hot when heated, and isn't the easiest thing to grip). DO NOT squeeze the mic too hard with the pliers or you will dent/bend/mar the fins/grills. This is what it looks like:

Note the large size of the microphone element. All my connections were good here, so I did not take it apart any further. But I do know what it looks like if I ever want to replace the mic element with a Heil or something.
