222-1 shortwave receiver Service log
Virgil Cheng vr2xgm

19-Mar-2025, PSU unit, History:

- Units acquired early 2000s
- 222-1 not frequently used SW receiver, put in storage
- Unit #1 dated Sep-1971, without serial number
- Unit #2 dated Feb-1974, without serial number
- Recently retrieved for inspection

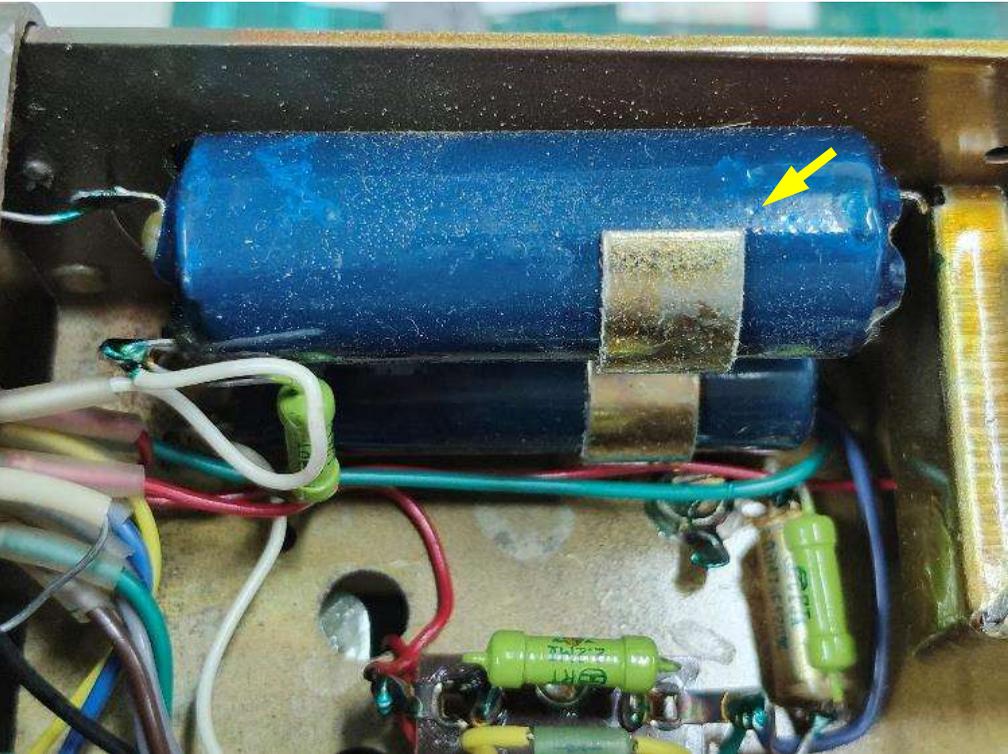
Ecap case is negative, blue jacket insulate case from chassis. Inadequate by today's standard

- Electrolytic capacitors need replacement
 - Long term reliability or vintage part preservation ?
 - Sealed part, tested functional, [keep vintage part](#)
- Rectifier diodes with 1971 date code, rating lower than popular 1N400x series diode first released in 1963
 - Long term reliability or vintage part preservation ?
 - Tested functional, current rating low by today's standard, [keep vintage part for the moment](#)

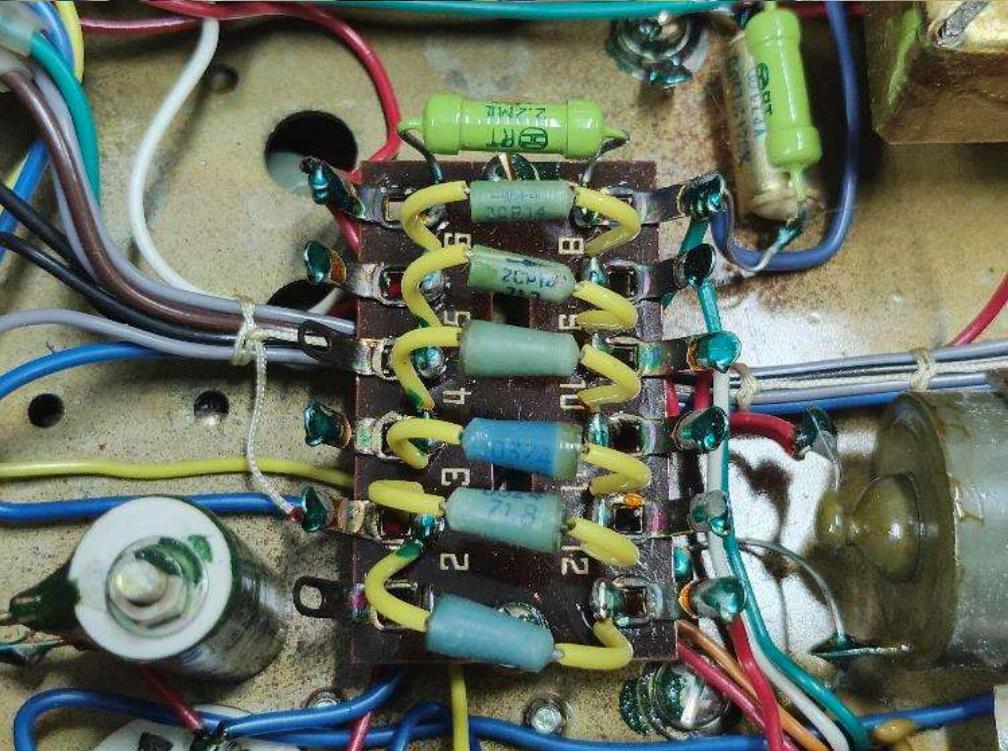
Rectifier diodes with 1971 date code

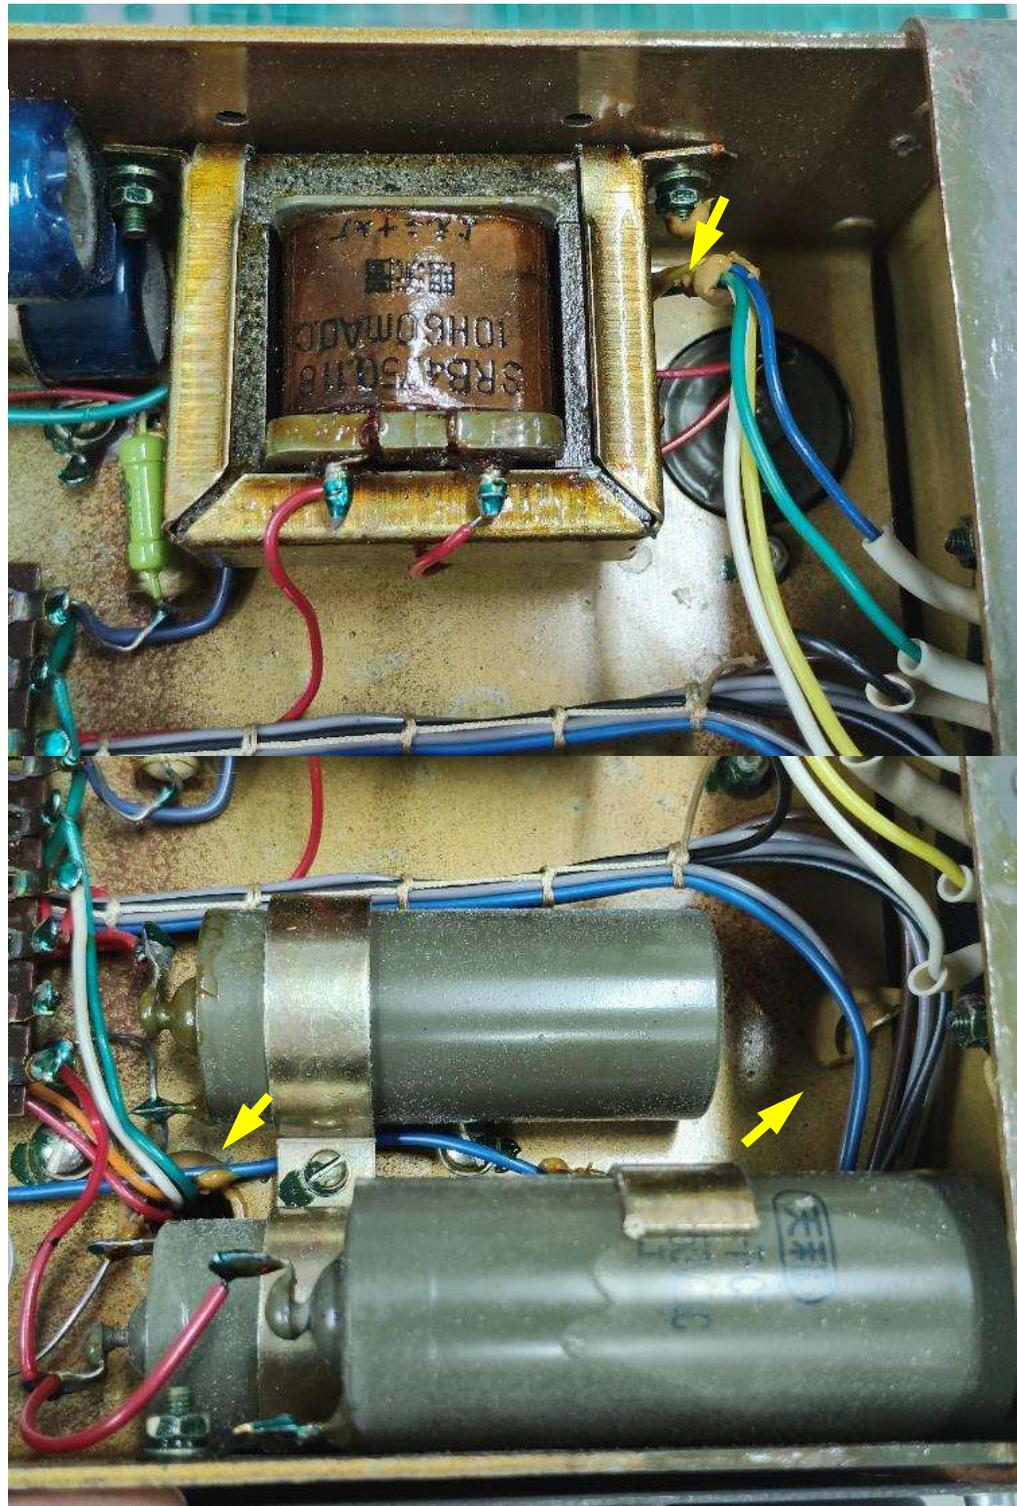
Disintegrated grommet dropped onto harness and chassis

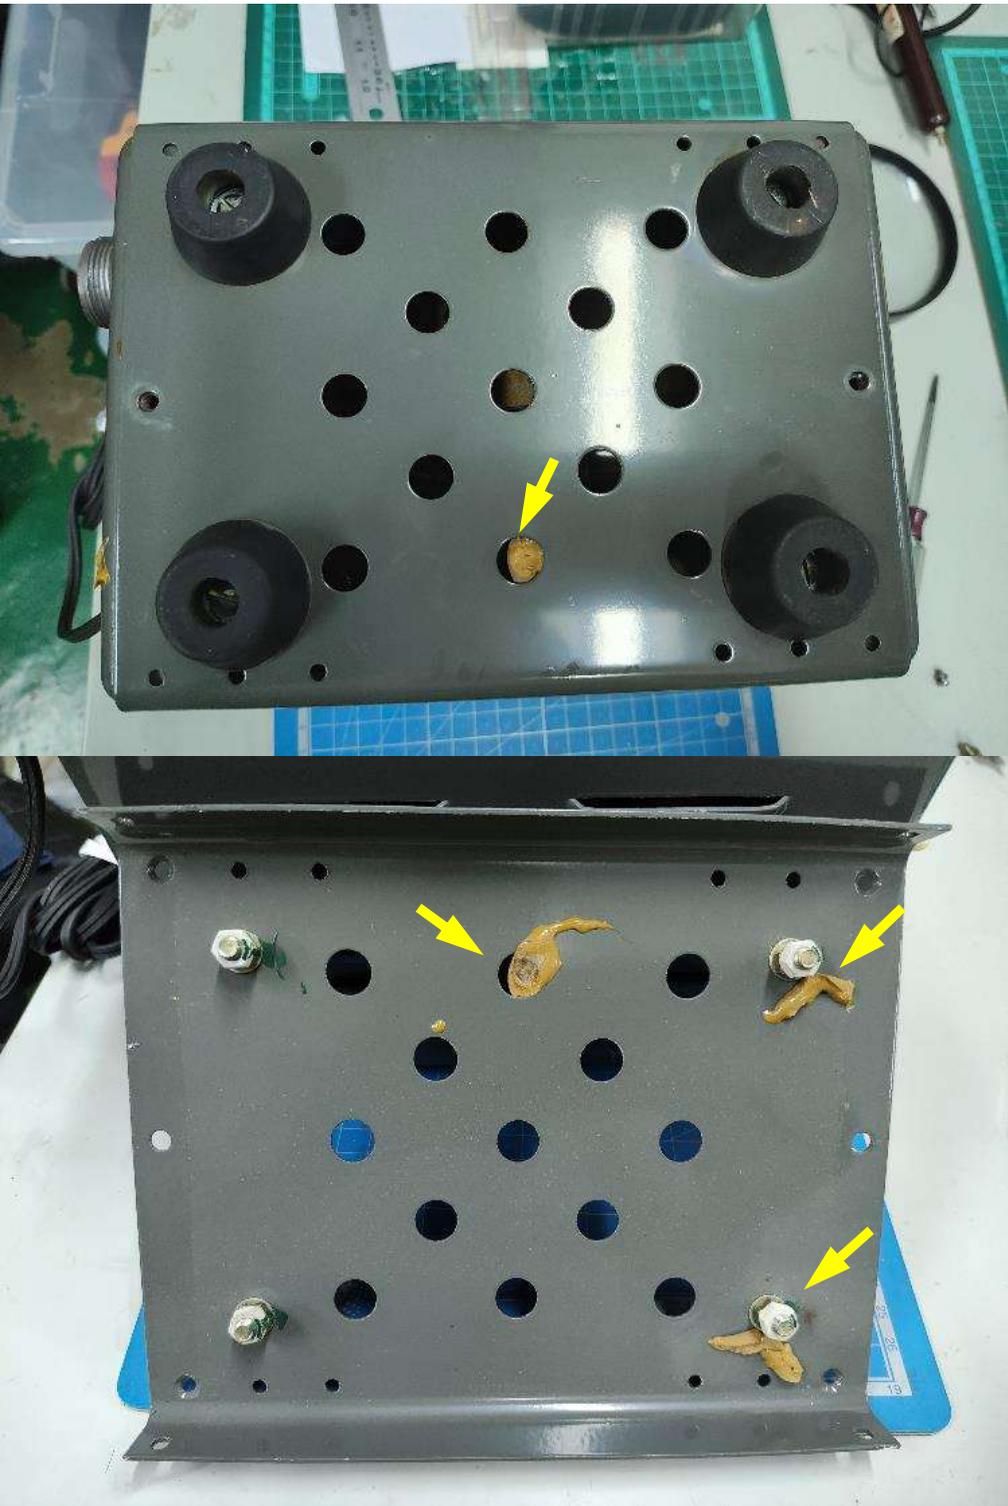
Grommet residue on bottom cover

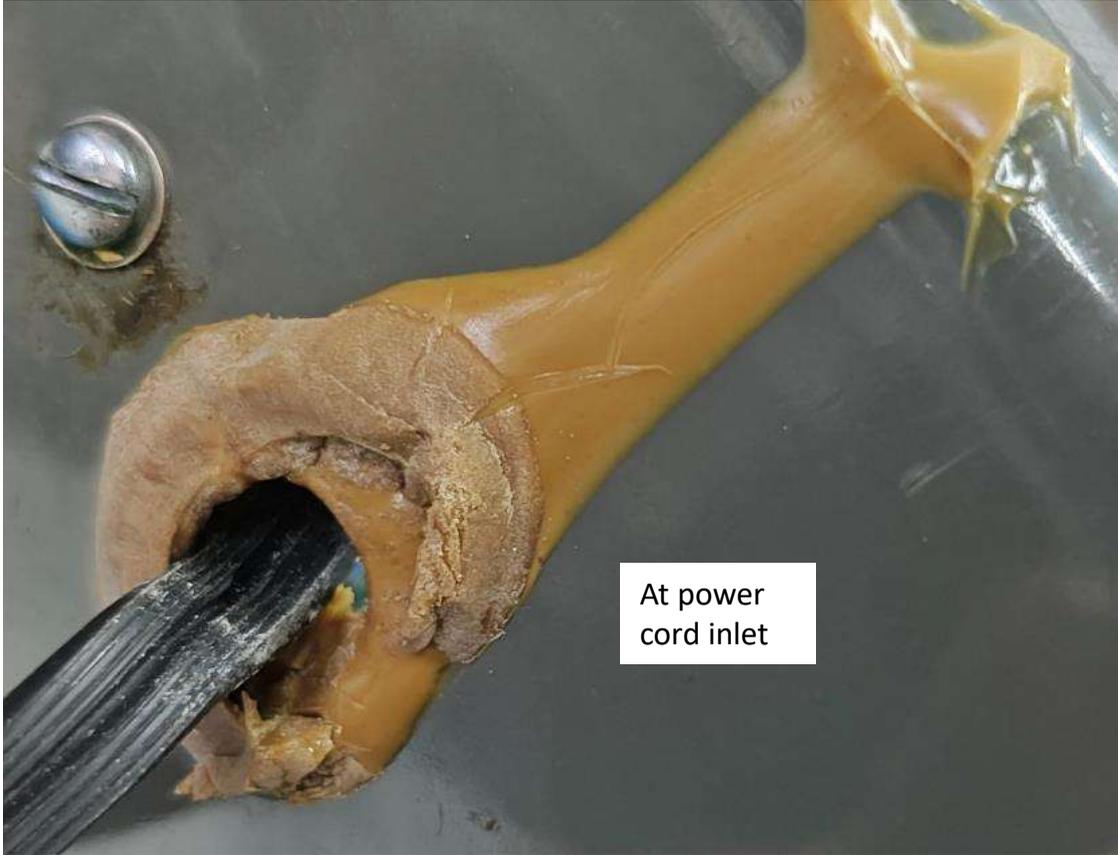
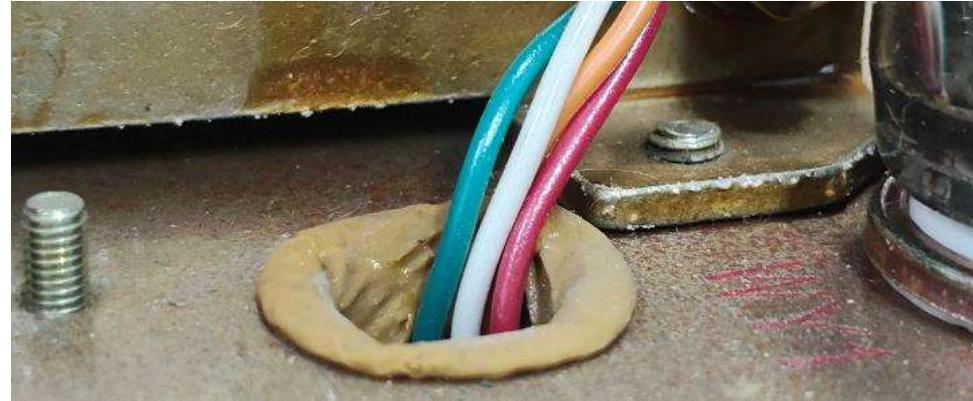
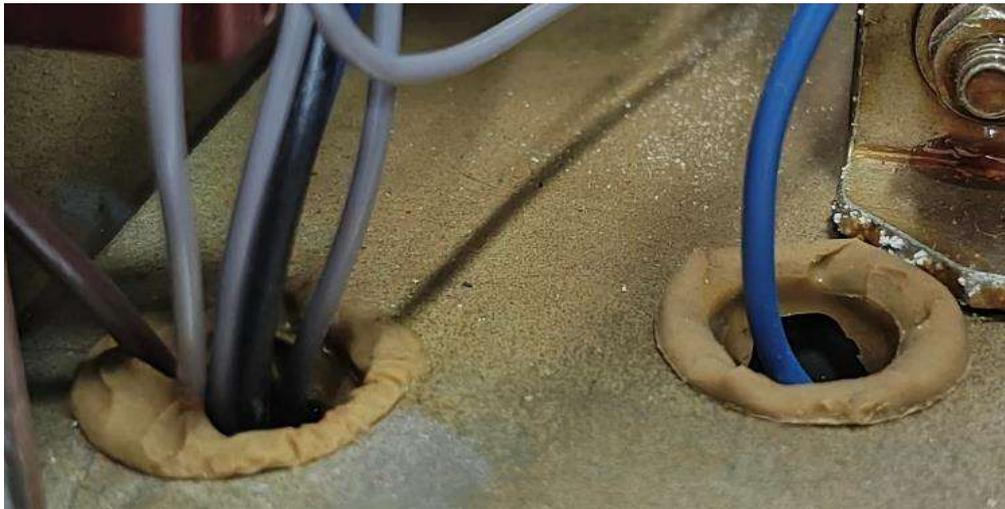
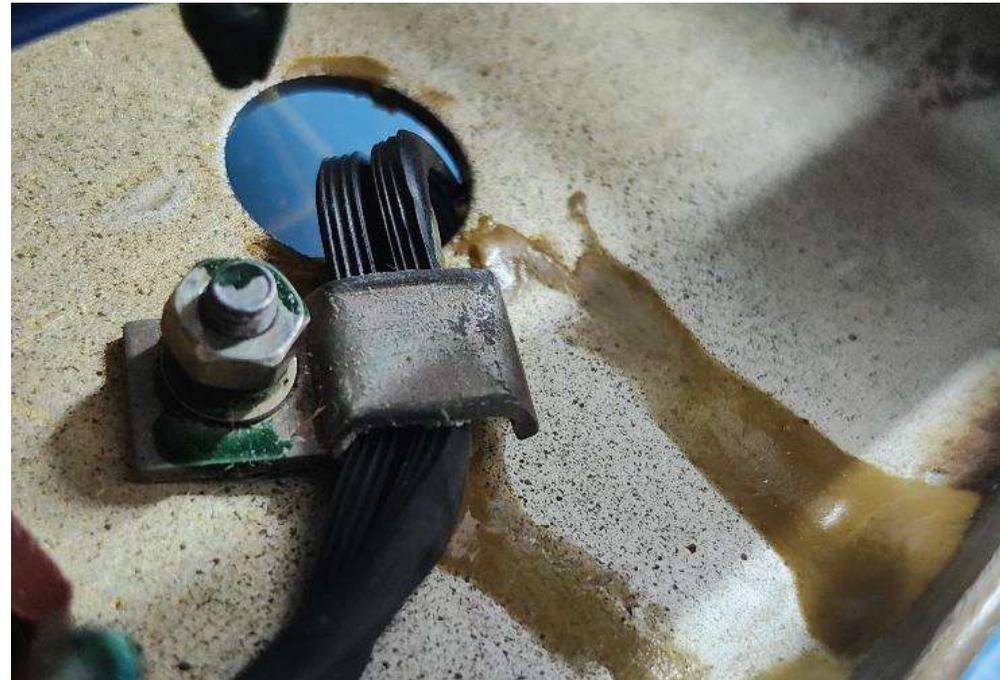
Grommet disintegration

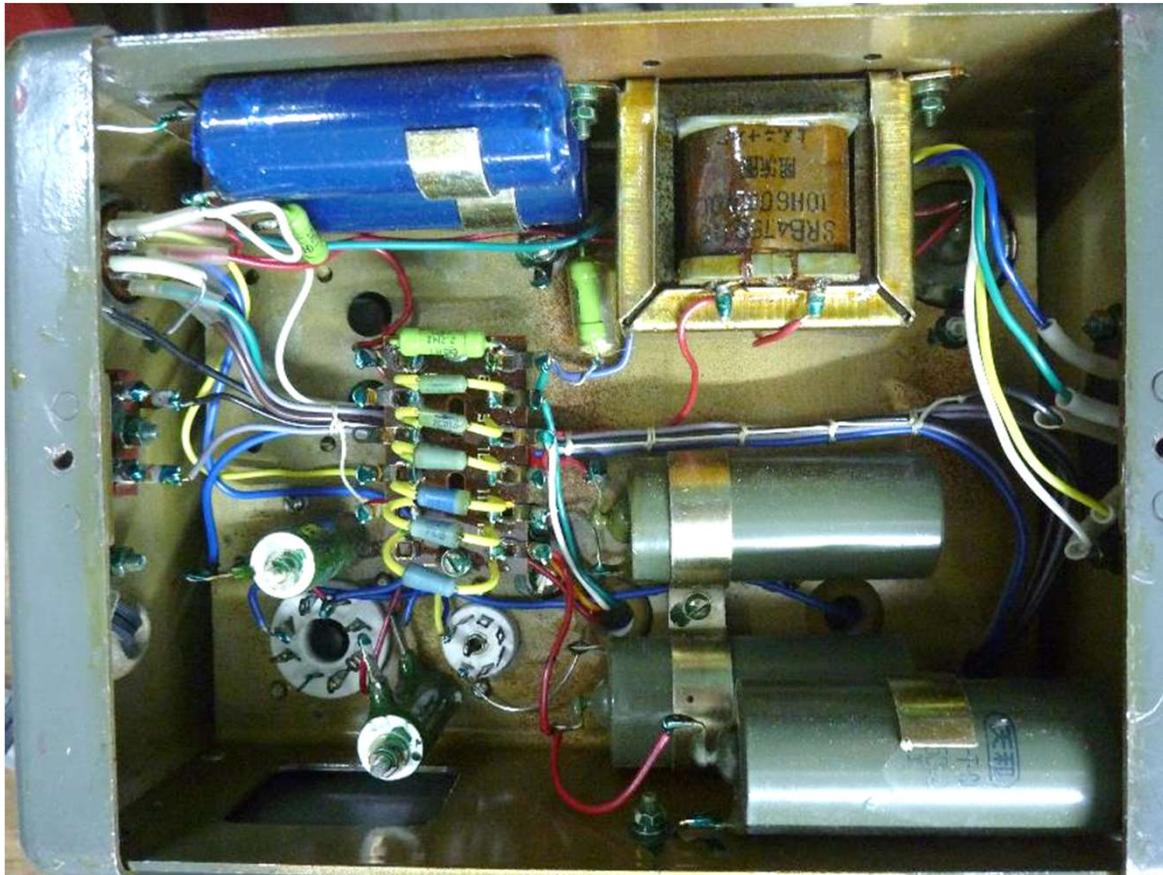
Jun-2011

Unit condition comparison present and 14 years ago, rubber grommets melted away

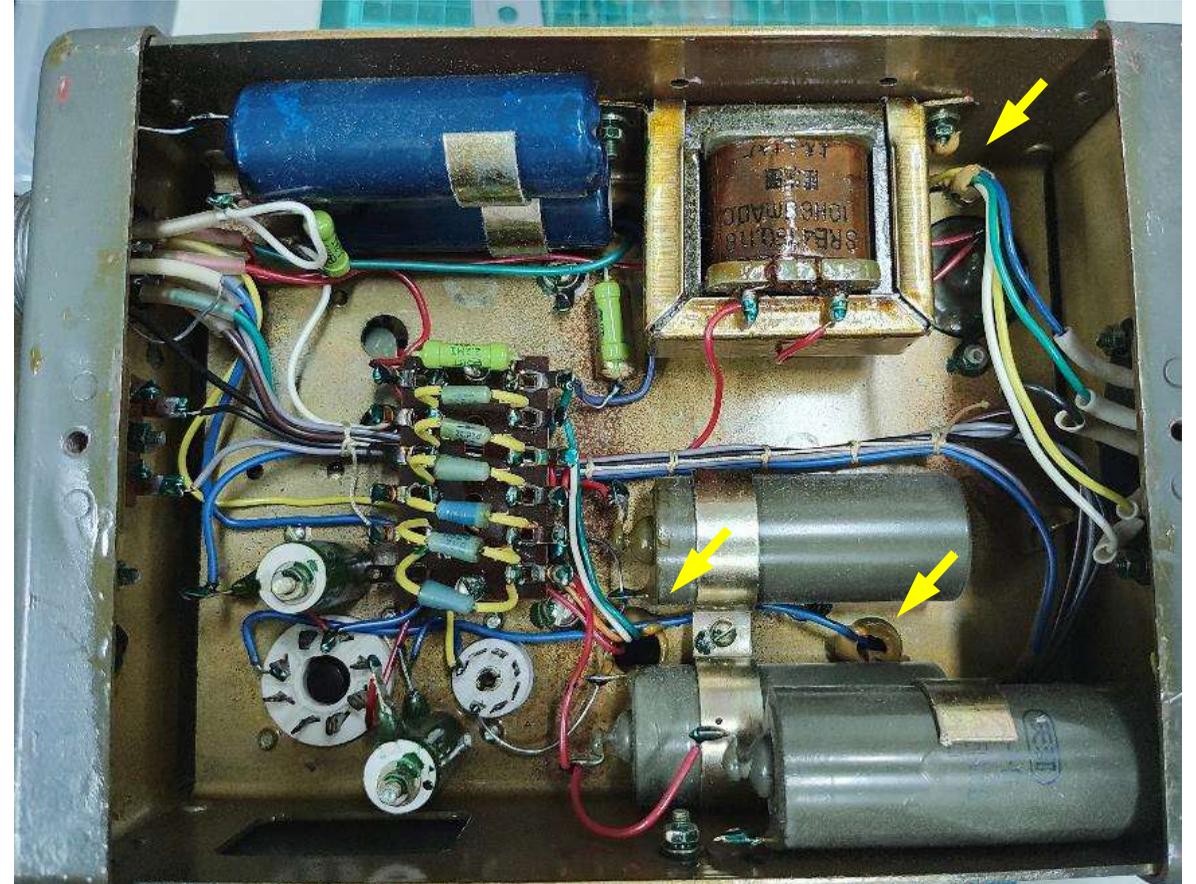
Mar-2025

- Rubber grommet disintegrated; fluid dropped to various places in chassis

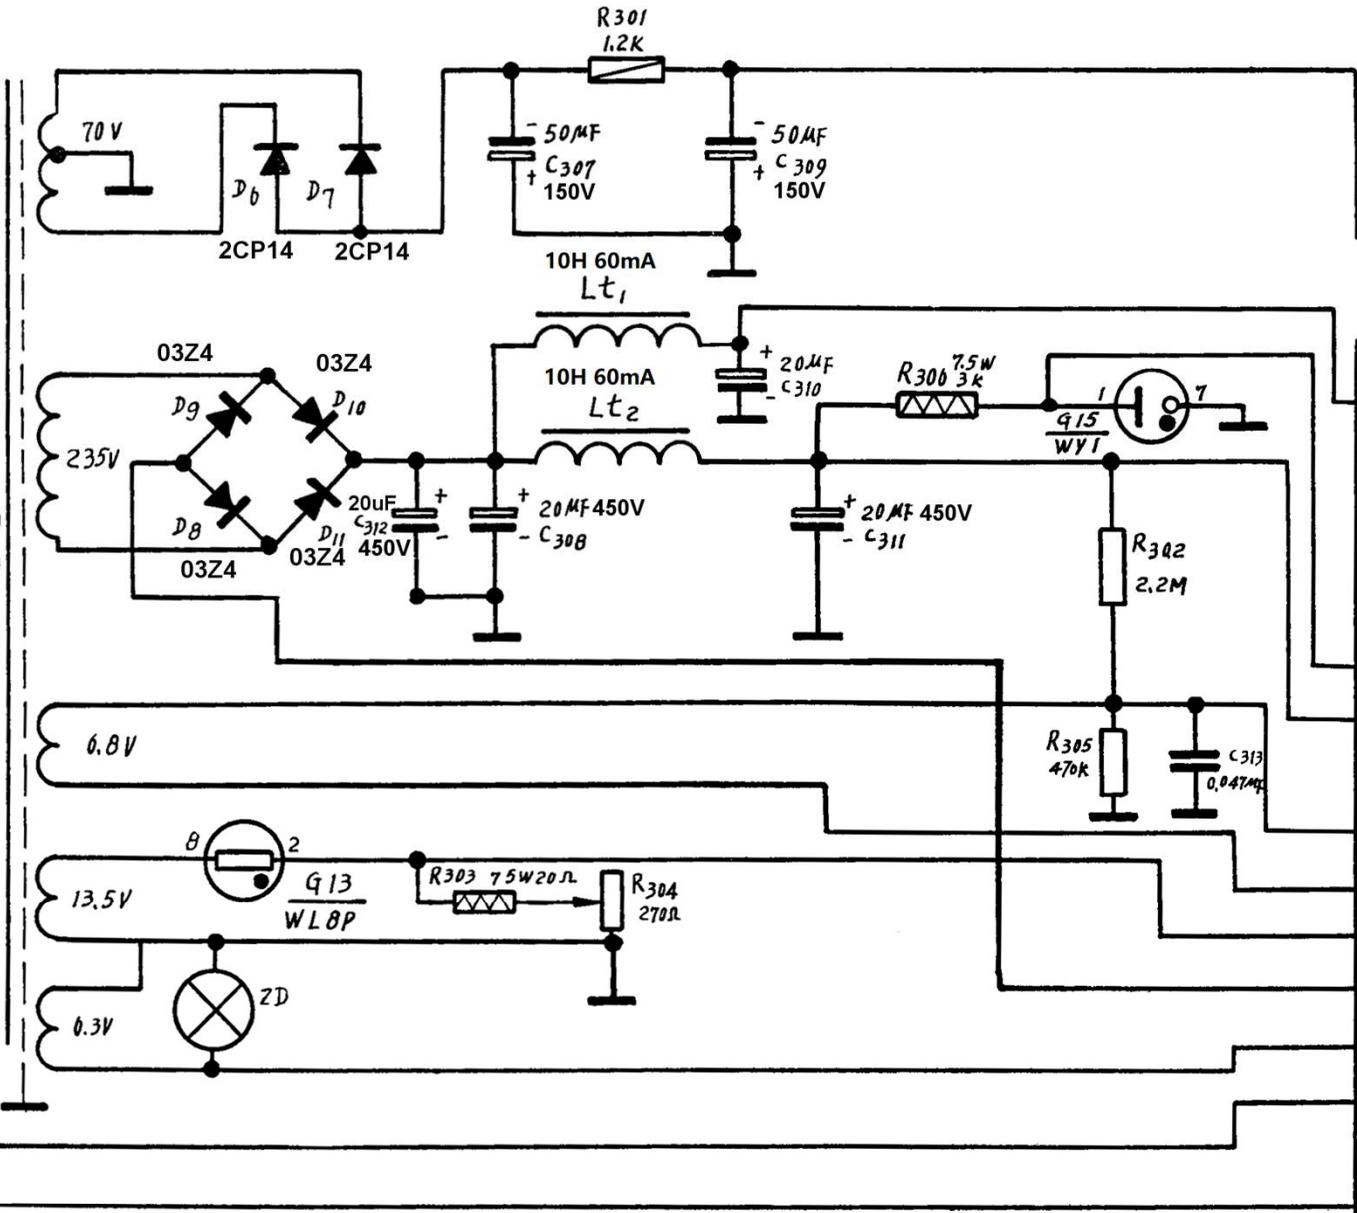
PSU schematic, operator's manual pg.55

Fuse inside voltage selector
 Rotate anticlockwise one step
 beyond 240V position to eject fuse
 from side slot, **DO NOT PULL**, this is
NOT a plug

CZ ₂	
编号	特性
1	-40V
2	
3	地
4	+250 (910 911)
5	
6	
7	
8	
9	+150V (總)
10	+250V
11	
12	~6.8V (+40V)
13	0
14	~6.3V (總)
15	0
16	~6.3V
17	~220V
18	
19	~220V

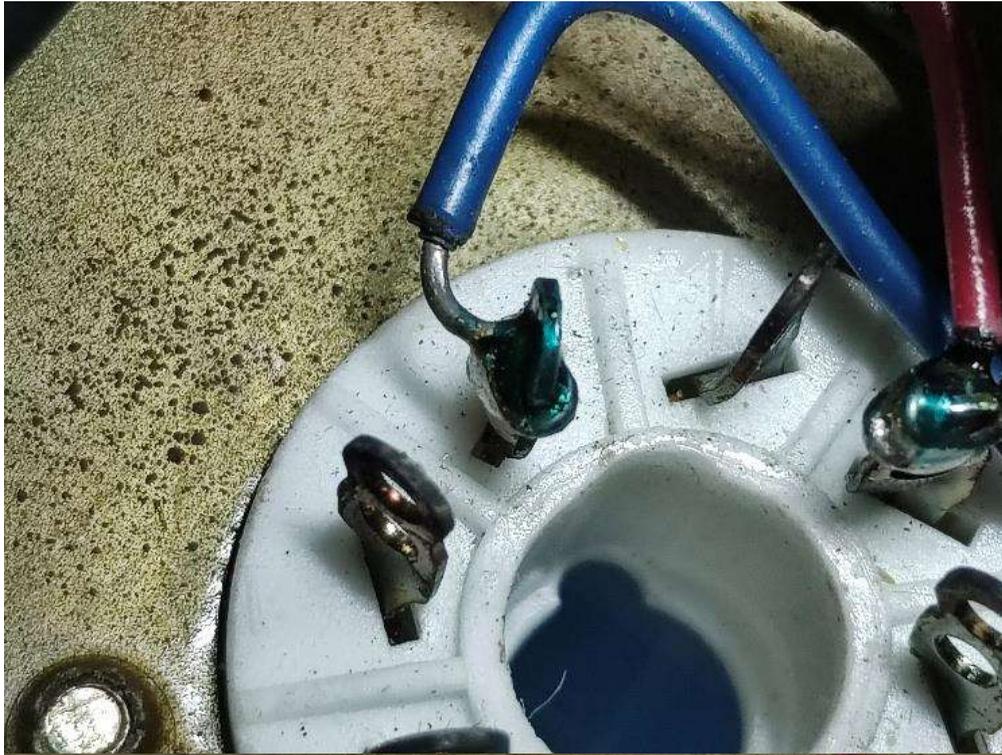
Original solder joint

First grommet replacement, de-solder ballast tube terminal, insert grommet, re-route wire, time consuming

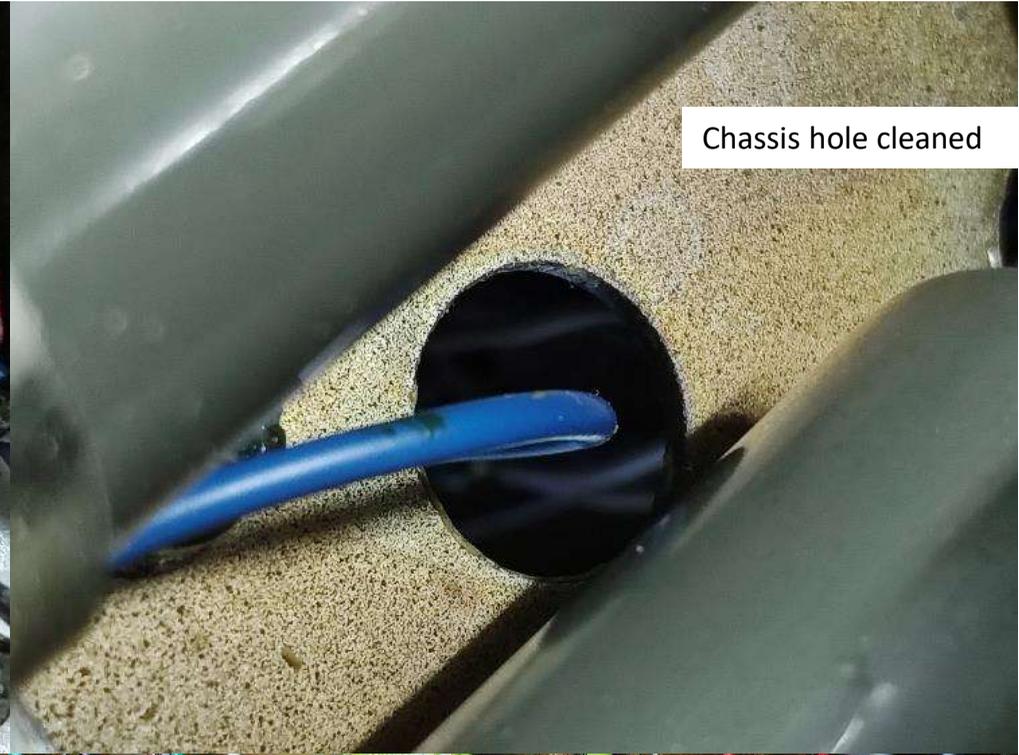
Chassis hole cleaned

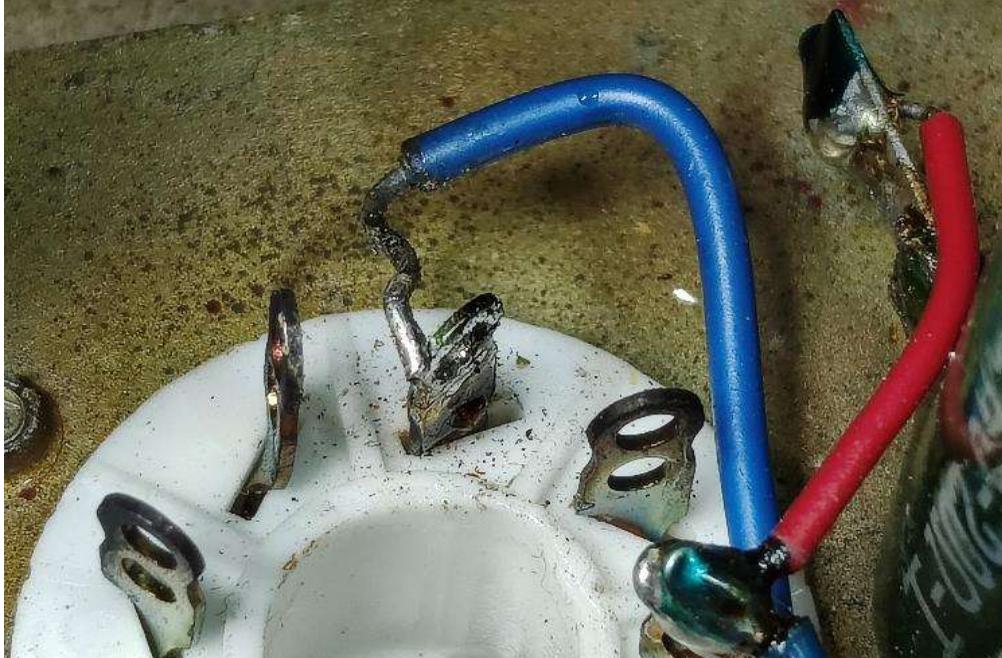
De-solder

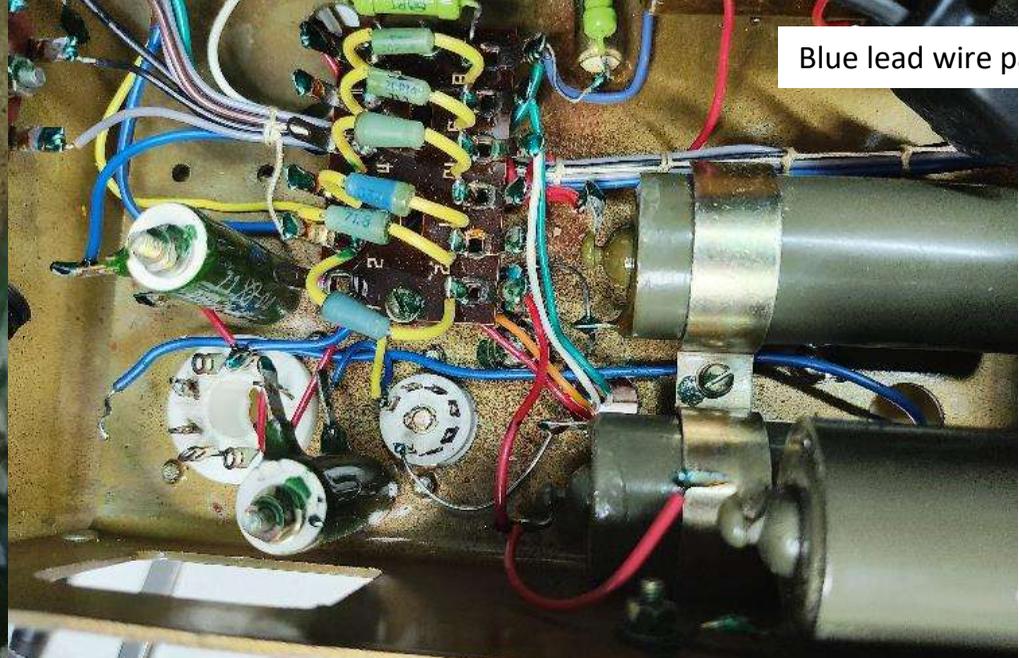
Blue lead wire path

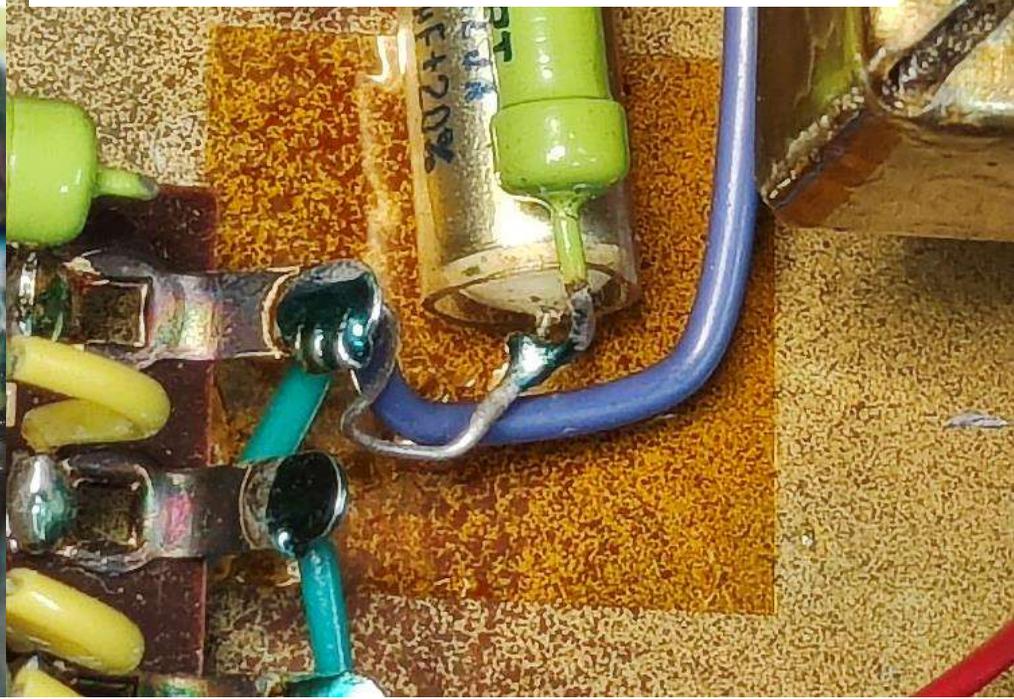
Hole with new Silicone grommet

Adding Kapton tape on resistor body to avoid heating wire insulation

Adding Kapton tape on chassis for better creepage distance

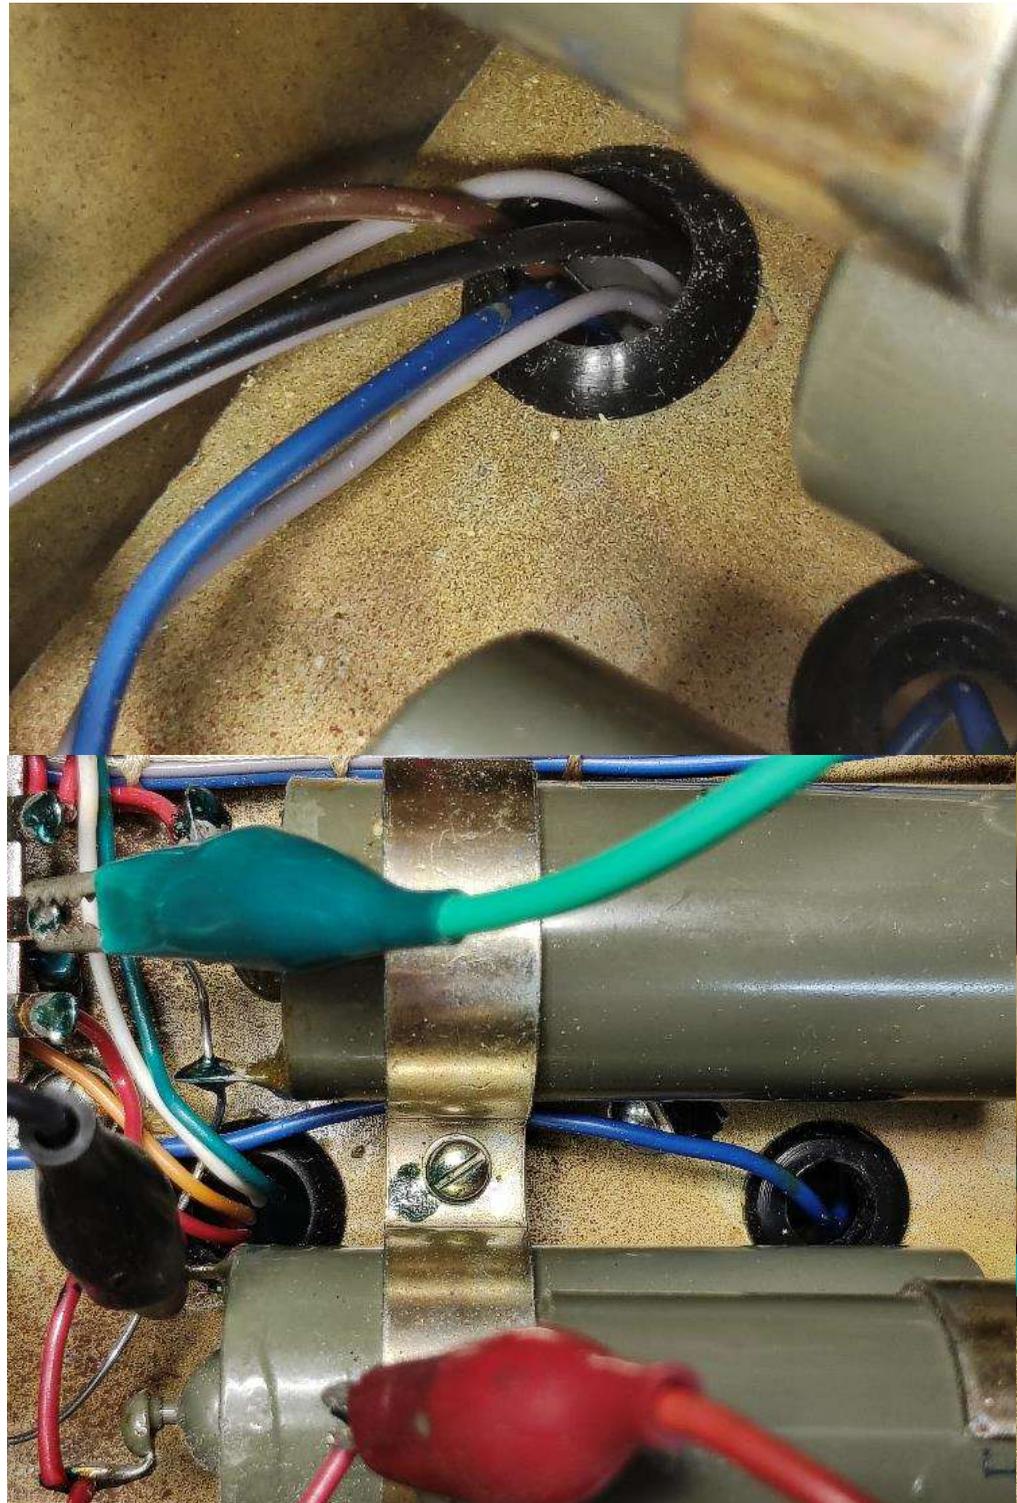
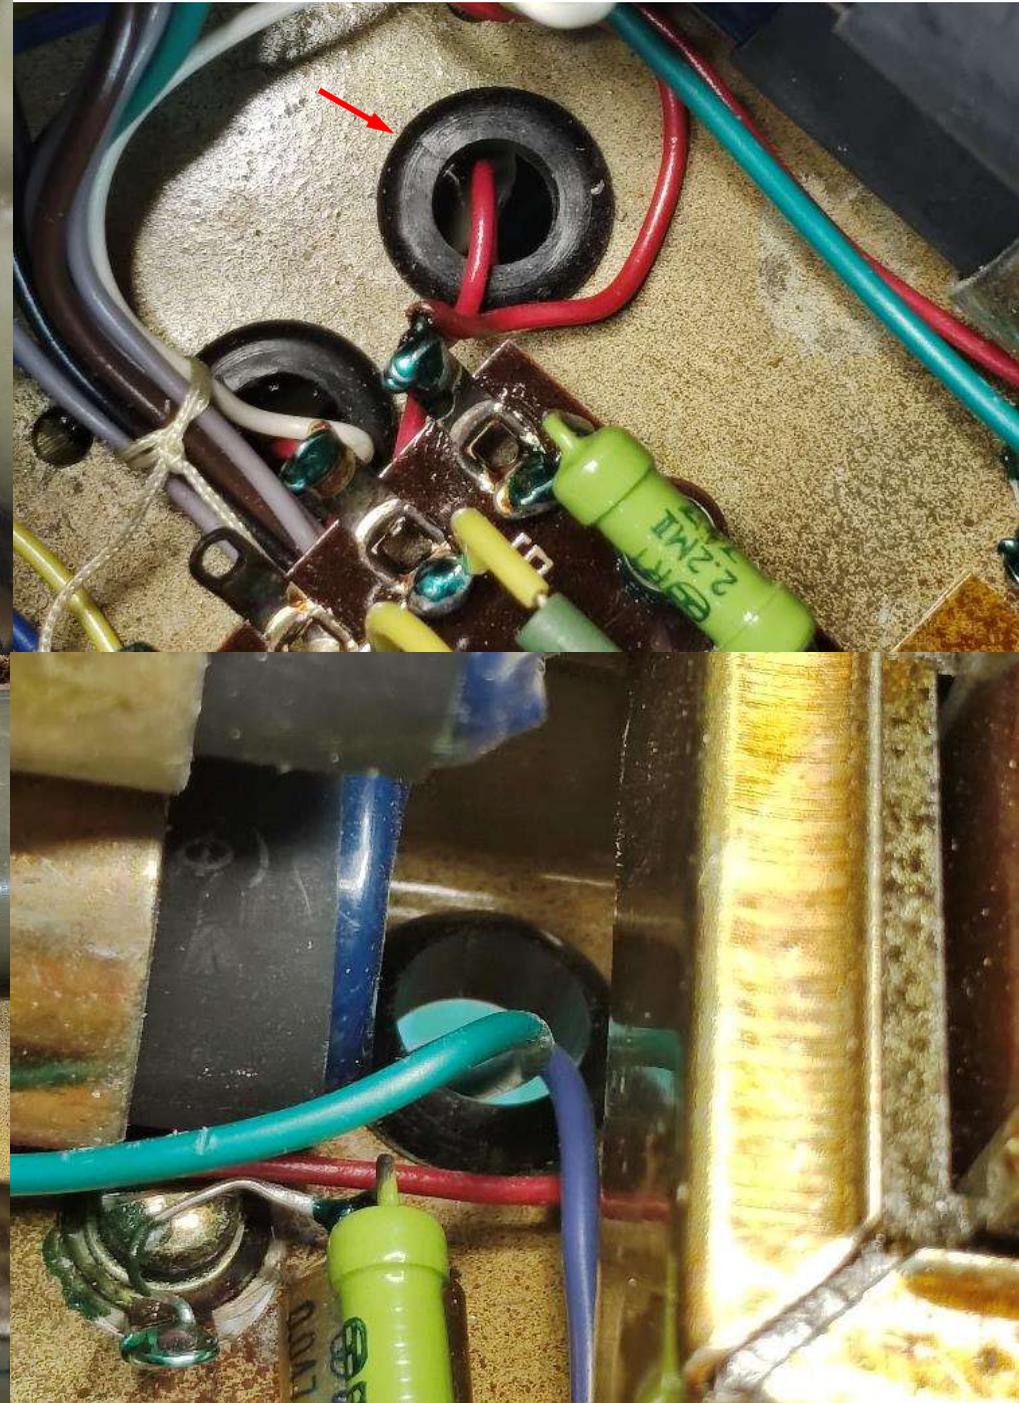
Holes with new grommets, these were done by cutting/splitting grommet allowing insertion without de-soldering many wires

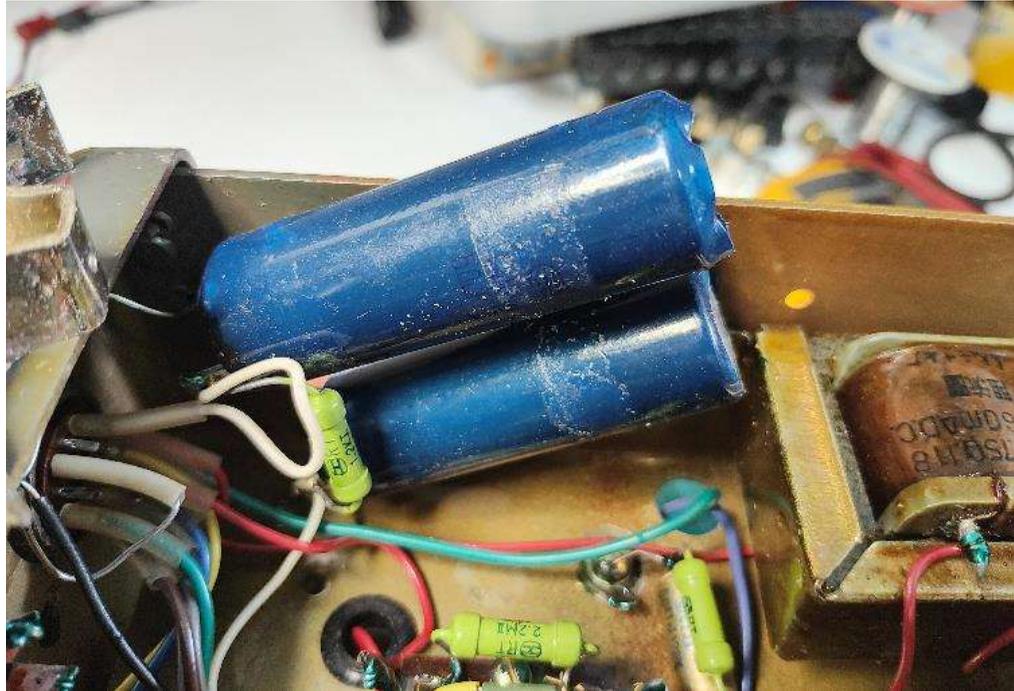
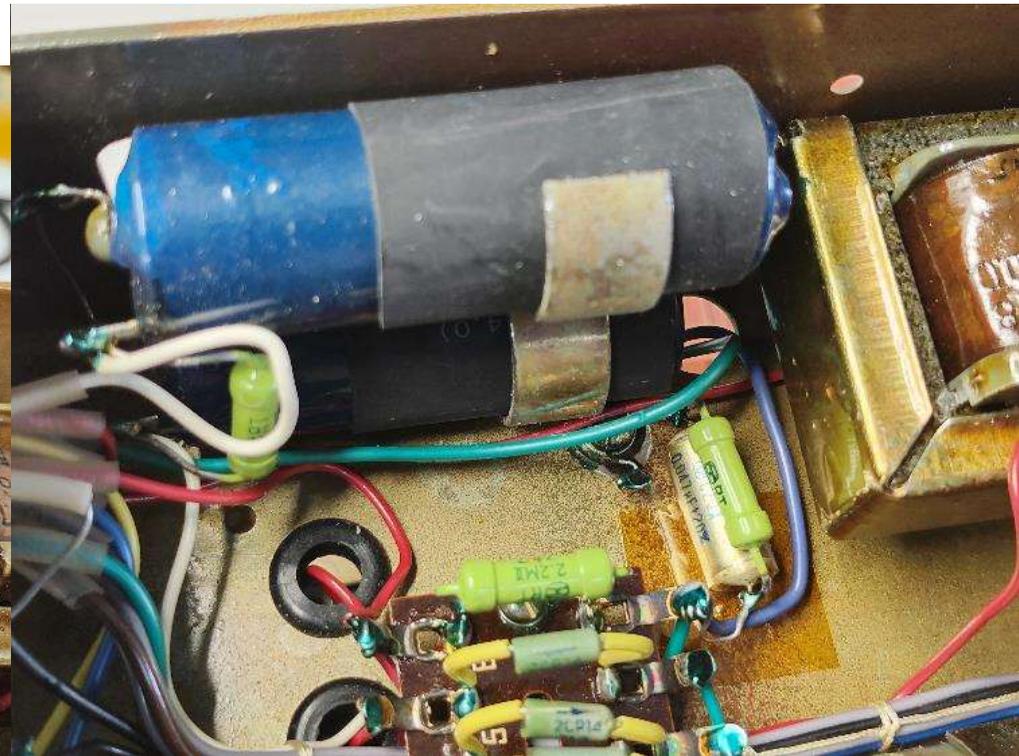
Adding heat shrinkable tube on capacitors casing

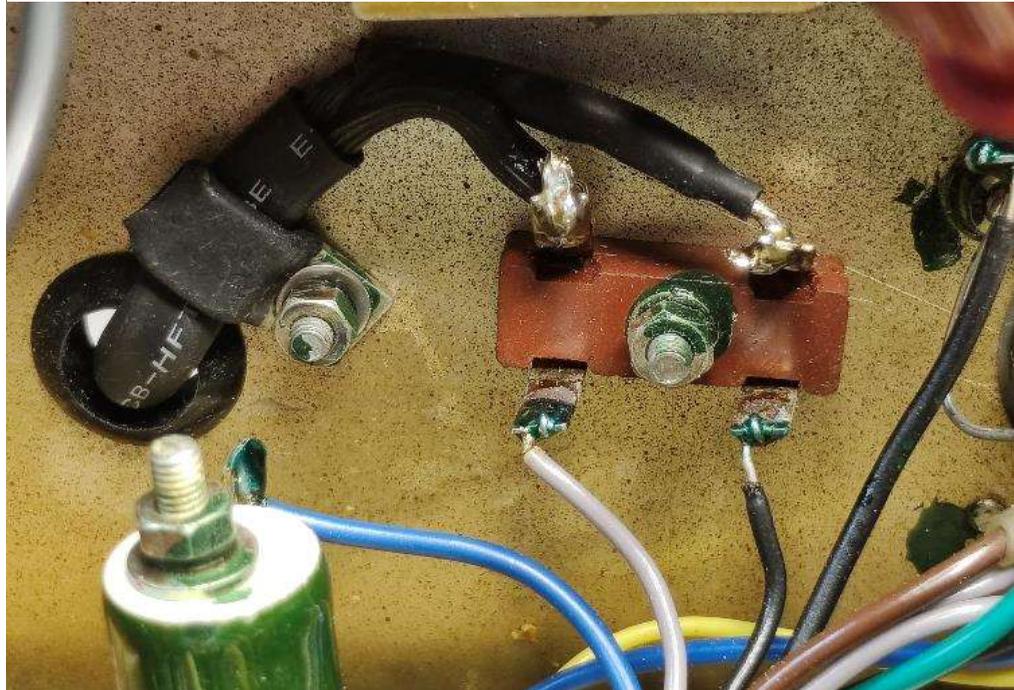
AC power cord, new grommet, de-solder, re-solder, add heat shrinkable tubes

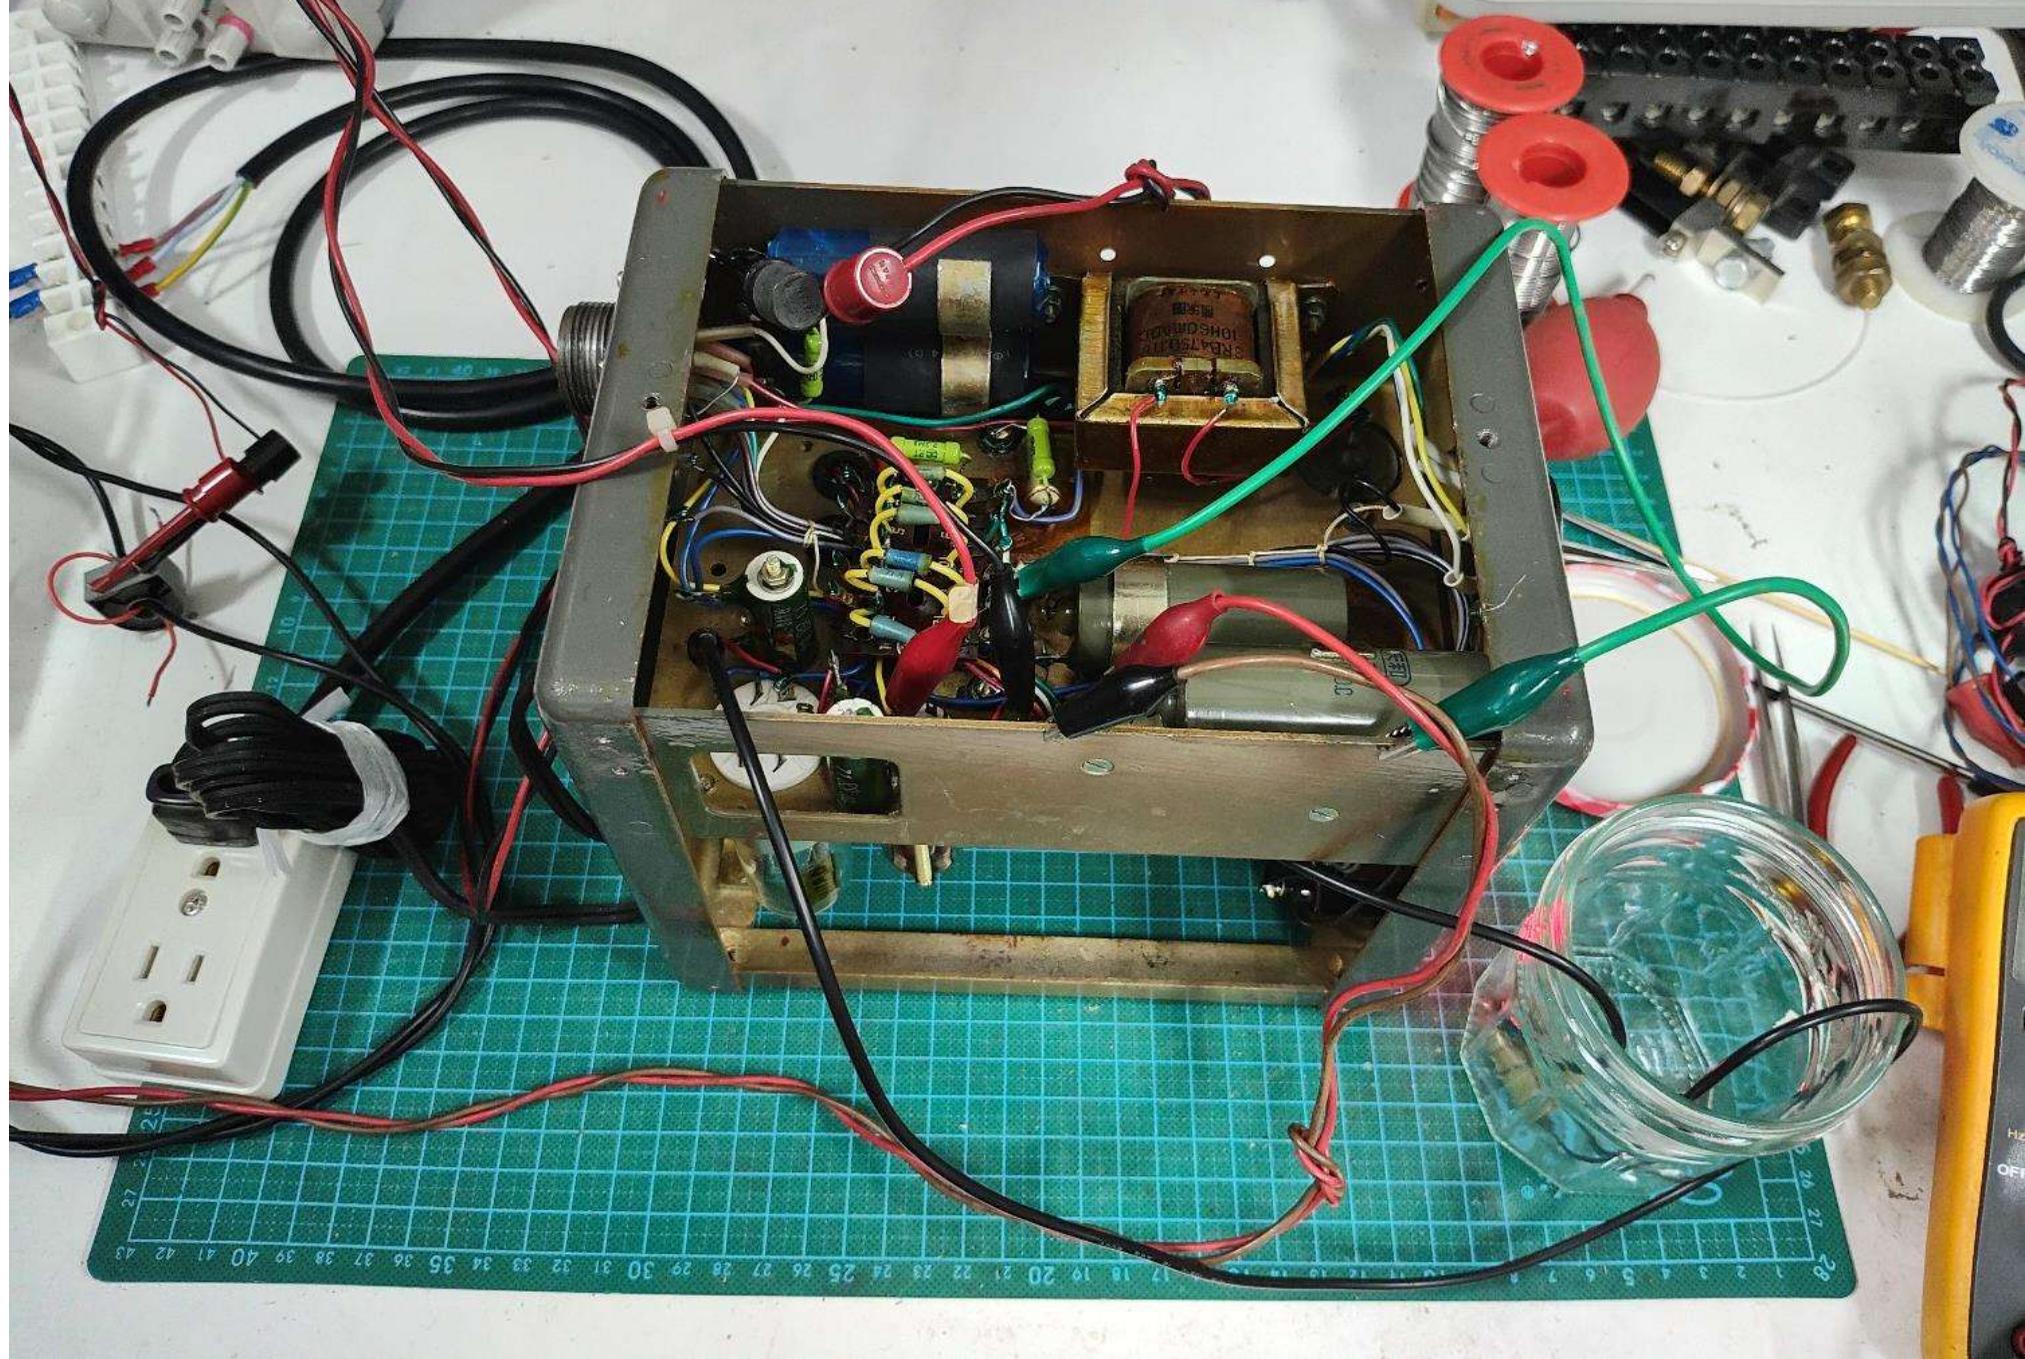
PSU unit check, monitoring capacitor voltages, regulated filament AC power: $6K4(0.3A)+6U1(0.3A)+6J1(0.17A)=0.77A$, loaded with 8Ω resistor
