222-1 shortwave receiver Service log
Virgil Cheng vr2xgm

19-Mar-2025, PSU unit, History:

- Units acquired early 2000s
- 222-1 not frequently used SW receiver, put in storage
- Unit #1 dated Sep-1971, without serial number
- Unit #2 dated Feb-1974, without serial number
- Recently retrieved for inspection

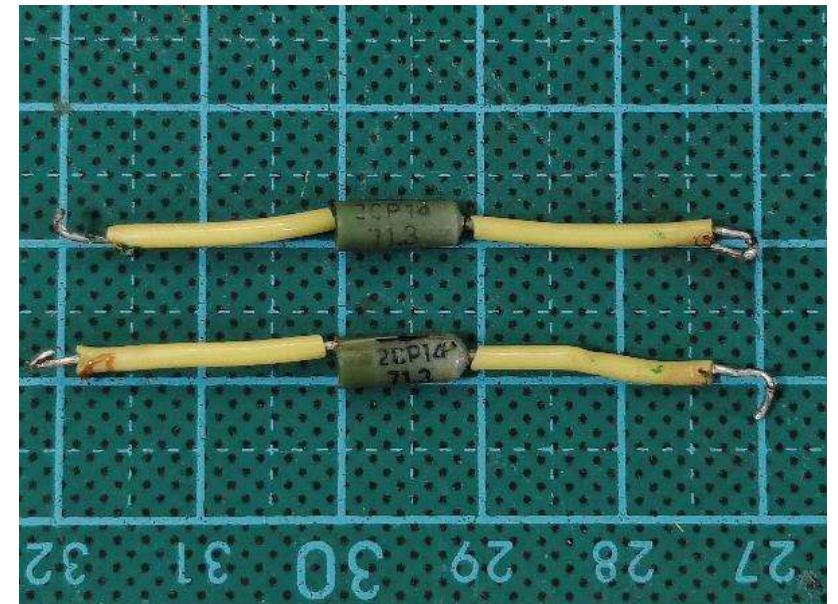
- Noticed -40V output dropped rapidly (~ 10 s to -3V) at power off after few hours burn-in
- ~ 3 V p-p 50Hz (not 100Hz) ripple observed at unloaded -40V output
 - Output unloaded and total capacitance is 100 μ F, indicates excessive leakage present
 - Capacitors C307/309 check good, capacitance 77 μ F/82 μ F leakage ~ 15 μ A at 30VDC
 - Disconnect capacitors -40V output measured 22K resistance to ground/chassis
 - D7 diode check ok but measured 22K with multimeter resistance range, leakage current measured 215 μ A at 30V reverse bias, note 2CP14 leakage current varies with different manufacturer, ranges from 5 μ A to 100 μ A, 215 μ A far exceeded most relaxed spec.
 - Vintage rectifiers quality questionable, replaced

Rectifier diodes replacement 29-Mar-2025

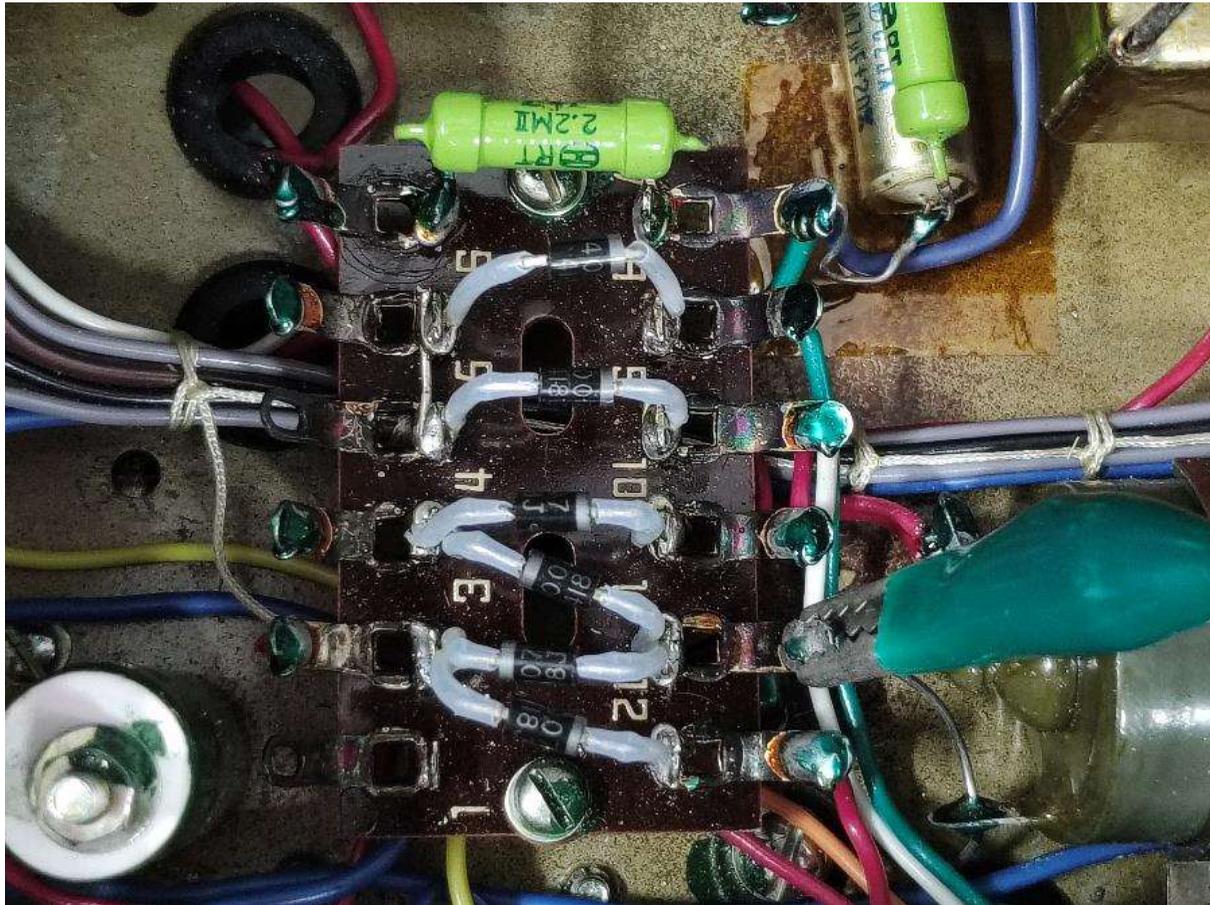
Rectifier diodes replaced 29-Mar-2025

1N4007 x 6 pcs

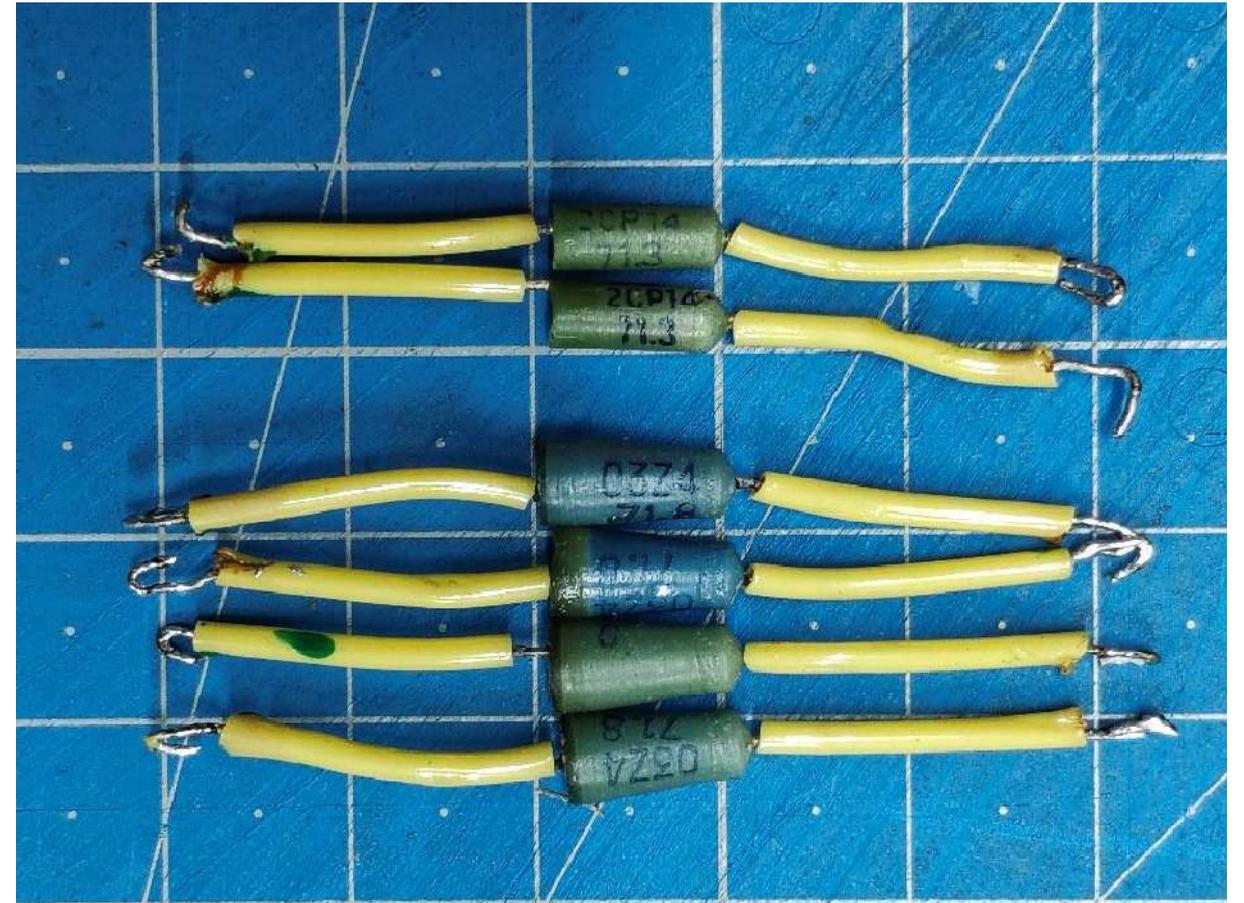
Original parts

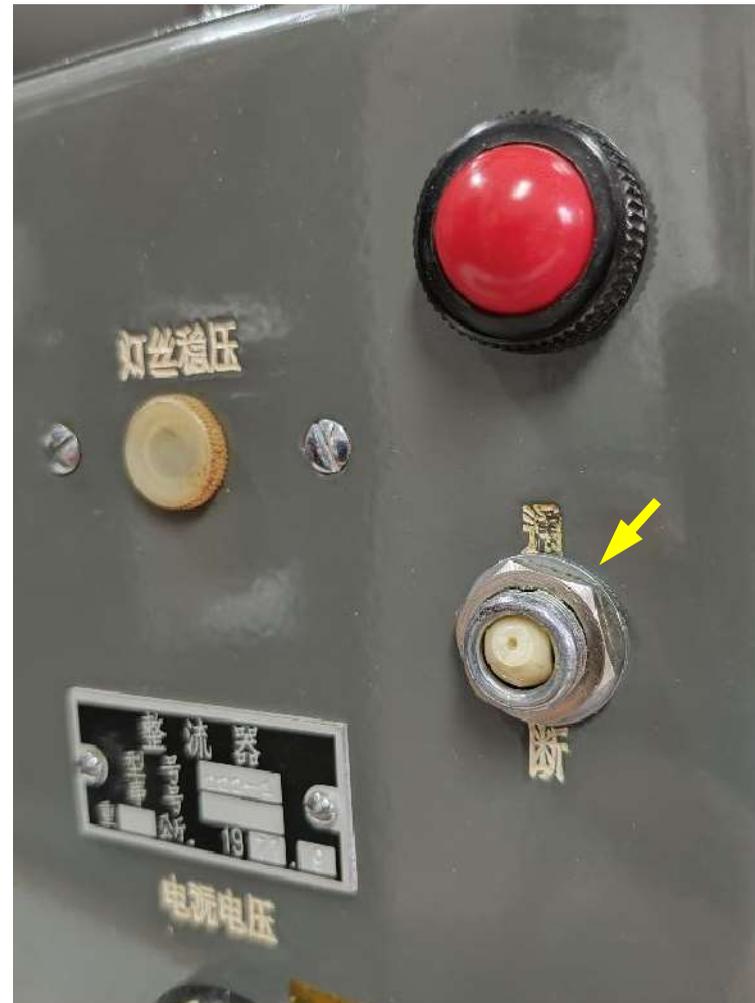
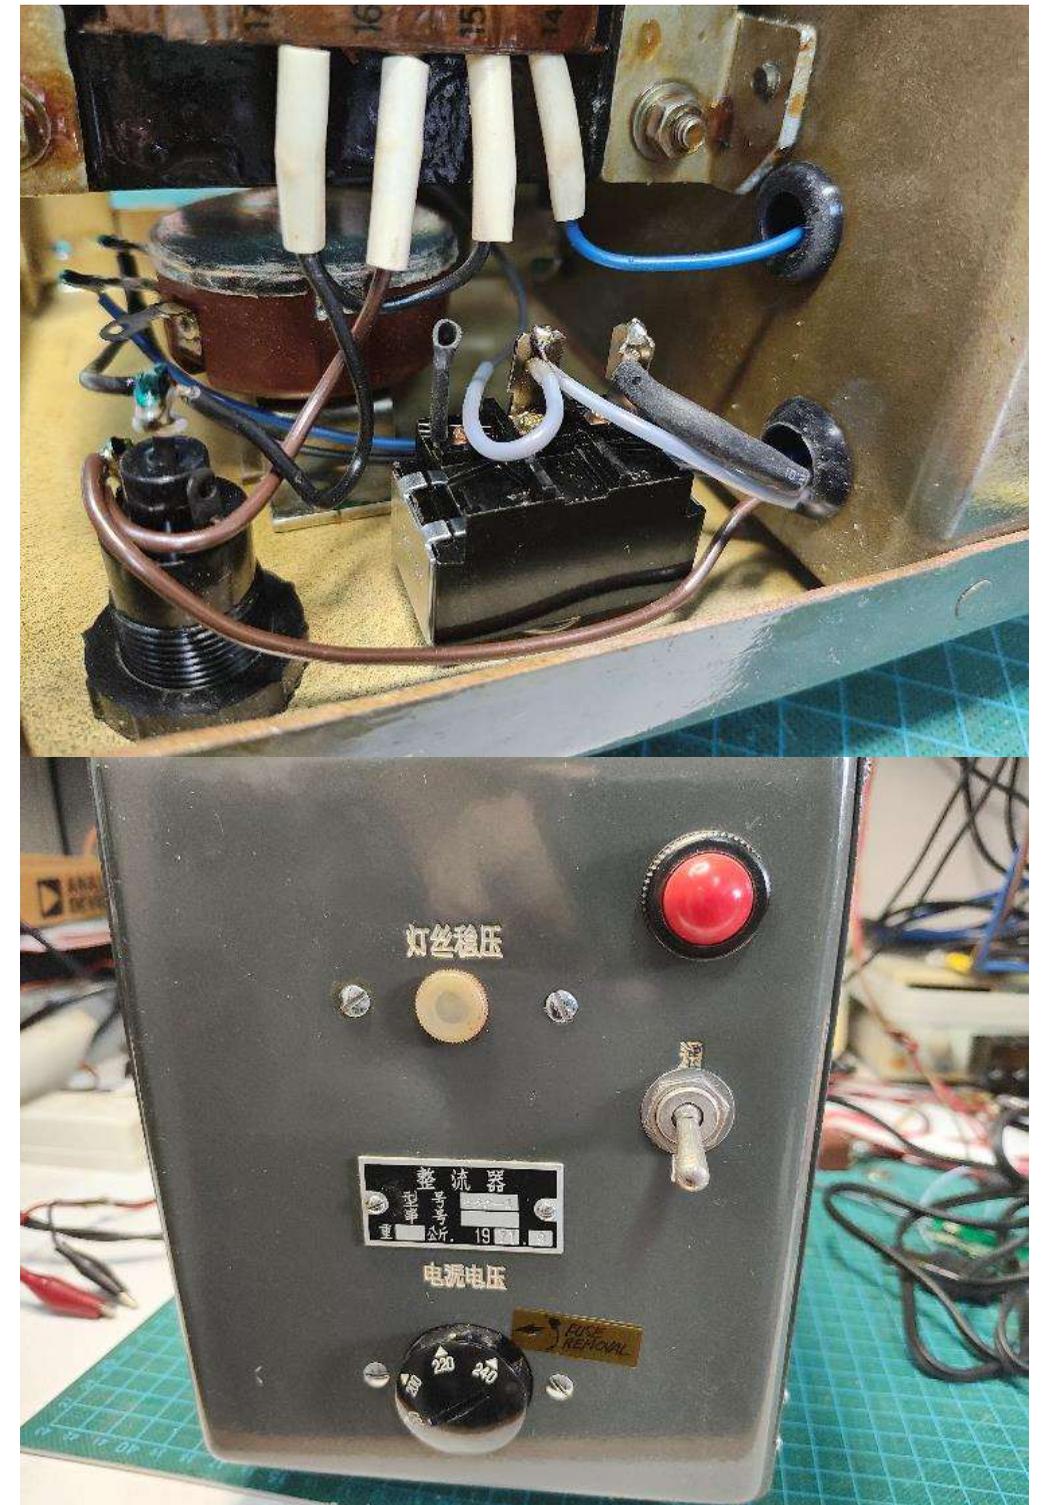
1-Apr-2025

- Power switch broken when flipped to ON position, plastic toggle turned brittle after 50yrs
- Found connector CZ2 pin # 17/19 swapped during switch replacement, not big issue since these two pins are connected to another parallel switch inside 222-1 radio.
- Replaced power switch (250V 10A type w/agency approval), correct CZ2 wiring

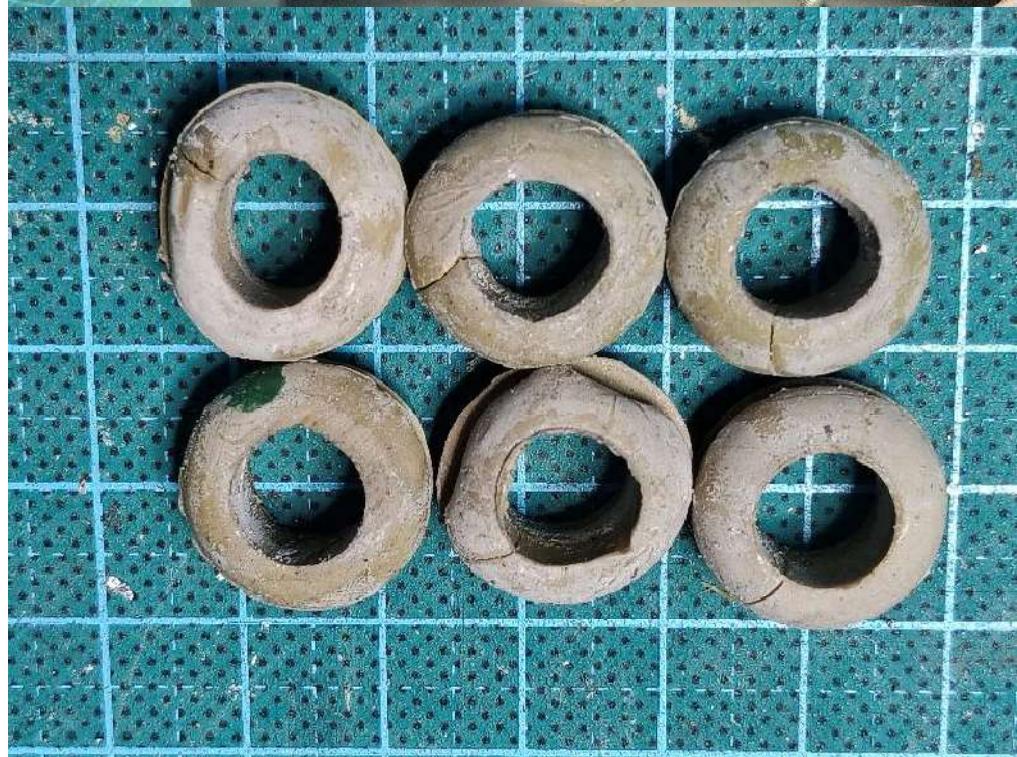
Rubber grommets removed

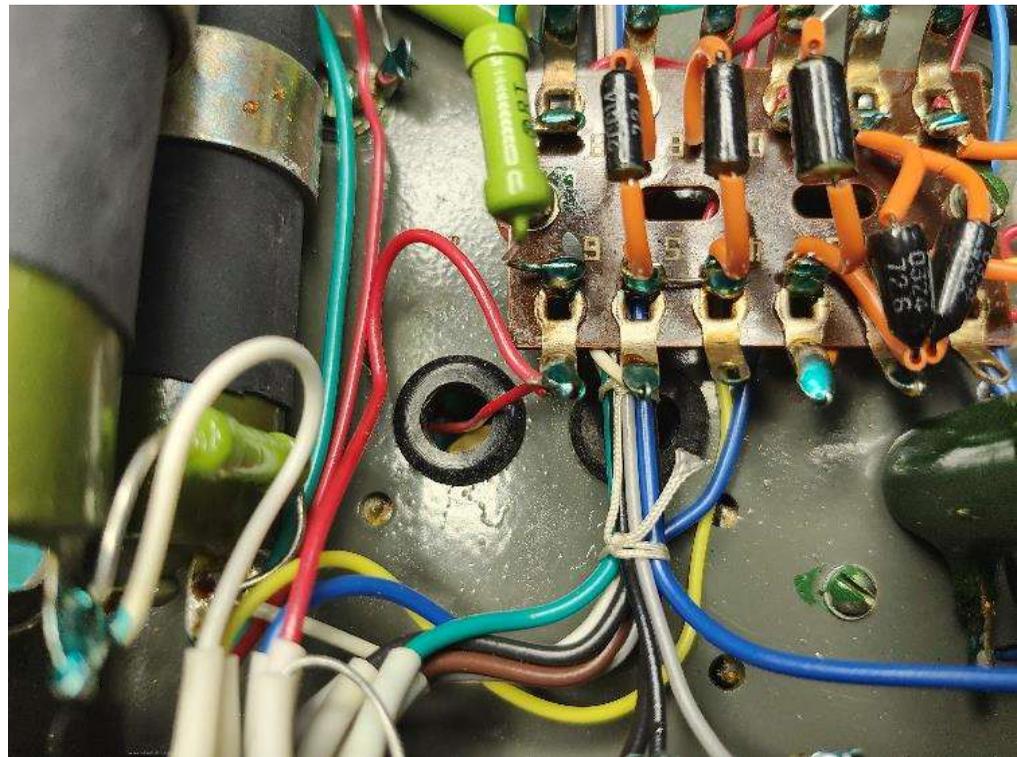
Rubber grommet replacement, rectifier diodes accidentally bent, later corrected. Diodes checked okay, not replaced

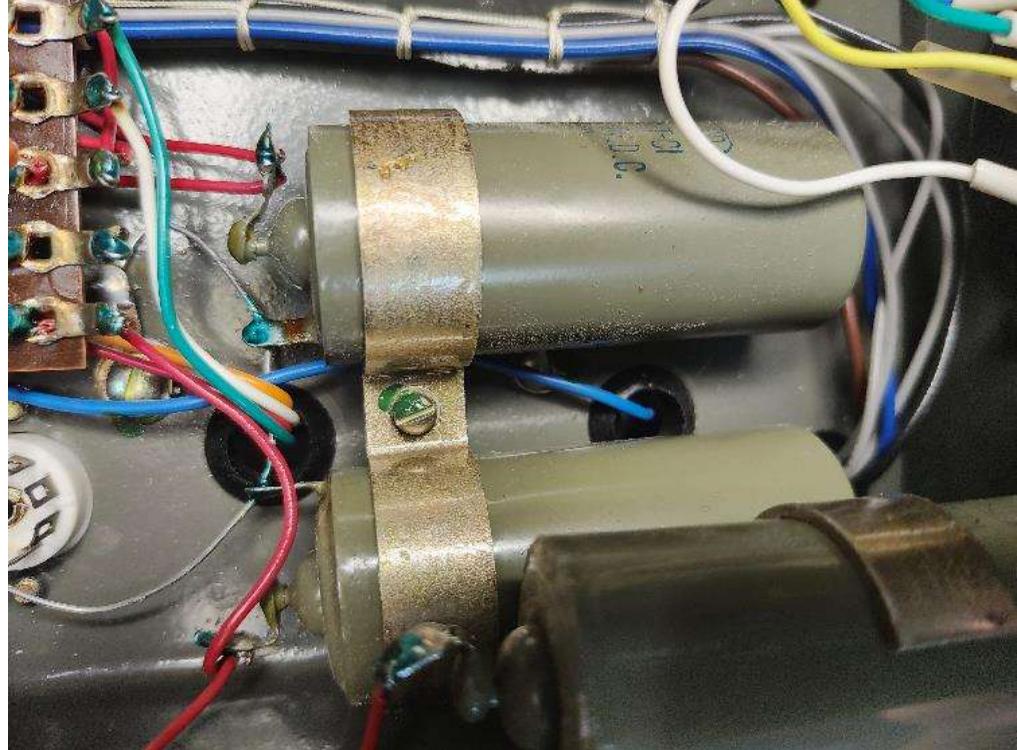
Rubber grommet replacement, retain original Ecaps

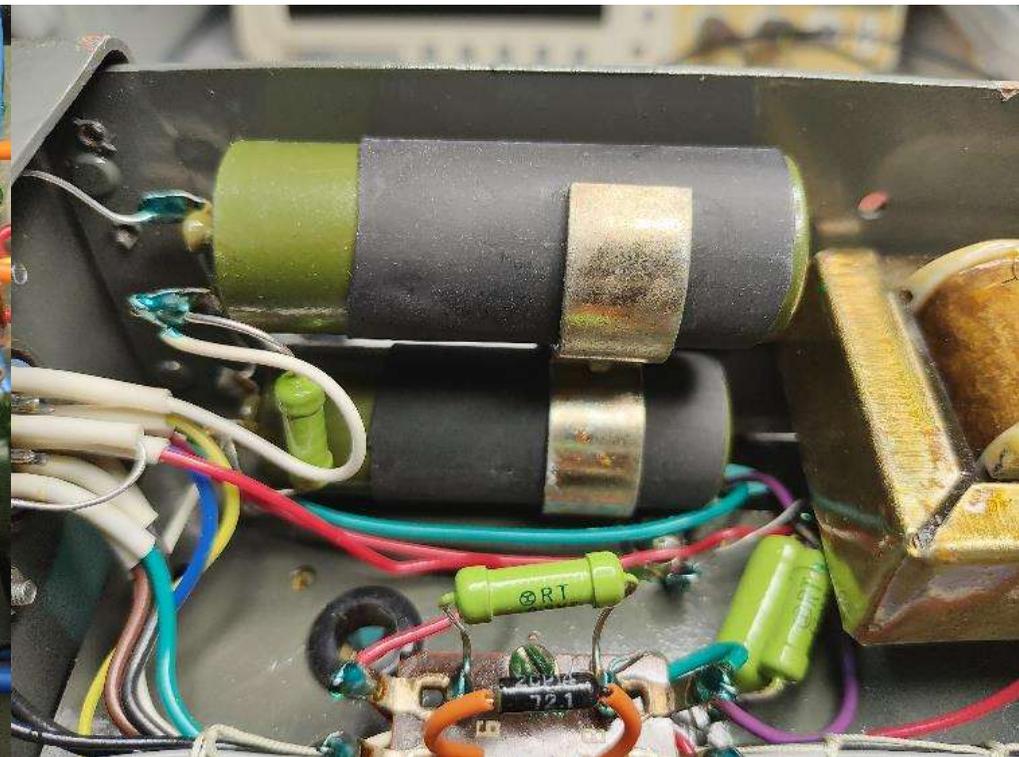
Heat shrinkable tubes on -40V capacitors. Retain original Ecaps. Ripple checked okay.

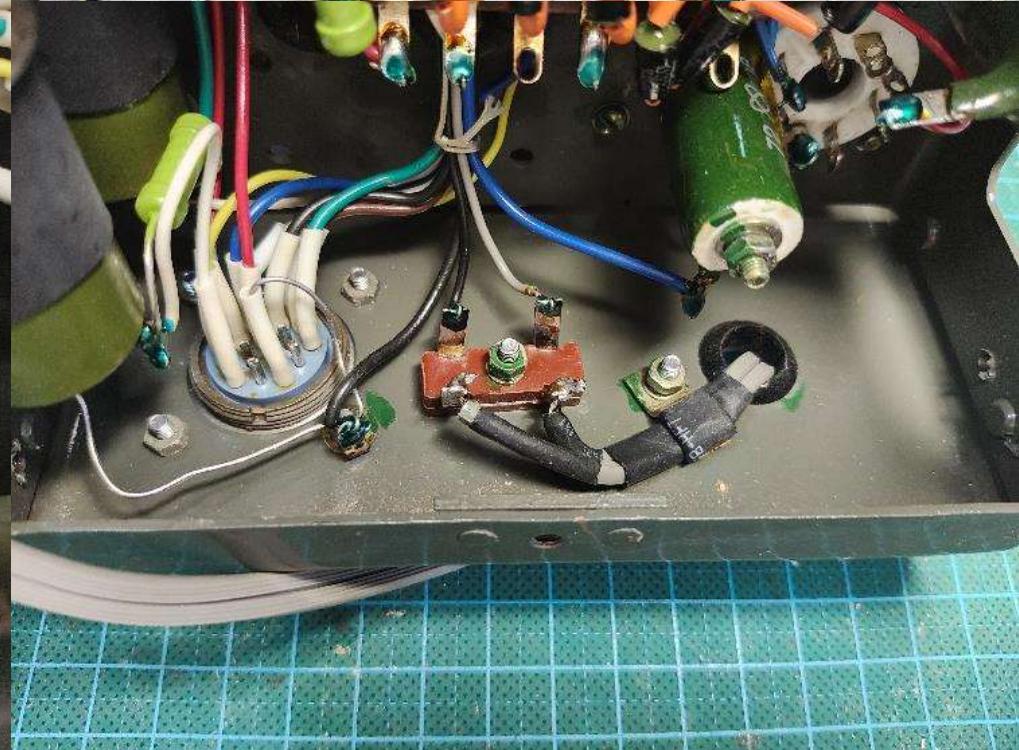
AC inlet grommet replacement and additional insulation, power cord condition acceptable, retained

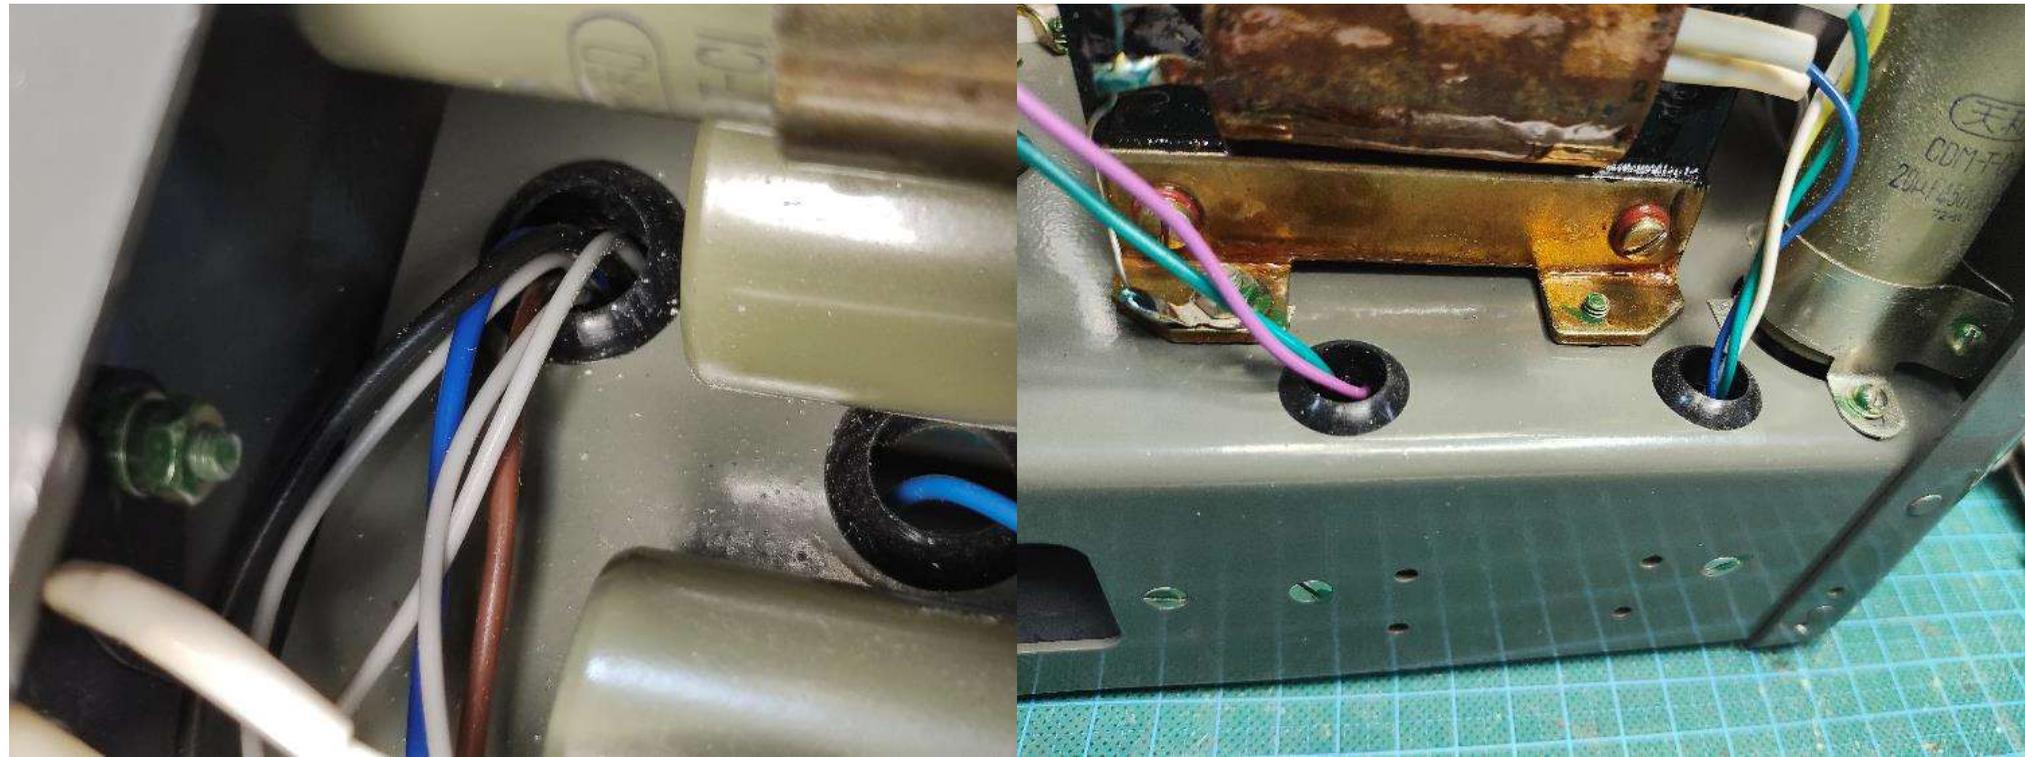
Rubber grommet replacement

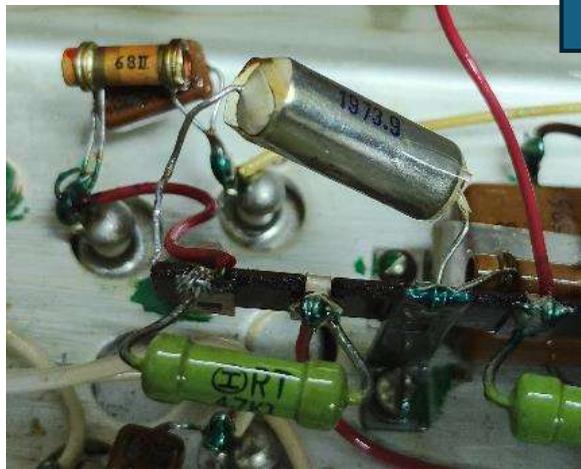
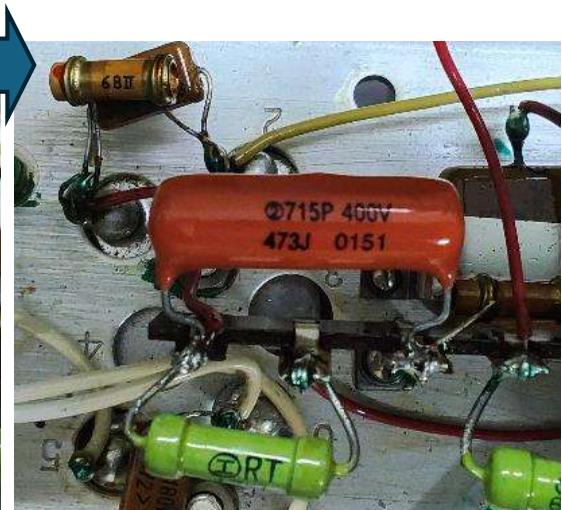
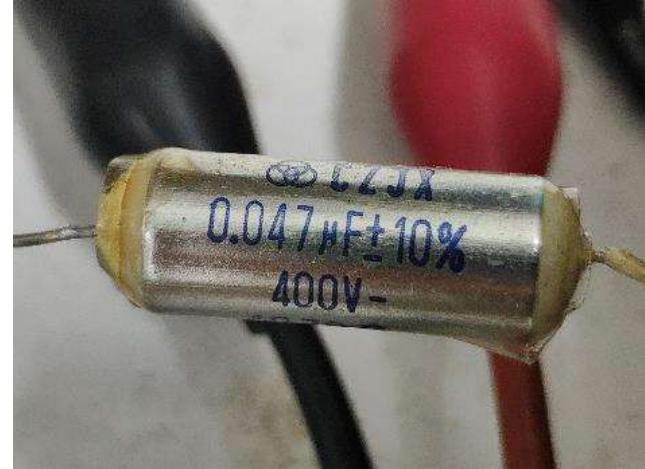
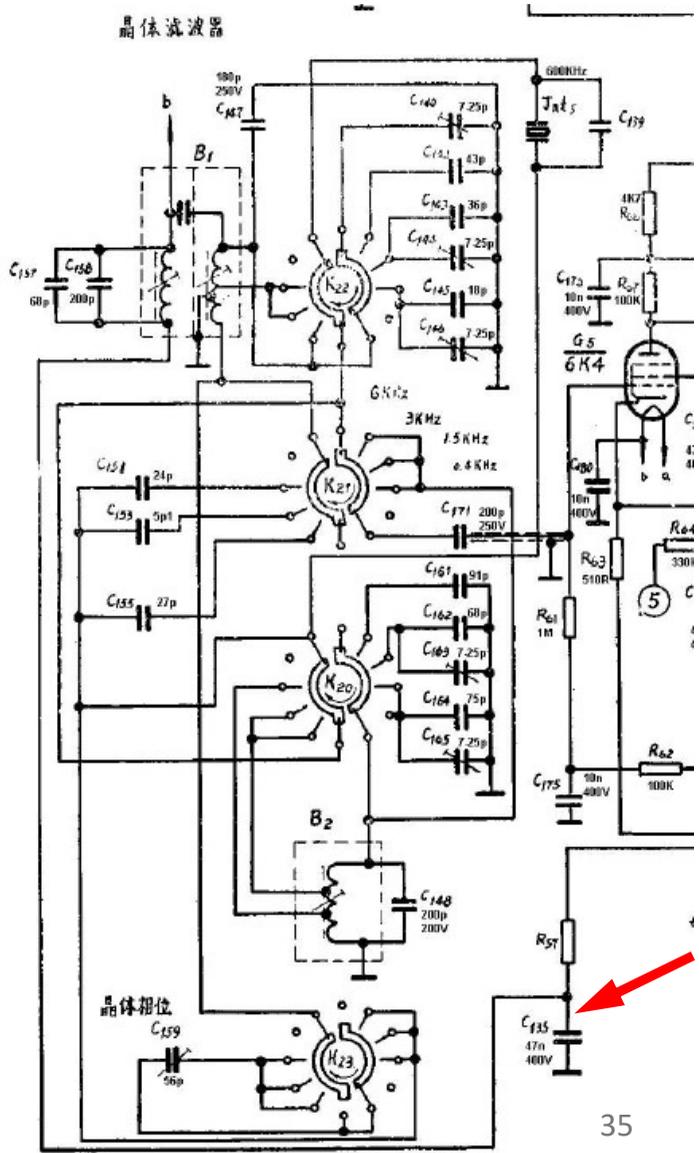
Unit serial number 11849, 26-Apr-2025

- Unit functional, capacitors were only visually inspected
- Picked one easy to remove capacitor for testing, this one was replaced irrespective of test result
 - pick C135, between mixer output and IF band pass filter 47n 400V
- C135, 0.047u 400V +/-10%, type CZJX, (C-电容capacitor, Z纸-paper, J金属-metal), date code 1973-9
 - 29.7n @100Hz, 29n @1KHz, 28n @100KHz, -36%
 - Leakage 0.27uA @200V DC
 - Replaced with Vishay Sprague 715P 47n 400V Polypropylene
- Capacitor deteriorated, schedule re-capping

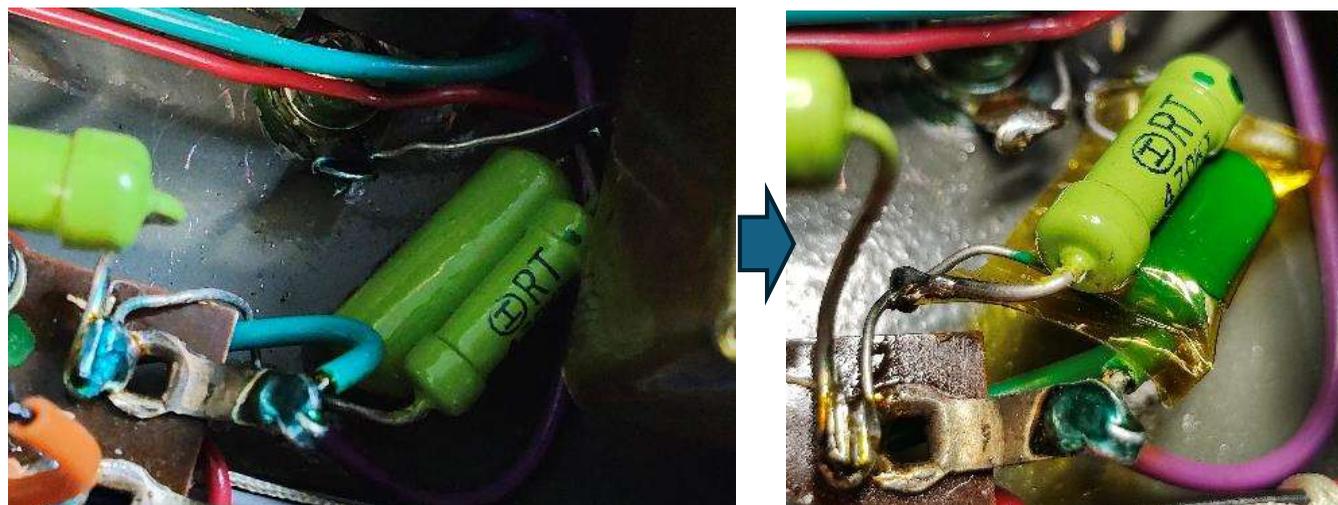
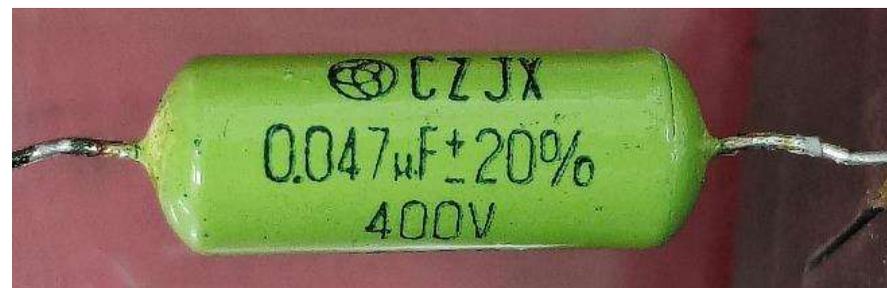
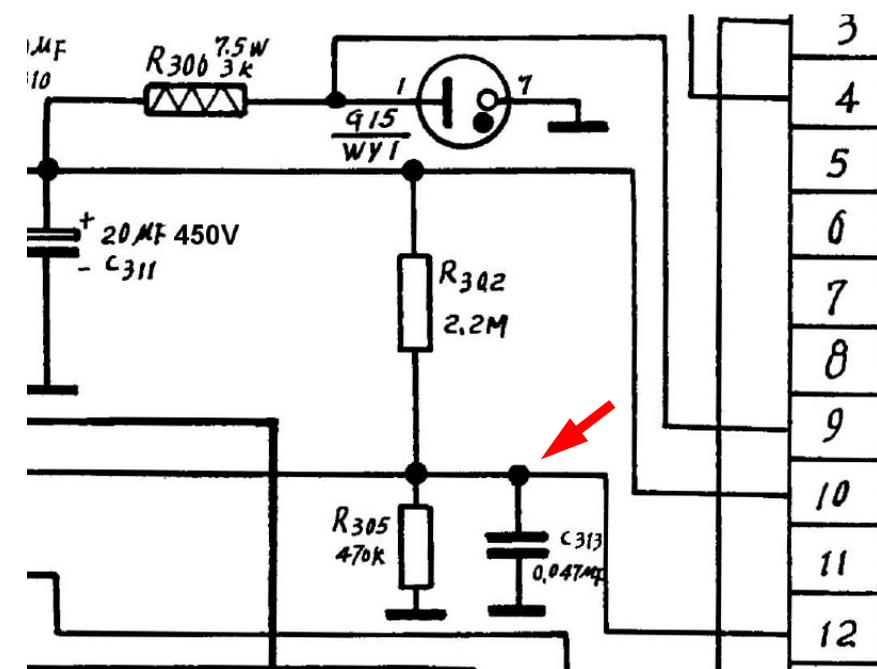
Feb-1974 PSU, no S/N, metallized paper cap replacement, 26-Apr-2025

- Unit checked functional ~ 1 month ago, capacitor C313 not replaced for vintage reason.
- C313, 0.047u 400V +/-20%, type CZJX, date code 1973-9
 - 70n @100Hz, +48% tolerance
 - Leakage 22uA @200V DC, ~100x previous result **high**
 - Replaced with Marcon/Taitso 2G473K 47n 10% 400VDC polyester, space constrain
 - Resistor R305 470K in parallel with C313 de-soldered / re-installed

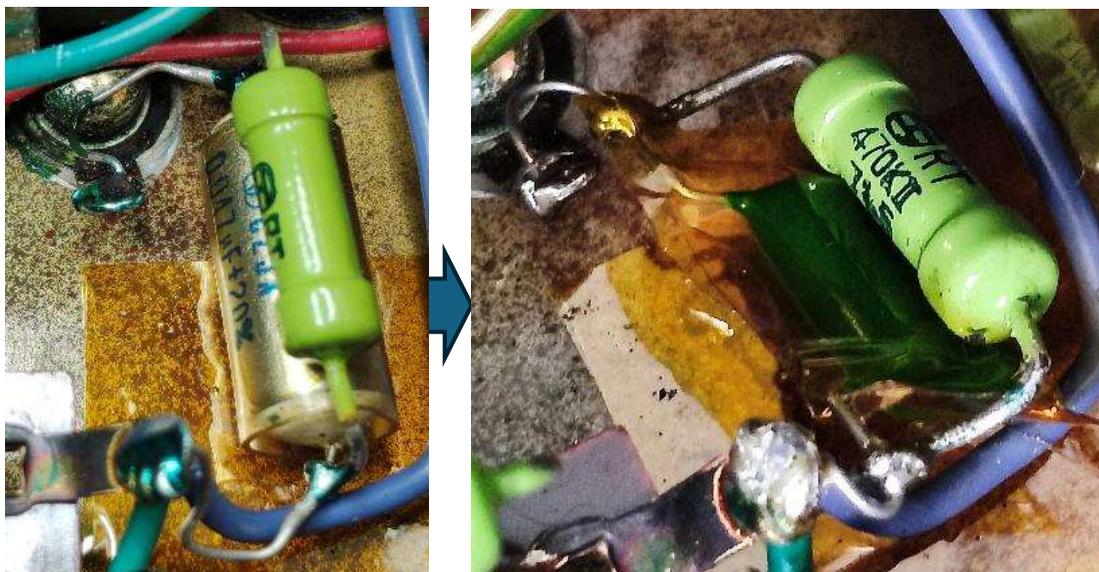
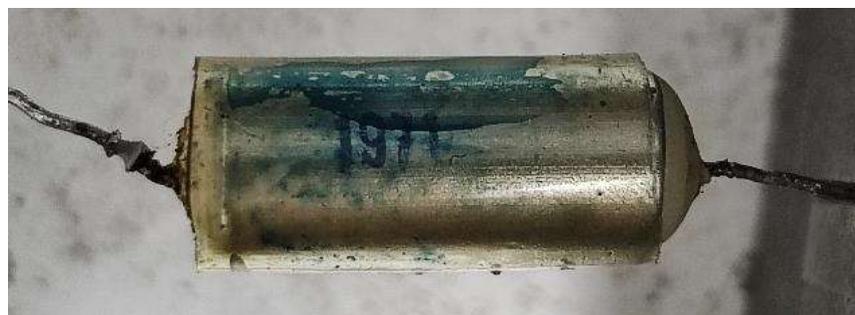
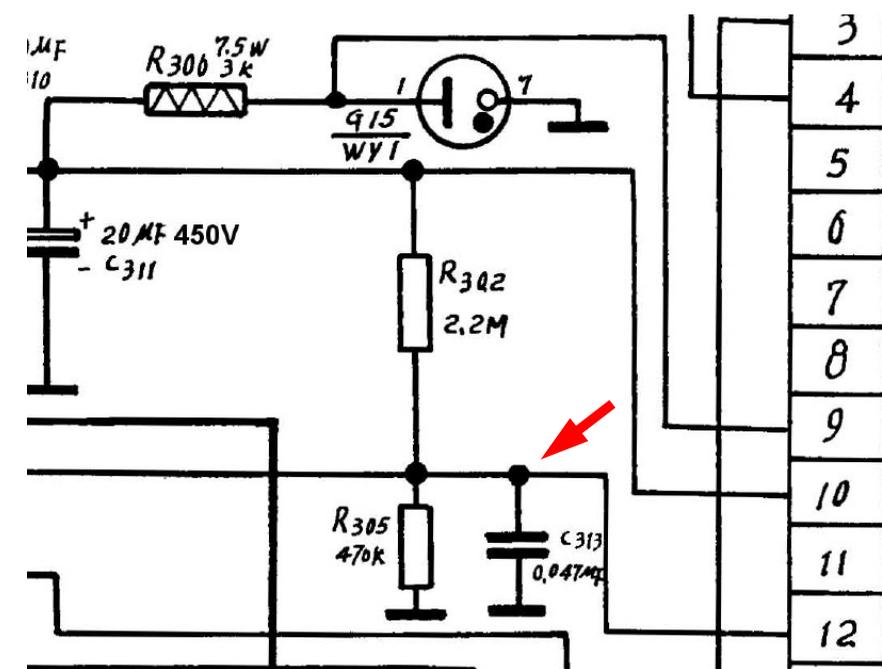
Sep-1971 PSU, no S/N, metallized paper cap replacement, 27-Apr-2025

- Unit checked functional ~ 1 month ago, capacitor C313 not replaced for vintage reason.
- C313, 0.047u 400V +/-20%, type CZJX, date code 1971-9
 - Oil leakage trapped inside jacket, marking partially dissolved
 - 21n @1KHz, -55%
 - Leakage 25uA @200V DC, **high**
 - Replaced with Marcon/Taitso 2G473K 47n 10% 400VDC polyester
 - Keep original R305 470K in parallel with C313 de-soldered / re-installed
- Confirmed capacitors questionable
