Introducing the BC-348

★ ★ BC-348 RECEIVER

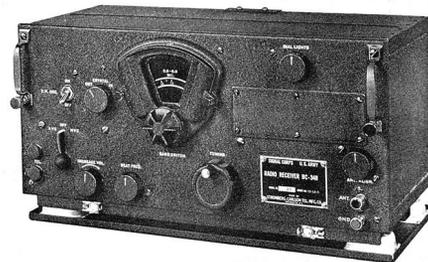
BC348 front view—see text. Courtesy AWA.

The receiver's few simple controls can be clearly seen in the front illustration (from the Bill Fizette article previously mentioned). At the upper right center is a dial light control that would be used, I presume, for dimming under combat conditions. The binding posts at lower right are for the antenna and ground. Just above them is the antenna adjust trimmer. The bandswitch is the star-shaped control just below the tuning dial. A rotating mask in the dial turns with the bandswitch, positioning a

window that exposes only the band in use.

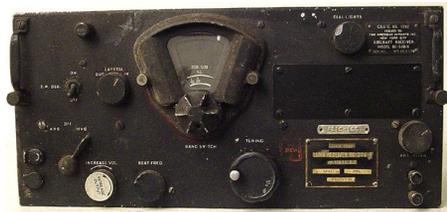
The front panel view of our BC-348-R reveals a lot of cosmetic problems. Non-matching knob at lower left (to be replaced, of course) is from an aircraft audio control box of the same vintage.

The front panel also had its cosmetic problems. Not only was it quite grimy, but there were numerous small dings where paint was missing as well as a couple of more mysterious issues. For one thing, someone had run a red marking pen over the panel under the bottom of the dial bezel; for another, it looked as if some amateur masking and repainting had been done on the ID plate.

Turning my attention to the many small dings where paint had flaked off, I found that a black felt-tipped "Sharpie" pen could be used to cover the exposed aluminum. This much improved the look of the panel, but I still have to deal with the dullness and unevenness of the finish.

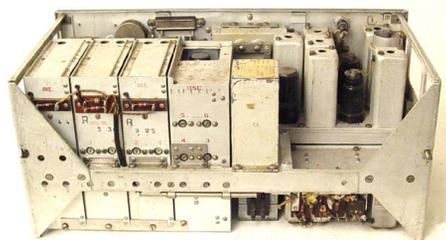
Inside, the set looks dingy, but has no sign of corrosion or mouse occupancy.

As expected, the insides of the radio were kind of dirty but—since they were mostly aluminum—I found no rust or corrosion. It looked like most of the dirt would clean off with a little soap and elbow grease. And, being cabinetless, the receiver had—at least—never become a secluded private home for generations of mice.

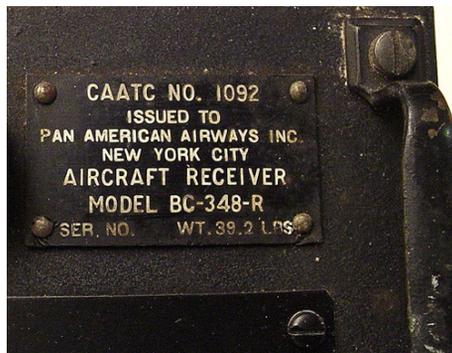
"CAATC" asset tag suggests that this radio might have made several Atlantic crossings aboard a Pan American Airways flying boat (see text).

An unusual asset tag on the upper-right-hand corner of the panel suggested that this set may have had a very interesting past. It is marked "CAATC No. 1092" and indicates that the set was issued to Pan American Airways and that its weight is 39.2 pounds.

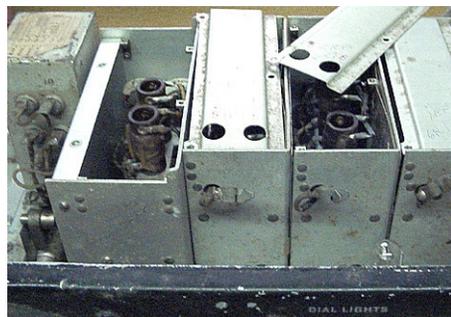
Disassembly began by removing covers from c.w. oscillator, first and second r.f., and converter modules.

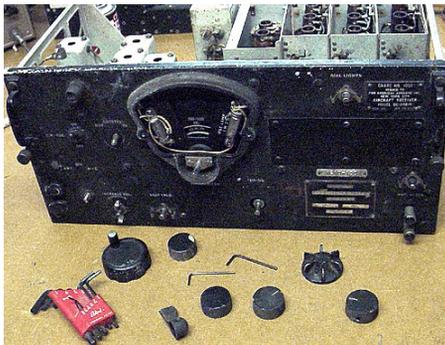
All knobs were taken off as first step in removing front panel.

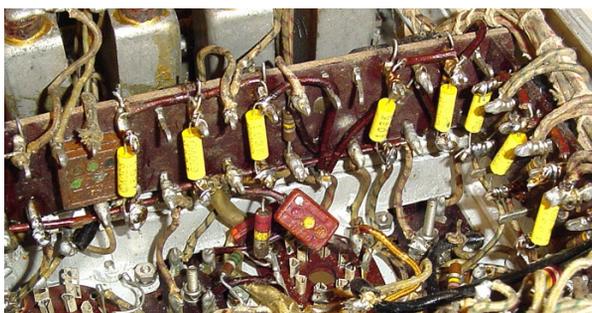
Here are two of the resistor boards after they were populated with new capacitors.

Notice that each has a lead that is bent over the top of the board and soldered to a terminal lug on the other side. Though not visible in the picture, a lead from the bottom of the capacitor is similarly bent around the bottom of the board and soldered to another terminal lug. It’s not apparent because of the angle of the photo, but the two lugs are far enough apart to accommodate the small size of a modern replacement capacitor.

There are ten paper capacitors, all .01 mfd, mounted on three resistor boards in the main chassis (i.f. and audio stages) of the set. As each of these was disconnected, I checked it for leakage and rated capacity. I was amazed to find that, without exception, the leakage of each was so high that it sent the meter on my capacitor tester off scale in the wrong direction.

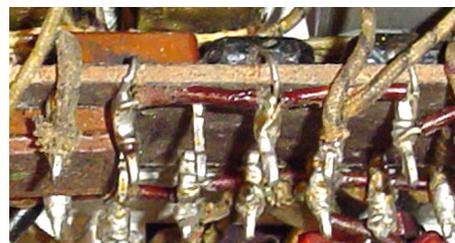
Inaccessible capacitors (top part of picture) were removed from the circuit by cutting their leads where they wrapped around the top of the resistor board. This made it possible to install new caps on the other side of the board (see text).

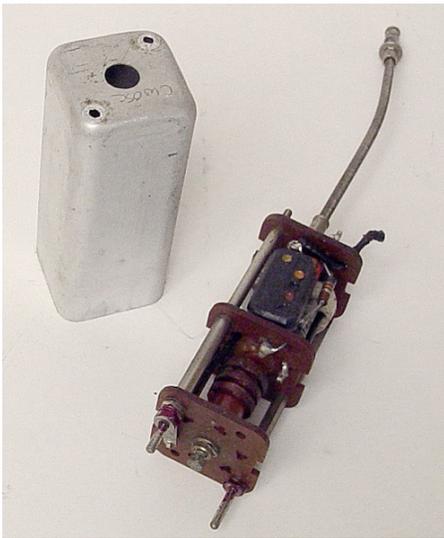
The c.w. oscillator module removed from its can. Original paper capacitor still in place. The flexible cable at the top connects with the front panel bfo control.

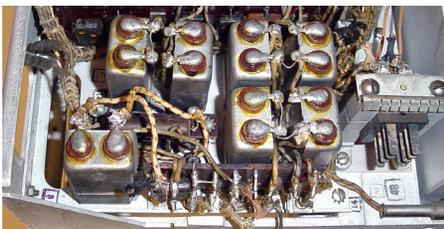
The bank of 0.5 mfd paper bathtub capacitors. After doing some testing, I'm hoping that all might still be ok.

I checked a couple of these for leakage and capacity. I think they are close enough to the leakage standard of 2k megohms to be worth a try and they're "on the button" as far as capacity value. I believe I'm going to leave the whole lot in place and troubleshoot them later only if they seem to be causing problems.

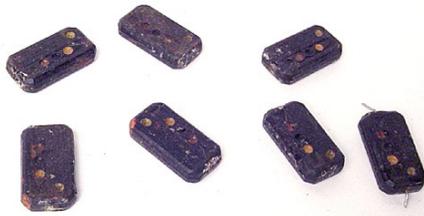
In fact, these units are as notorious for failing as the infamous Sprague “Black Beauty” (otherwise known as “Bumblebee”) capacitors encountered in our previous (Trans-Oceanic) restoration. Any conscientious restoration of a radio harboring the “quasi micas” must include the replacement of every one of them.

Just a few of those paper-caps-that-look-like micas originally used in the BC-348. If you ever work on a set using these, you know what to do!

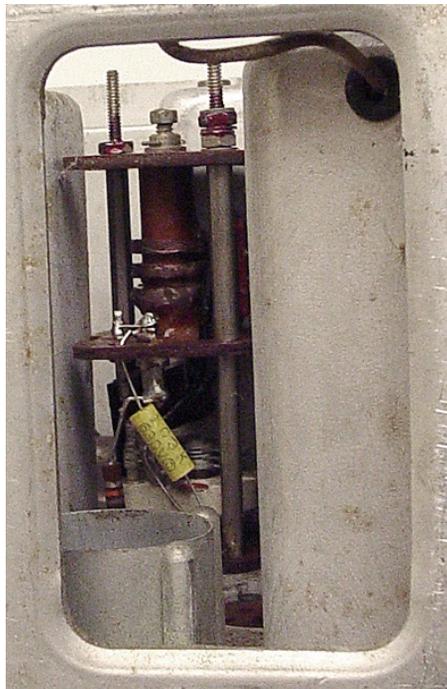
Peeking between a couple of shield cans at the opened c.w. oscillator gives us a view of the replaced paper capacitor.

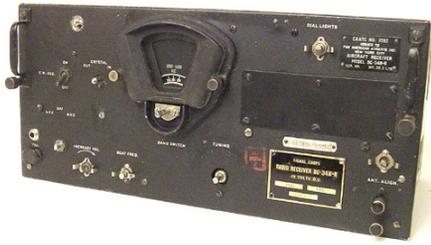
Thanks to its front-panel face lift, our BC-348 is beginning to look quite sharp – even without its control knobs.

I had removed the front panel of this radio back in July and done a little cosmetic work on it. After washing with Murphy's Oil Soap, I used Q-tips and rubbing alcohol to get rid of most of the red crayon someone had used to outline under the bottom of the tuning dial bezel. After that the panel looked better, but the crackle finish was still dull and lifeless. I did make a major improvement in the looks of the ID plate by coating it with gloss varnish before temporarily setting the panel aside.

The lubricant is simply sprayed onto a cloth (Turkish toweling material recommended) and applied thickly to the surface. After sitting for five minutes, the excess is removed with paper towels. Then more Turkish toweling is used to polish the remainder into the finish. After this treatment, Lane recommends that the piece be allowed to sit for 24 hours, after which it can be handled without leaving fingerprints.

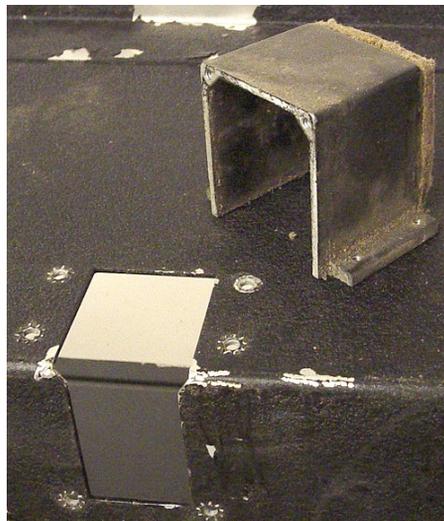
Removal of the connecting plug shield from the inside of the BC-348's cabinet makes it possible to feed in power supply wiring without drilling holes.

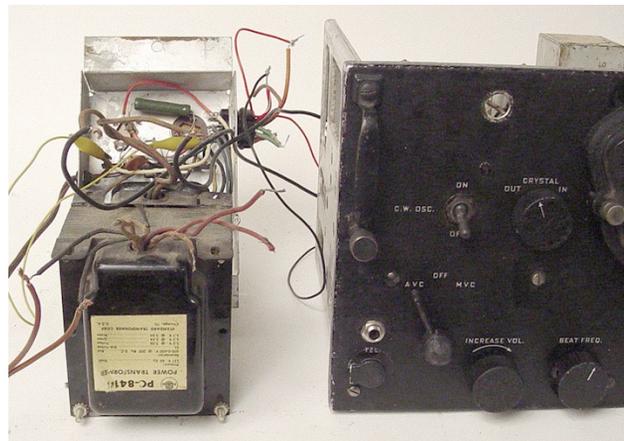
Temporary lashup for test-powering the BC-348. Meters and variac (see text) not shown.

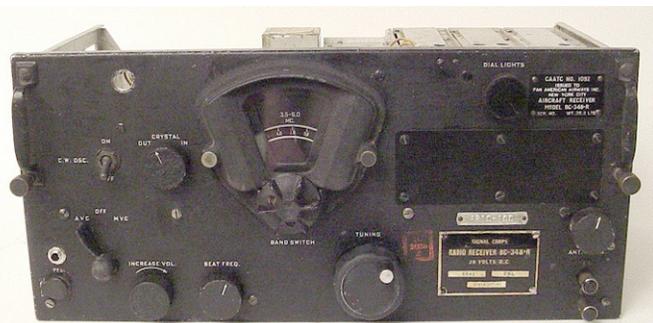
With knobs installed, front panel is now virtually complete. Hole at upper left, made by previous owner for a fuse, may eventually accommodate a fuse holder or a send/receive switch.

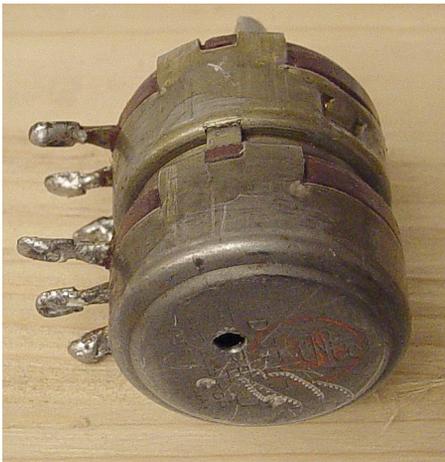
Hole drilled in rear potentiometer of the volume control made it possible to inject a shot of control cleaner.

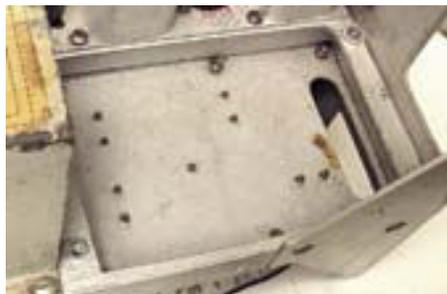
The empty dynamotor well on the BC-348 chassis.

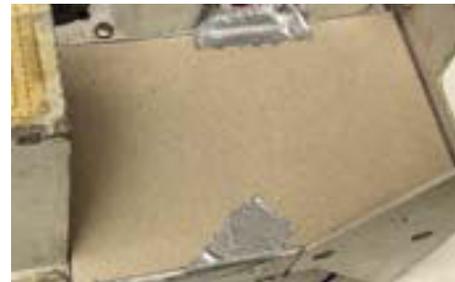
Fitting a cardboard template over the dynamotor well.

To get the placement for my mounting screw locations, I centered the template over the dynamotor well and duct-taped it down. Then I applied rubbing pressure with my fingertips over each of the tapped holes until its outline began to show through the cardboard. Adjusting a desk lamp for crosslight, I could now see good representations of the openings. Carefully estimating the center of each opening, I used a nail to make holes through the cardboard at those locations.

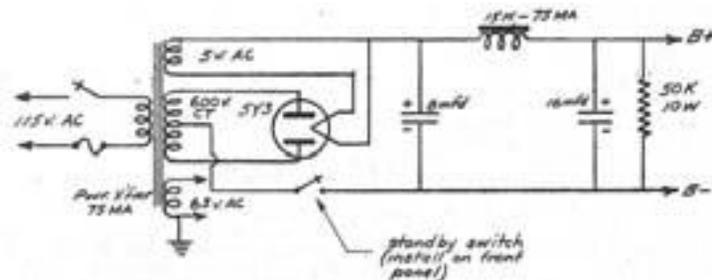
Figure 1. Suggested BC-348 power supply from 1940s conversion publication (see text).

The power supply circuit employs a standard full-wave rectifier. I'm including a schematic of the BC-348 power supply that was recommended in a popular surplus conversion handbook of the mid 1940s (Figure 1). This is essentially the circuit of my supply, except – to save space and power – I used a couple of

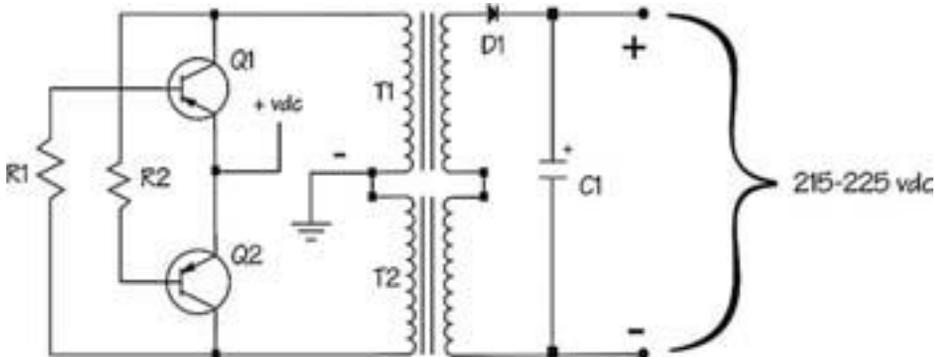
Figure 3. N3TPM's circuit for solid state dynamotor replacement. See text.

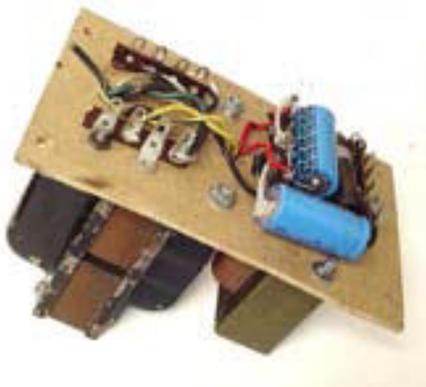
The power supply board is now almost ready to mount over the dynamotor well.

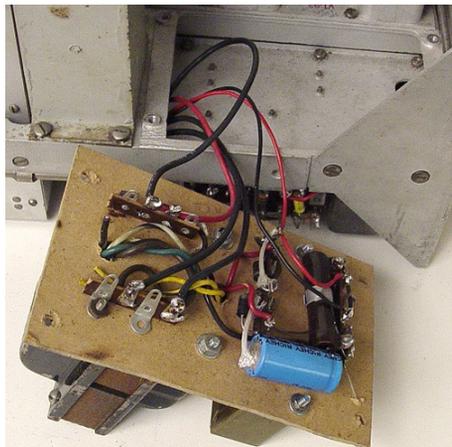
Power supply connected to the newly installed wiring for testing.

contributed by a friend and a choke I picked up at last August’s Antique Wireless Association Annual Conference. With this transformer, the B plus voltage turned out to be about 50 volts too high.

Since I didn’t have a higher-value dropping resistor on hand, I decided to try reconfiguring the power supply filter from capacitor input to choke input. This was accomplished simply by removing the filter capacitor from the transformer side of the choke – leaving just the capacitor on the far side. The B plus voltage now dropped to an acceptable level, and I was interested to see that the receiver hum level had not noticeably increased. I now mounted my dropping resistor on top of the power supply board, where it would have more ventilation for heat dissipation, and wired it in permanently.

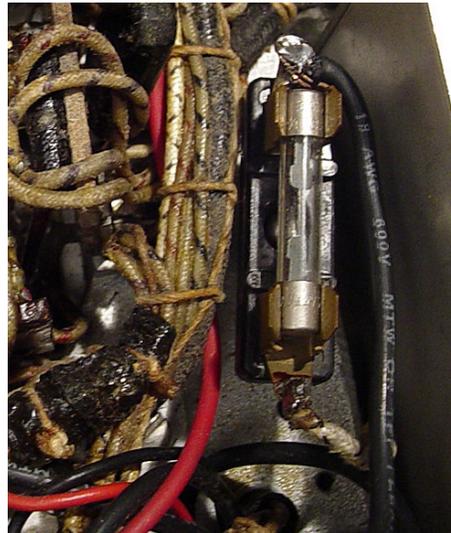
A replacement fuse block was installed at the original fuse location, but raised on a spacer for easier access.

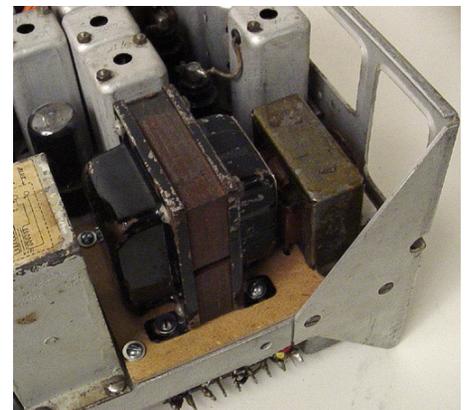
The power supply chassis fits snugly over the dynamotor well—which is deep enough to allow clearance for parts and wiring. I admit, the transformer and choke are not exactly pretty—but they do their job!

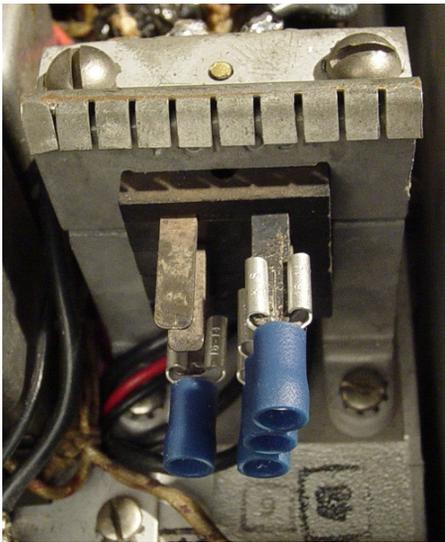
The power/control connector is here shown upside down to show the fit of the slide-on terminals. See the accompanying diagram, which is shown right side up, for numbering of locations.

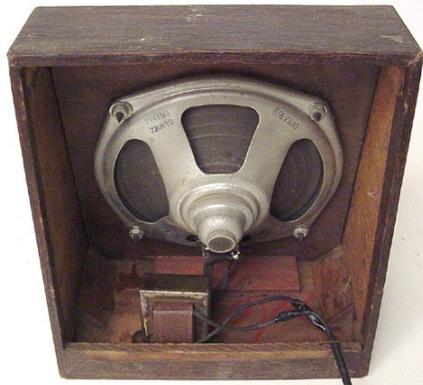
Speaker and output transformer in small tabletop baffle – all scrounged from junkbox. The baffle will get a coat of black paint to match the radio.

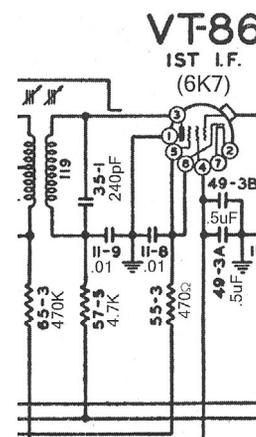
Fig. 1. Schematic of first i.f. stage showing the trouble spots (see text).

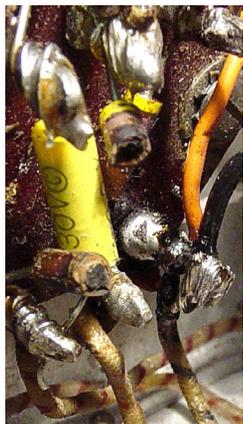
The two ends of the burned resistor after I fished them out from behind one of my replacement capacitors.

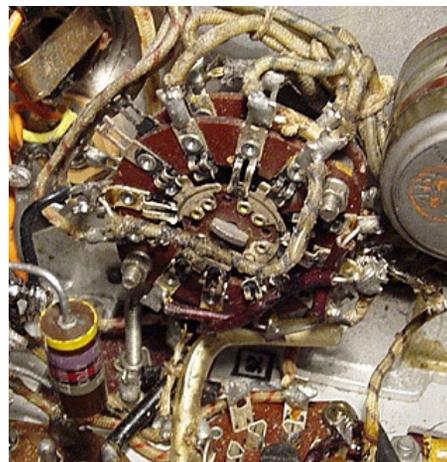
The base of the problem i.f. transformer (long screw protruding from center) can be seen between my large 5-watt replacement resistor and the back wafer of the “avc-off-mvc” switch.

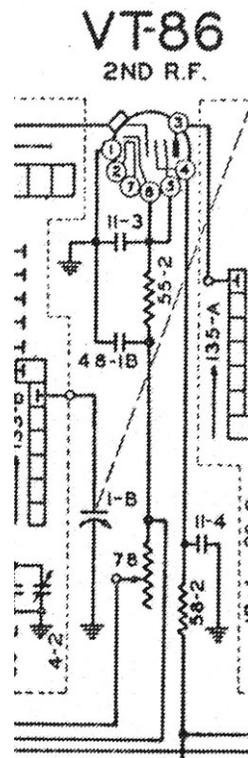
The arrangement consists of rheostat 78 (see Fig. 1) in series with the cathode return of second r.f. tube VT-86 (6K7 in civilian nomenclature). This rheostat is ganged to the shaft of the main tuning capacitor in such a way that it increases in resistance – decreasing the sensitivity of the receiver – as higher frequencies are tuned in.

Fig. 1. Sensitivity rheostat, labeled “78,” (see text) can be seen near bottom of the picture.

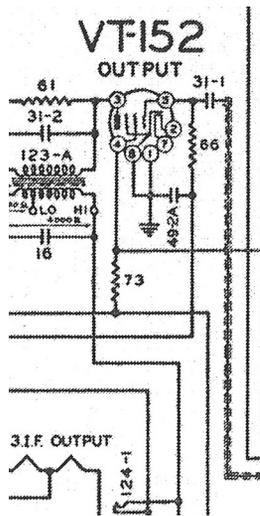
Fig. 2. Mica capacitor 31-1 (top of picture) couples diode plate 1 of second detector tube (not shown) to grid of output tube. Socket voltage measurements suggested capacitor was defective.

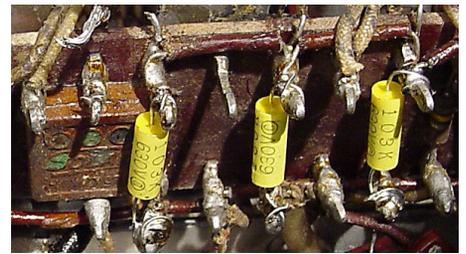
Mica capacitor 31-1 (far left) disconnected for testing. It flunked leakage and capacitance tests. Light-colored cylindrical units at right are replacement paper caps installed earlier.

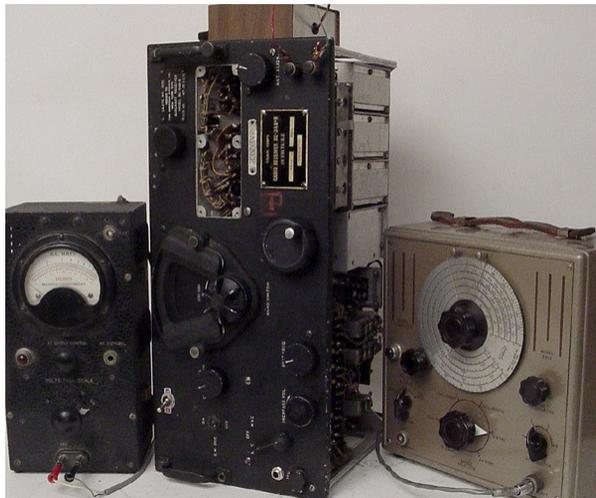
The BC-348 with instruments used for alignment. AC VTVM at left, dummy antenna atop receiver, service generator at right.

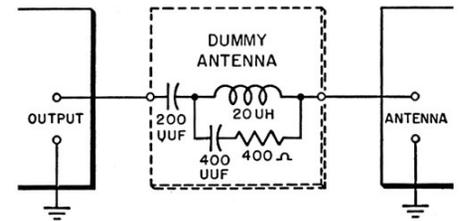
RMA DUMMY ANTENNA
20 uh choke is 49 turns No. 30 enameled wire close-wound (1/2" long) on 1/2"-diameter plastic tube.

Fig. 1. Specifications for dummy antenna as originally recommended by the Radio Manufacturers' Association.

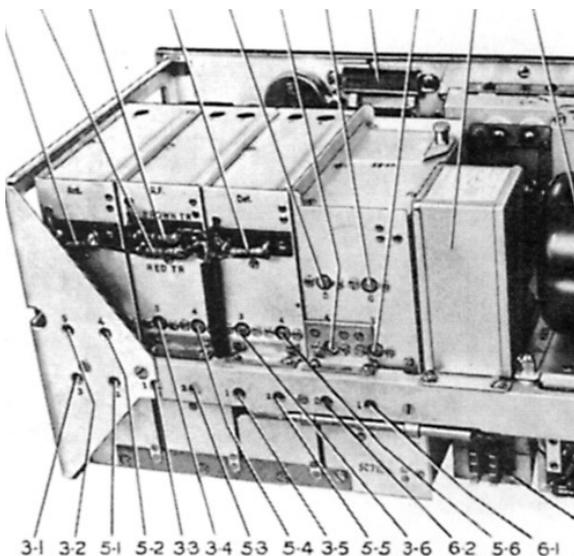
Each of the coded openings in Figure 3 gives access to a screwdriver-adjusted trimmer. Metal screwdrivers are ok here – which is just

Fig. 3. Section from manual illustration showing how trimmer locations are identified by designations from alignment data chart.

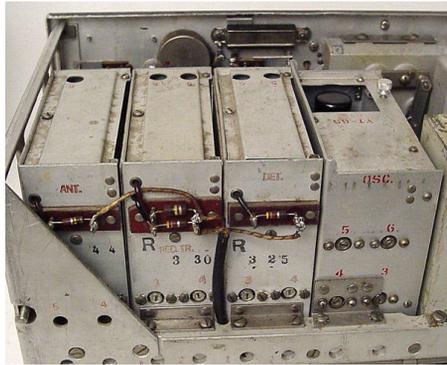
The BC-348's removable r.f. modules. From left: first r.f., second r.f., converter, oscillator.

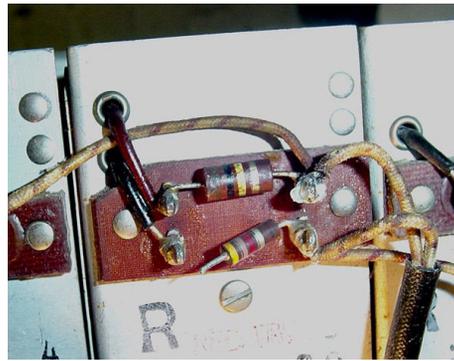
Plate and grid resistor are mounted on back panel of r.f. modules. The 4700-ohm first r.f. plate resistor (shown disconnected) measured almost 6500 ohms, so was replaced.

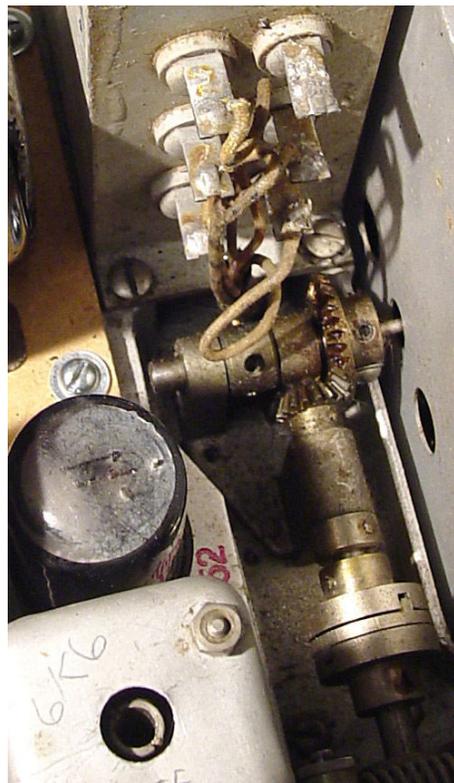
Actuating shaft from geared band change control (right center) can be seen entering hole in wall of oscillator module (see text).
