Restoring a 'Breting 12' Communications Receiver – Gerry O'Hara

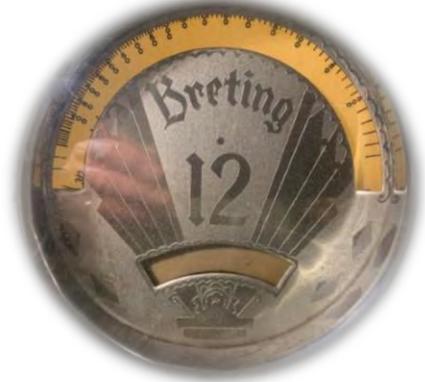
it arrived it appeared to be in reasonably good

physical shape (photo, below), however, a number of other projects had to be completed prior to checking it out and it remained in the 'waiting room' (garage) before finally arriving on the workbench several months later. However, I was in for a bit of a disappointment...

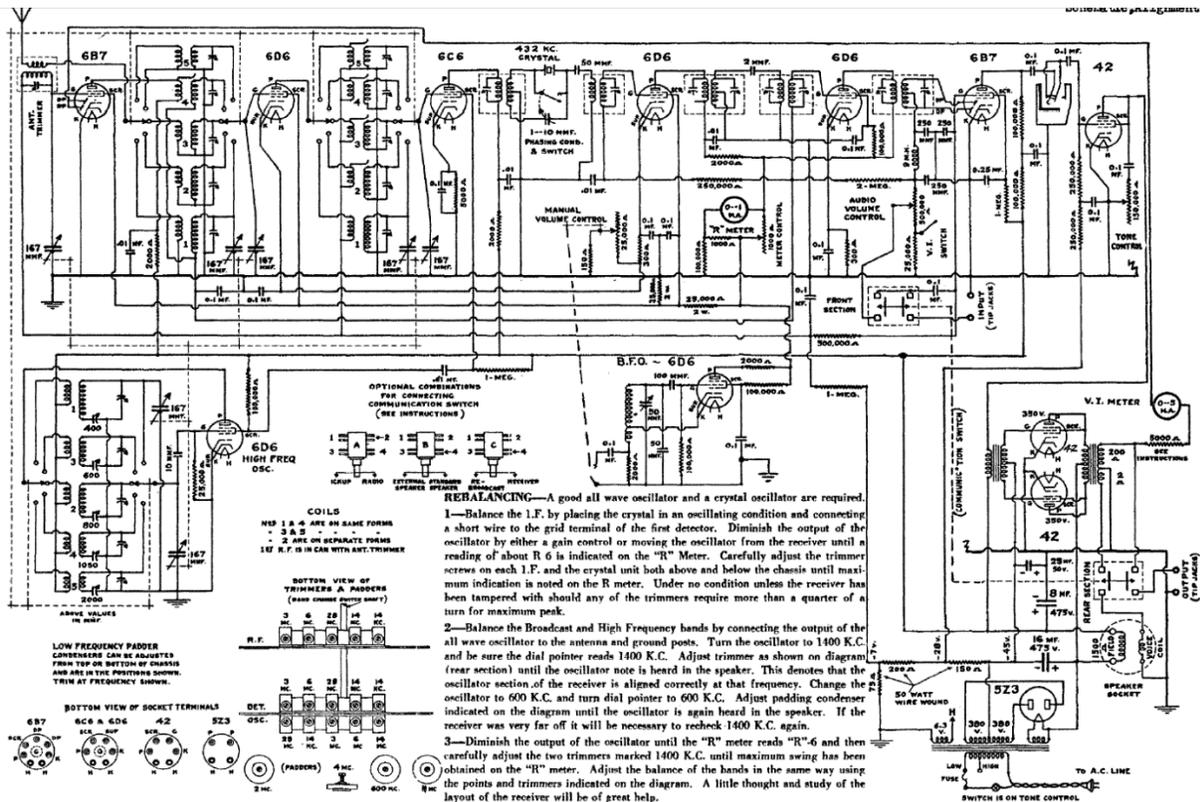
At first glance the Breting 12 follows a typical communications receiver topology for the mid-1930's – see schematic below (also see the full-size schematics, one with several errors corrected, in the Appendix), with two stages of RF amplification (6B7, 6D6), mixer (6C6), local oscillator (6D6), a crystal

filter followed by two stages of IF amplification (2 x 6D6), BFO (6D6), detector/1st AF amplifier (6B7), AF driver (#42), push-pull output (2 x #42) and rectifier (5Z3). However, closer examination identifies several more unusual features:

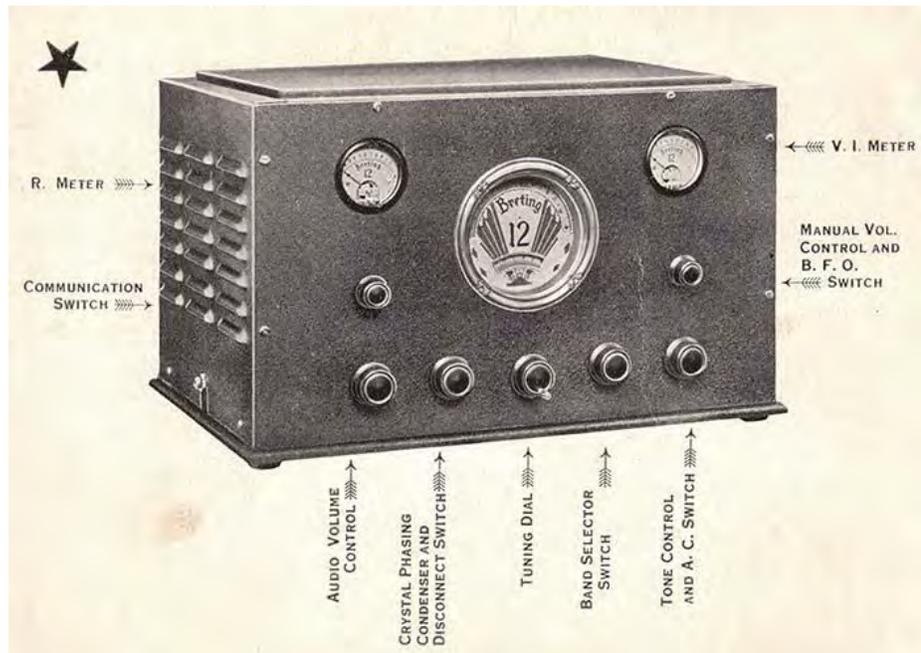
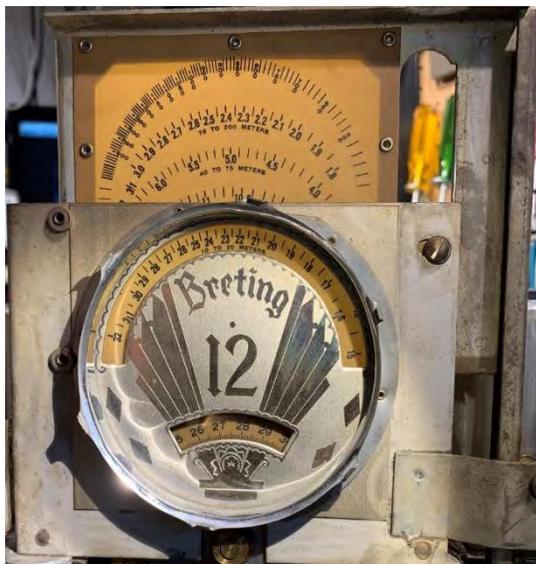
tap screws, and the front panel is held in place by nuts on some of the control shafts. The chassis is chrome-plated steel, and is a little lightweight given that it is not braced internally, allowing a degree of 'flex' when not supported by the base plate and cabinet. The dial, dial escutcheon and meter faces are the real distinguishing features of the receiver, all having a distinct 'art deco' silver-coloured metal styling and lettering. Early models had an 'oak leaves and acorns' pattern in a gold tone on the dial mask, whereas later models, as the one featured in this article, had a vertical 'ray' pattern either side of the '12' in the centre of the dial mask (photo, left).

The band change switch operated a vertical 'guillotine'-style shutter mechanism via a rack and pinion arrangement (photo, left), with the band in use being displayed through a semi-circular slot in the dial mask. An articulated dial lamp that rotates with the tuning gang shaft projects a red translucent triangular dial pointer onto the scale, and the logging scale rotating at a higher speed, is illuminated by a fixed dial lamp.

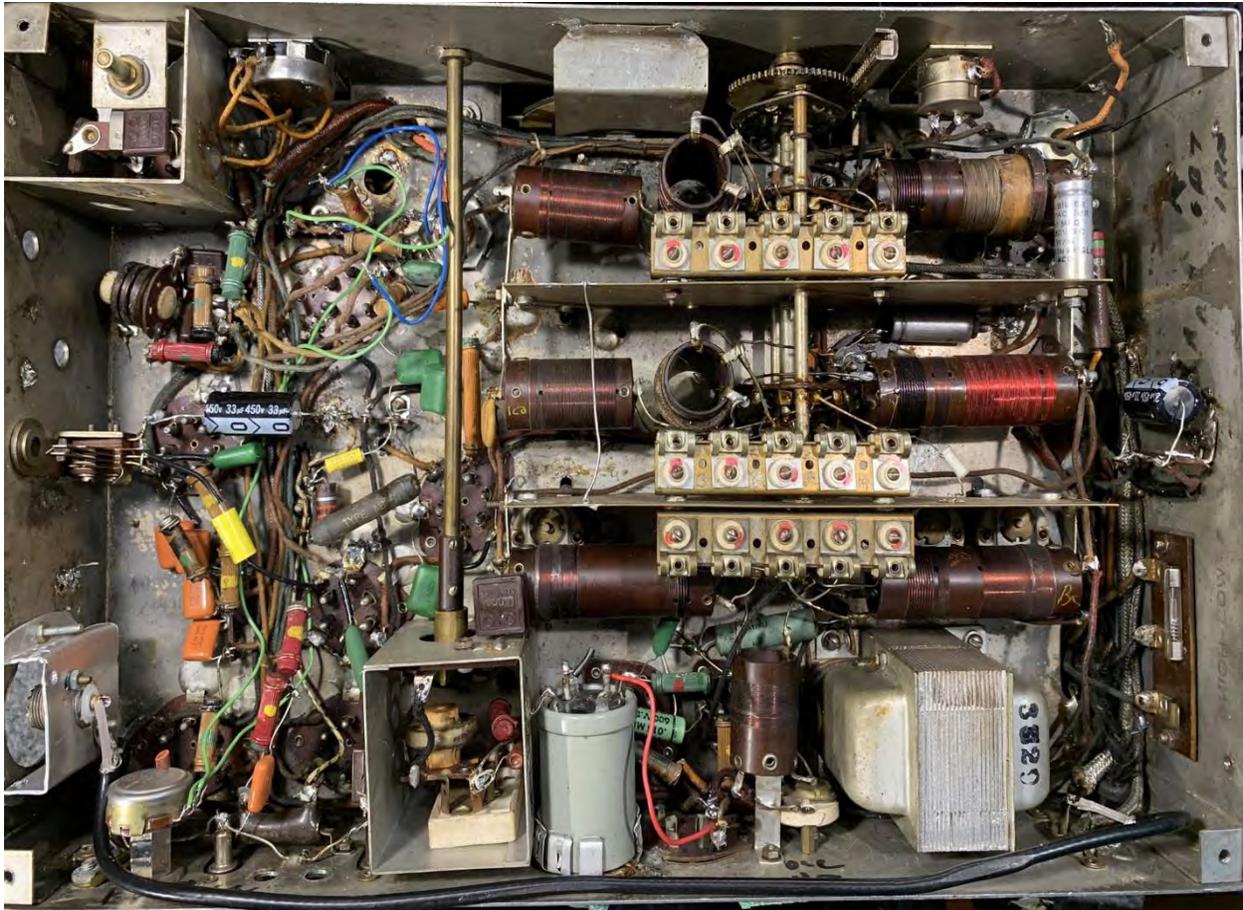
I was quite disappointed when I removed the base plate and checked under the chassis – it was a real 'horror show' of someone's (actually, probably several folks') bodged workmanship, comprising many repairs and mods: rats nest wiring, hardly any original passive components – these mostly having been replaced with assorted junk box parts, some of the worst soldering I have ever seen, butchered metalwork, and general filth and mess (photo, below). Indeed, there was not much left of the original electronics save for the transformers, coils, silver mica capacitors, switches and some resistors.

The owner's request was, given the collectability of this set (unusual and fairly scarce, plus its eye-candy art-deco dial), to 'give it the works' regarding refurbishment, ie. re-stuffing capacitors, reproducing resistors, etc. However, as can be seen, there were none of the original capacitors left to re-stuff, and I can only guess at what some of the original resistors looked like, though probably all 'dogbone' types.

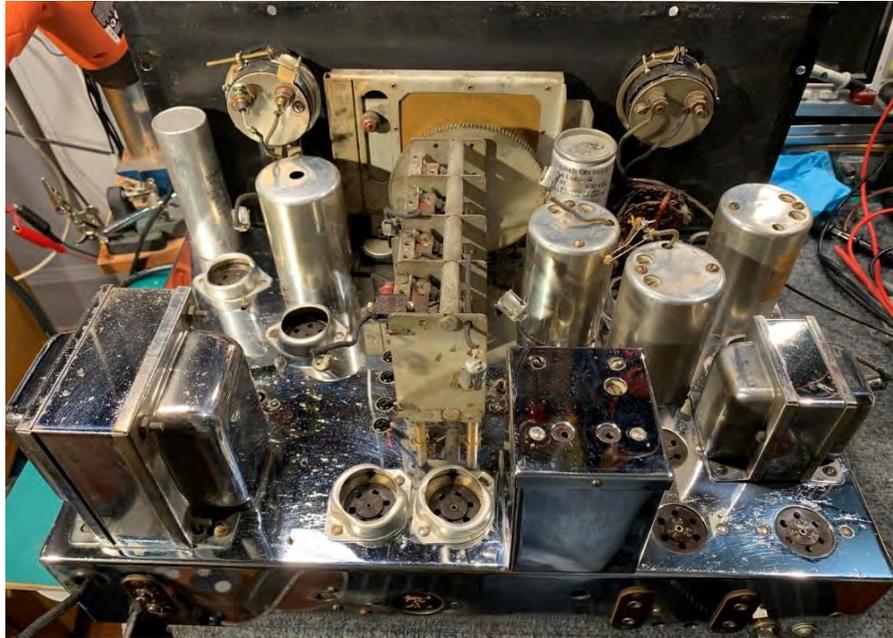
I also cleaned the chassis top, the tube shields and tube envelopes. I then tested the tubes on a STARK 9-66 mutual conductance tube tester: they all test good - no shorts and all within their spec. for Gm as follows:

- 6D6's: Gm's of 1750, 1850, 1650, 1550 and 1525 (ok range 1260-2000)
- 6C6: Gm of 1450 (ok range 695-1100)
- 6B7s: Gm's of 950 and 1000 (ok range 630-1100). Both diodes in both test weak. These are used as detector/AGC, in one of the 6B7's and to rectify the audio output for the 'VI Meter' in the other (in the 1st RF amplifier tube), so likely ok
- #42s: Gm's of 2050, 2150 and 2150 (ok range 1260-2000)
- 5Z3: both diodes ok

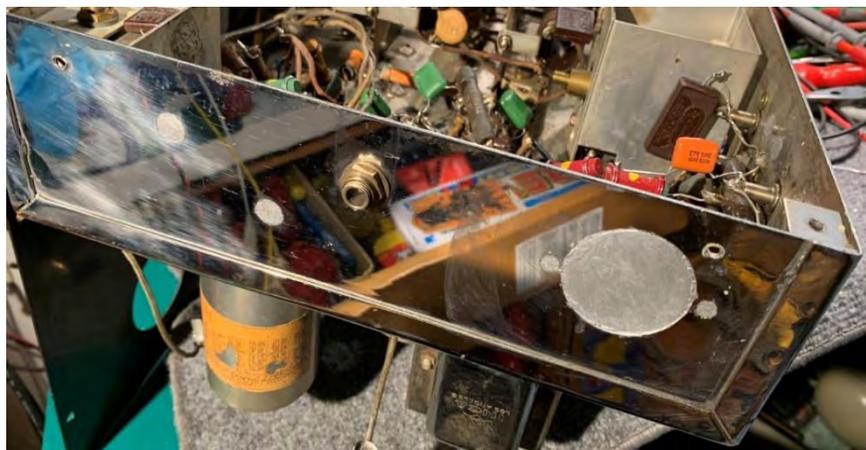
Several surplus holes drilled by someone in the chassis were then plugged: I used JB-Weld to fill the smaller holes in one chassis side and the rear apron, and a plastic disk for the larger (2") diameter hole in the chassis side, held in place with JB-Weld (photo, right). I then gave the JB-Weld and the plastic disk a coat of metallic paint – the

result looks a bit like the areas of the chassis where I removed large gobs of solder – not 'pretty', but much better than gaping holes⁵.

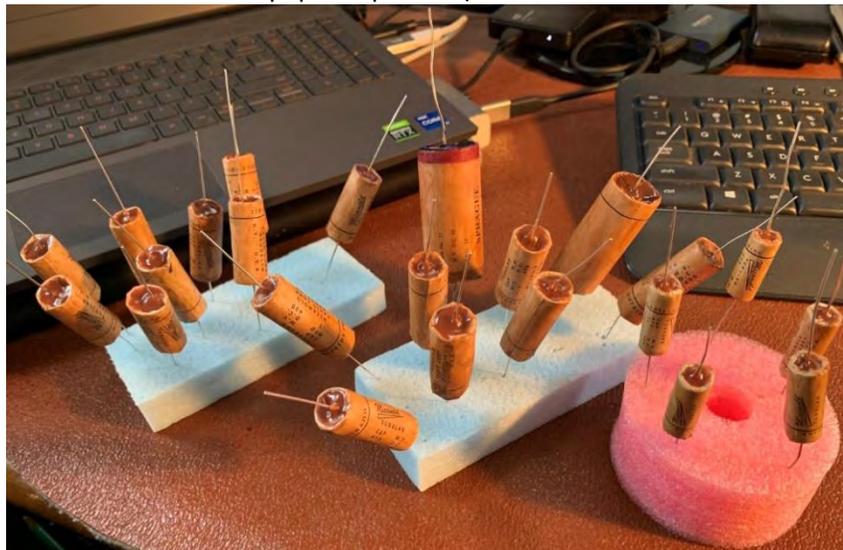
Next, I re-stuffed the two can electrolytics. At least one of these is a replacement (but likely both), and are of different manufacture (one 'Sangamo' brand and one 'Cornell Dubilier'). One of these, the Cornell Dubilier one, was still wired into the circuit, though the other had its leads cut off and had been replaced with a modern 33uF part. One of these can capacitors, a standard spigot type, has its can grounded, and the other does not, this therefore being a dual flying-lead type.

I re-stuffed both can capacitors by hacksawing the can in two around a half-inch from the base (photo, right), removing the guts/cleaning out the can, installing the new capacitor(s)⁹, cutting an approx. 2" length of 'Schedule 40' PVC pipe and using this to joint the two halves together with some glue (but not too much as it may have to be split apart in the future to replace the capacitor - yes, I have had to do that a couple of times!). This sounds time-consuming, but it takes less than an hour per can from start to finish. Once the new capacitor is installed (photo, right, second from top), some aluminum tape is wrapped around the base of the can (across the join), and a label installed over the top as needed (bottom photo, right).

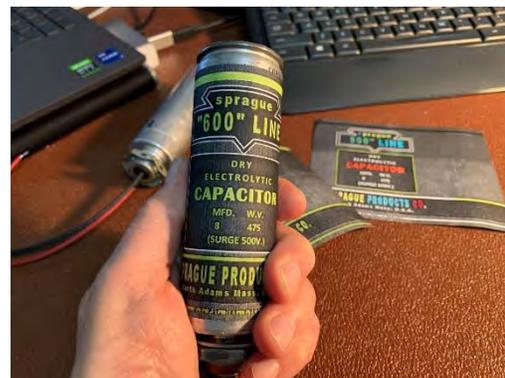
Next, I started work on a relatively simple section of the electronics: the RF amplifiers, oscillator and mixer sections, plus part of the power supply. This involved removing a broken (non-original) tag strip that had been soldered to the chassis side, and installing a bolt-in replacement using the original hole in the chassis for this. I also installed a new chassis solder tag to wire-in the reproduction tubular (axial) 25uF electrolytic, again using the original hole in the chassis for the screw. I then replaced four capacitors in the RF amplifier sections and two in the local oscillator and mixer sections of the chassis. There was a 0.02uF capacitor (a replacement) that had been installed from the higher-impedance

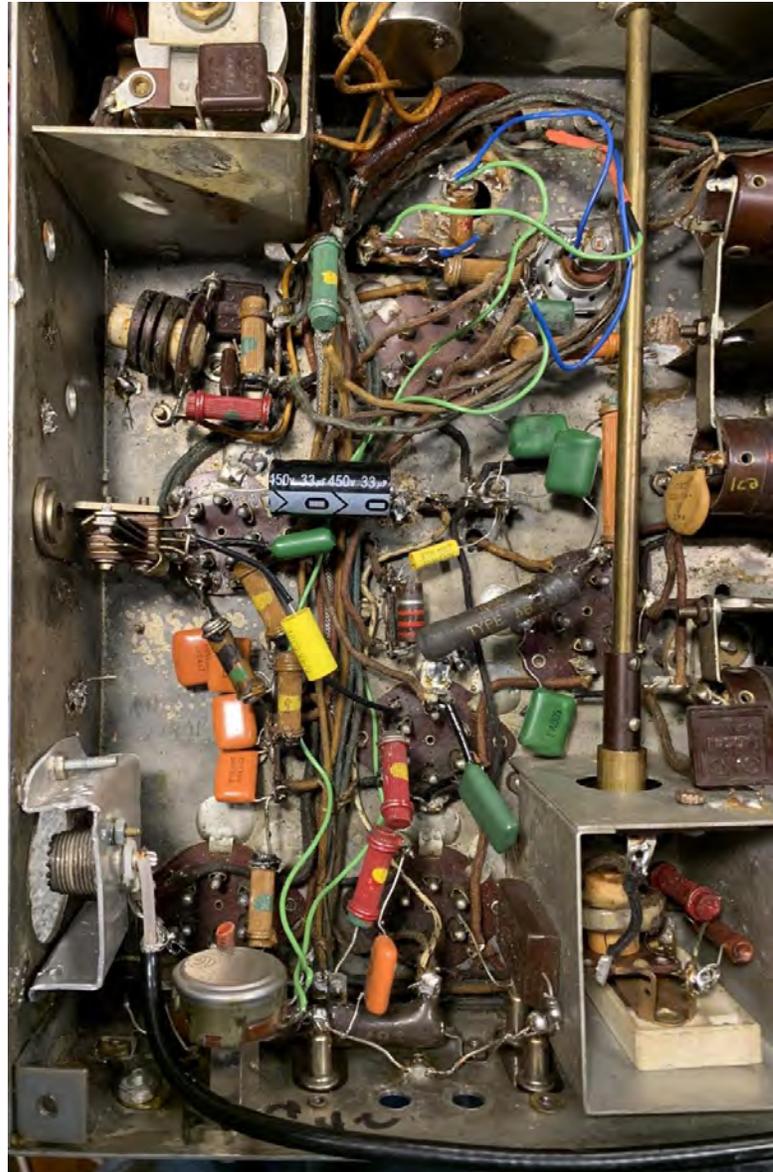
Next, I started to work on the 'rats nest' IF/AF section of the chassis (photo, right). First, I spent an hour checking the wiring against the (corrected) schematic, noting several differences, wires that 'went nowhere', missing wires, and some wiring errors, as well as identifying which component in the chassis was which on the schematic - not always straightforward as, when comparing with the photos of the (mostly) original chassis at the Western Historic Radio Museum, they were sometimes located in a different position on each chassis.

I then started replacing the motley selection of junk box capacitors with the reproduction parts, checking and tidying the wiring as I progressed, noting several dry joints and a couple that had no solder on them at all - the joints simply pulled apart. There are a couple of capacitors that are hand-drawn onto the schematic, one of which is not present on the Western Historic Radio Museum photos. These were both bypass capacitors located at sensible places in the circuit, so I decided to fit them into this chassis.

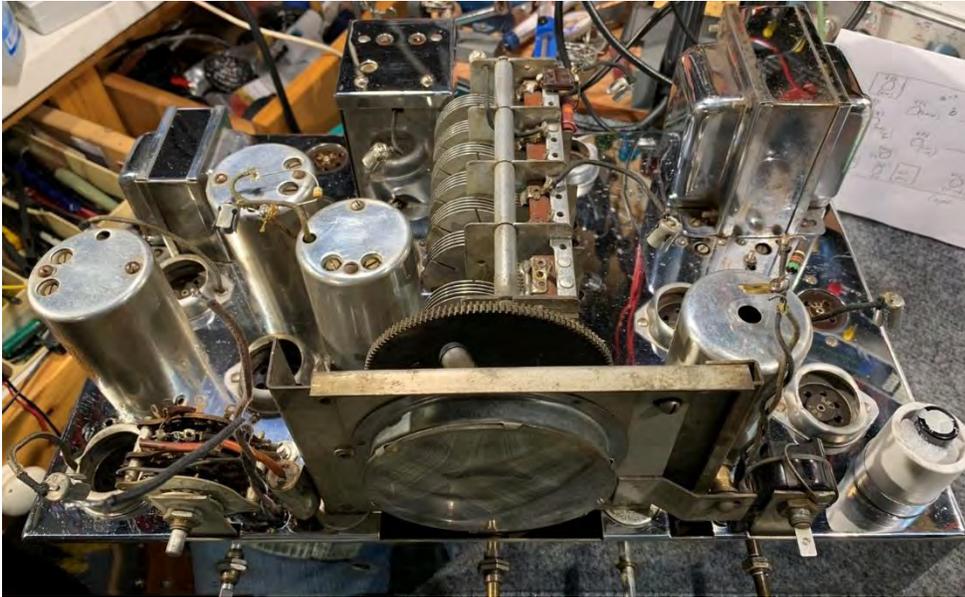
While looking carefully, I found what was likely to be an original capacitor buried deep in the BFO compartment, access to which necessitated loosening and removal of the compartment screen, and removal of the front panel (photo, below of the chassis with front panel removed) to gain access to and allow the undoing of the securing bolts on the BFO pitch capacitor.

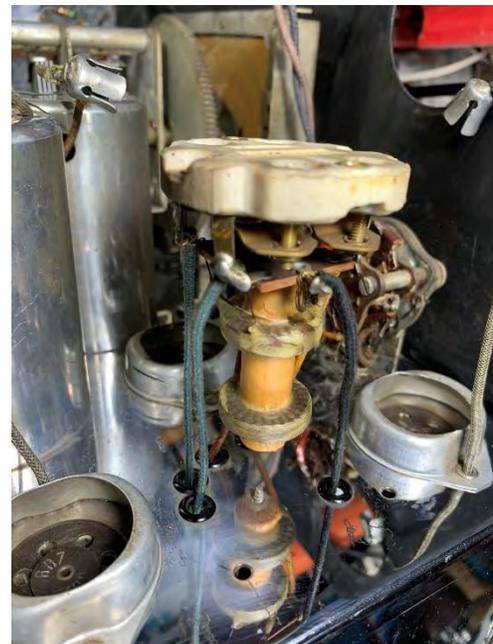
The screening can was removed from the third IF transformer (photo, right) to confirm the wiring to the plate of the second IF amplifier tube as this wire was missing under the chassis. I located the wire and brought it under the chassis through an eyelet. This was followed by a series of 'tidying-up' jobs around the chassis, including:

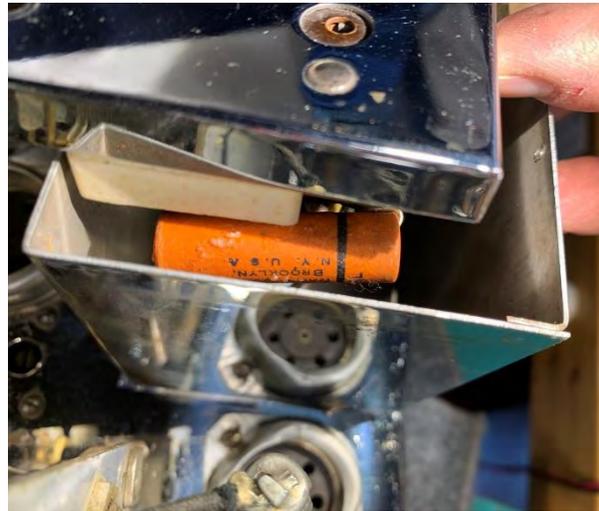
- Opening up the crystal filter screening can to change out the 0.01uF capacitor located in there: I found that it was an original 'Micamold' brand part (photo, right). I usually don't bother restuffing capacitors that are hidden inside IF cans and the like, but I re-stuffed this one (I simply slit the case, removed the guts, popped in the new capacitor with some packing material, and then put some brown hot-melt glue into the ends – takes about 5 minutes) – photo, below;

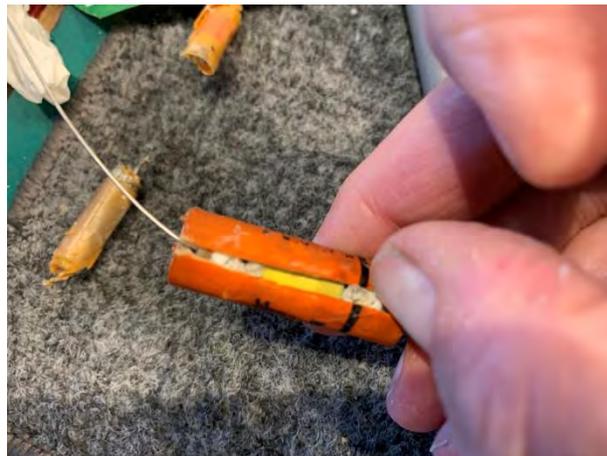
- Removing a surplus 0.01uF 'Micamold' brand Bakelite lozenge (paper) capacitor someone had

added to the output 'tip jack' socket and checking operation of the 'Communications Switch';

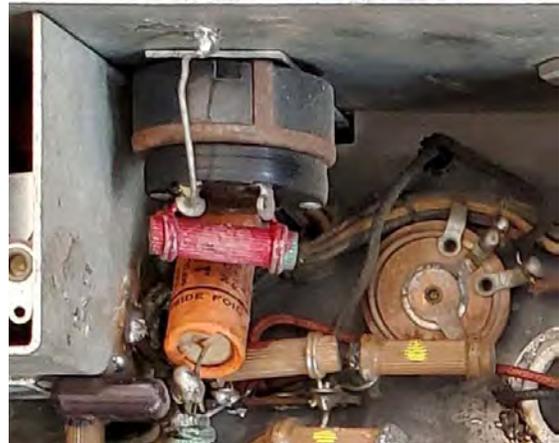
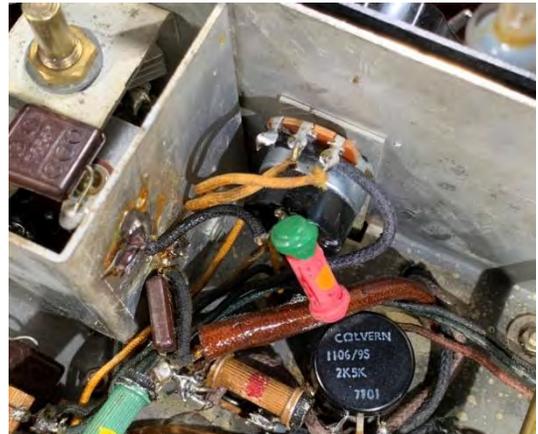
I deduced that the 25Kohm resistor was part of the AF Gain control, which should have had a switch fitted (this had been replaced in this chassis for a part without a switch). The photo, right, shows the arrangement in the early model chassis at the Western Historic Radio Museum. The resistor is connected between the 'cold' end of the pot and ground, and the switch shorts this out during normal operation of the set, and switches in when using the 'V.I.' meter to provide a fixed level of AF gain as described on and comments by the Western Historic Radio Museum website thus:

I found a new 500Kohm log-taper pot with switch and replaced the (previously replaced) AF gain control on the chassis with it. I wired the switch with a 25Kohm resistor as per the schematic to act as in the Western Historic Radio Museum's description. I used an old 250Kohm 'dogbone' style resistor that had drifted to over 330Kohm with a new 27Kohm resistor in parallel (and hidden). I changed the yellow dot on the resistor body to an orange one so it looks like an old 25Kohm part as it should (photo, right).

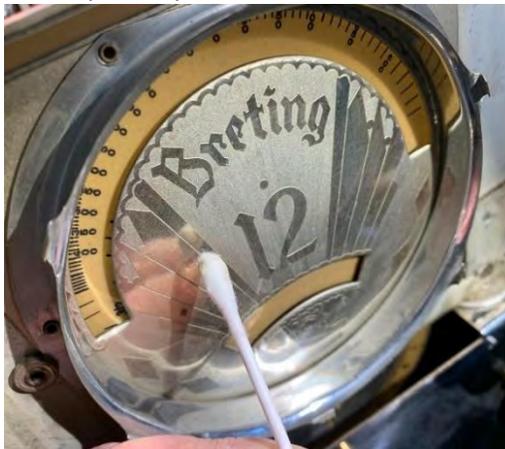
That done, and while I had the front panel removed, I decided to dismantle and clean the dial and dial cover glass and front panel. I was very careful removing the dial glass as this is very thin convex glass, held in place by small metal tabs which have to be pried away to release it. The dial was cleaned

carefully with Q-Tips and a little IPA (photo, left). The dial glass was very grubby and greatly benefited from a clean on both sides. The dial itself was not very grimy - mainly surface dust, so it was only brushed gently with a soft brush - its all too easy to remove markings from radio dials if IPA (or even water) is used. On reassembly, I crimped the metal tabs just enough to retain the dial

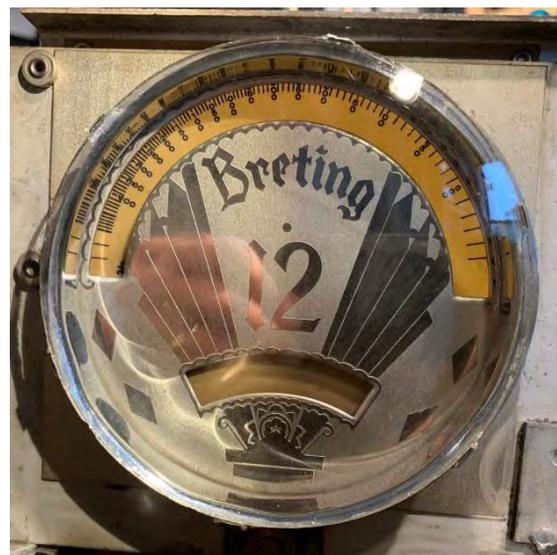
glass and added a small dab of Duco cement to each tab to make sure the glass was held firmly – photo, right. I cleaned behind the front panel and reinstalled it, then paid some attention to the meters.

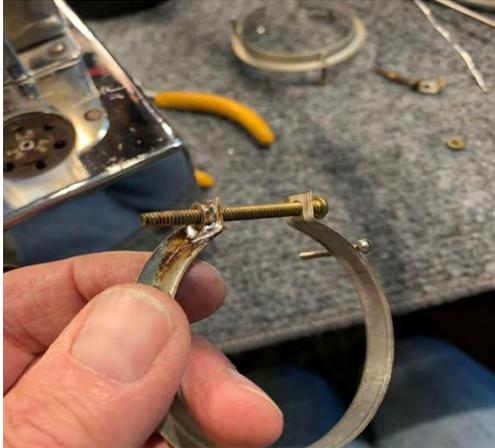
I had removed the meters before I took the front panel off the chassis, noting that one of the mounting clamps was broken (photo, top right on page 15). On closer inspection, I noticed that the

'good' clamp had suffered the same fate and had been repaired by someone previously - simply soldering the broken part back on. This seemed to have worked ok, so I duplicated the repair on the broken clamp (photo, below). That done, I re-fitted the meters to the front panel. I also re-made the wire connections to the meters using the correct type of 'hook' lugs,

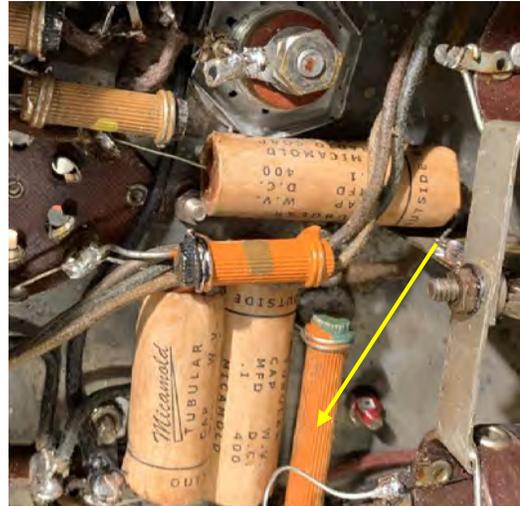
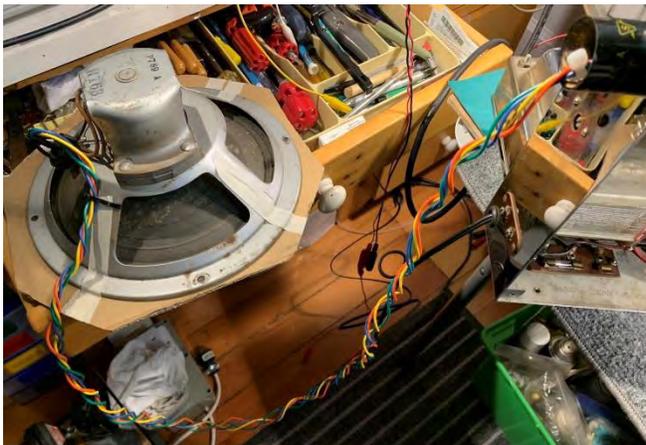
I found an electrodynamic speaker with a 1690ohm field coil and a 3 ohm voice coil - near enough to that specified on the schematic (1500ohm field coil). I wired it up to a four pin plug (a tube base removed from a failed #80 tube), plugged it in to the speaker socket on the chassis (photo, left) and did a few further resistance checks. Satisfied with the results, I powered-up the chassis using a Variac, noting the wattage: at 110vAC, the chassis was drawing around 75W (about right for a 12 tube chassis). I could hear a slight 'hiss' from the speaker, but

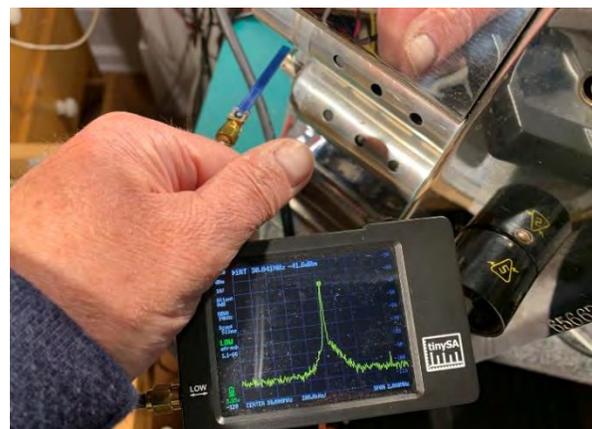
I then checked that the local oscillator was operating - I used a 'TinySA' spectrum analyser coupled to an E-Field probe placed near the local oscillator tube to sniff the local oscillator signal (photo, right), and confirmed that the oscillator was

working well on all bands. Next, a 432KHz AM modulated signal (that is the correct nominal IF for the Breting 12) was injected into the grid of the 2nd IF tube and a strong signal was heard from the speaker. I did the same for the 1st IF stage and a stronger signal was heard. I then tried injecting the IF signal into the grid of the mixer tube and and... nothing, unless I turned the signal generator up to around 0.3v(!). I then tried injecting the signal into one of the crystal socket pins and a loud signal was again heard, confirming all was ok 'downstream' of the crystal, though shorting the crystal made little difference.

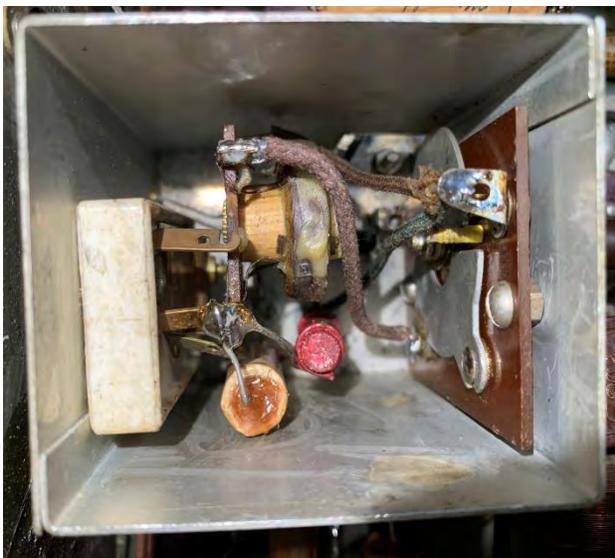
Close inspection of the wiring and several continuity checks in the crystal phasing compartment under the chassis identified another (subtle) wiring error (circled in upper schematic, right), which effectively shorted out the crystal coupling transformer secondary winding(!). I corrected the wiring to what it should be per the schematic, below, right (bearing in mind the schematic is also riddled with errors!) – photo below. This fixed the problem and the receiver was now receiving signals on all bands. A short demo video of the set receiving on the Broadcast band at this stage of the work can be viewed

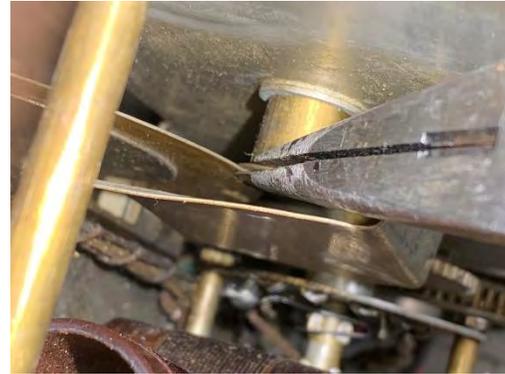
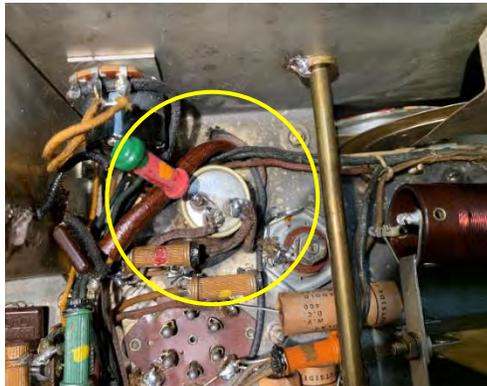
local oscillator: the pinch wheel was splayed out and making intermittent contact with the edge of the phenolic logging scale dial, which itself was greasy. I gently nipped the pinch wheel halves together around their full circumference (photo, right), and also cleaned the greasy grime off it and also around the edge of the logging scale dial with naphtha and then IPA, applied with a Q-Tip, such that it made reliable contact. I also noticed that the stationary dial bulb (that illuminates the logging scale dial) was not working - I had replaced the bulb, but because it is hard to reach, I found that I could not snug it fully home in its socket (its a #40 screw thread type) such that the tip made connection with the contact at the base of its socket. I removed the bulb and built up the tip contact with solder such that the bulb did not need to be screwed in quite as far for it to make contact - this remedied the problem. However, with the bulb now illuminated, I noticed that the logging scale was

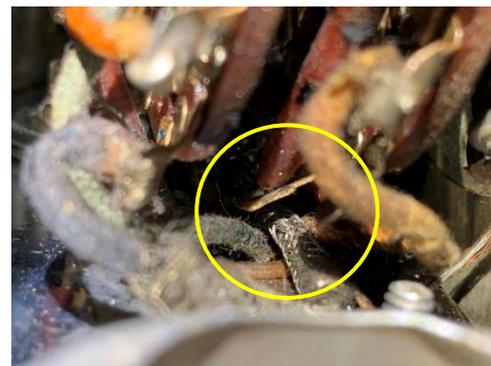
Resistance checks identified that the higher impedance secondary winding on the output transformer that supplies the audio signal for this meter was shorted to ground. I had previously checked the (DC) resistance of this winding at 20ohms. Careful inspection of the 'Communications Switch' located the problem - a screening braid from the rear apron audio input 'pin jack' was rubbing against a switch contact solder lug underneath the switch (between the switch and the chassis - circled on photo, right) - impossible to see from above or from behind the switch, but visible when viewed from the side with the 1st RF amplifier tube

and screening can removed. Operating the switch occasionally moved the contact away from the braid and hence the intermittent operation I had noted earlier. I simply pushed the screened wire to one side, away from the switch contact and the problem was fixed.

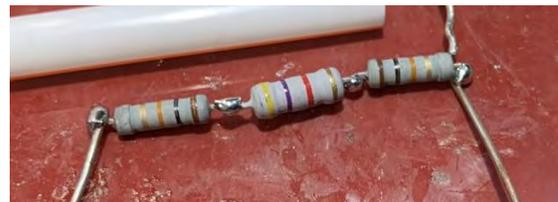
- Identify the resistance value and wattage of the original part (the original parts are often much larger for the same wattage rating than modern resistors);
- I then select one or a combination of several resistors (usually 1W rated flameproof parts) that approximate the specified nominal resistance value, ie. is within the tolerance rating of the part. For example, to make the 35Kohm 2W part, I used 2 x 10Kohm and 1 x 15Kohm 1W rated parts in series (selecting a combination of values to make sure that no individual resistor will be overloaded). As the resistors will be encapsulated, I de-rate the parts by using a combination that that will provide around 1.5x the specified wattage rating of each resistor;
- If several resistors are being used in series, I solder them together, leaving minimal space between the individual resistors (photo, right);

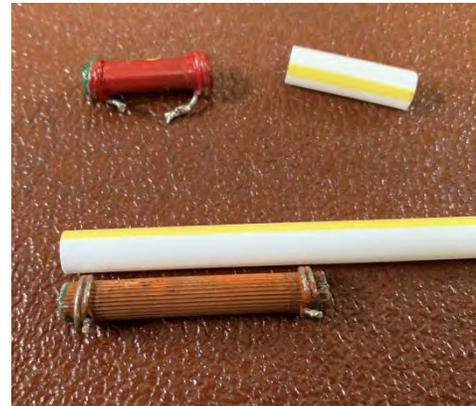
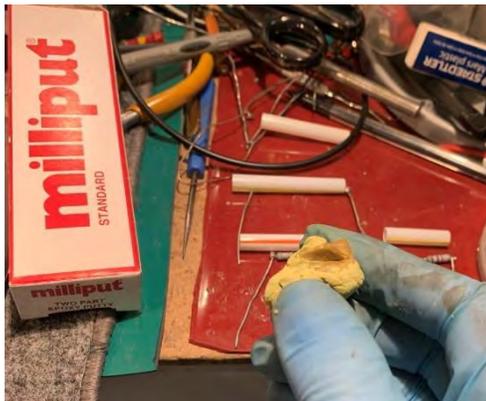
- I attach thicker lead wires to the end resistors to match the other resistors in the chassis (old resistors tended to have much thicker leads than modern parts);
- I then cut a piece of plastic or (or paper) drinking straw of similar internal diameter to the desired resistor diameter to the required length of the length of the resistor (photo, right) and slit it longitudinally;
- I mix sufficient two-part epoxy putty, eg. 'Milliput' brand, available in hobby shops, to make a batch of resistors (up to six, as otherwise the putty may harden

prior to fabricating all the parts) – photo, left;

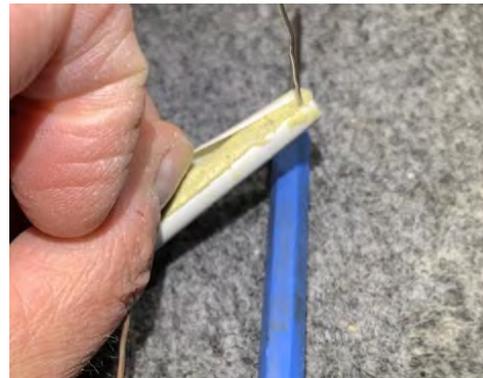
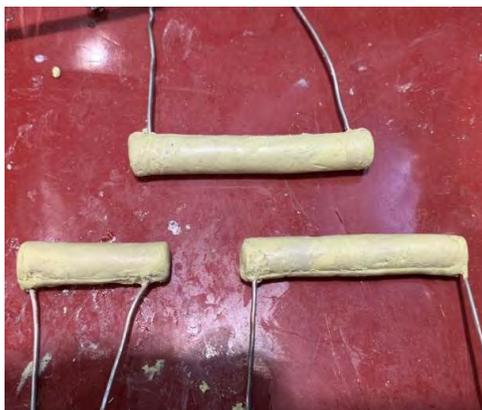
- The 'Milliput' putty takes around four hours to harden fully. Once hardened, I peel off the straw 'case' – photos, below and below left (plastic straw ones can be

retained and re-used, though paper ones tend to fall apart), and trim any stray pieces of putty off the

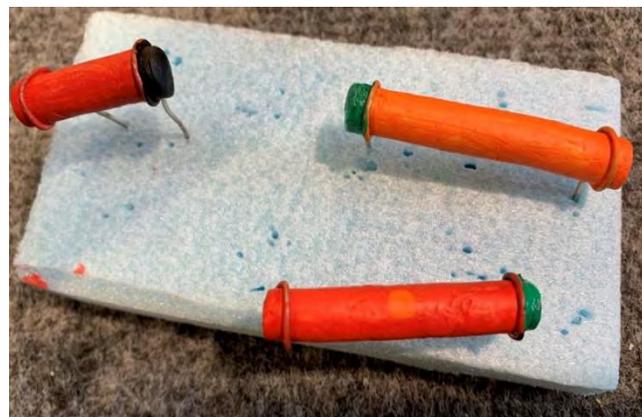
- Paint the resistor in the correct colour code (body-end-spot or whatever the original parts used);
- After the first coat of paint, I wrap the wire leads around the ends of the resistor bodies as per the original parts, and apply a second coat of paint - I use acrylic paints from a dollar store – photo, above;

- To 'age' the parts, I apply a coat of thinned amber shellac once the paint is fully dry (photo, right).

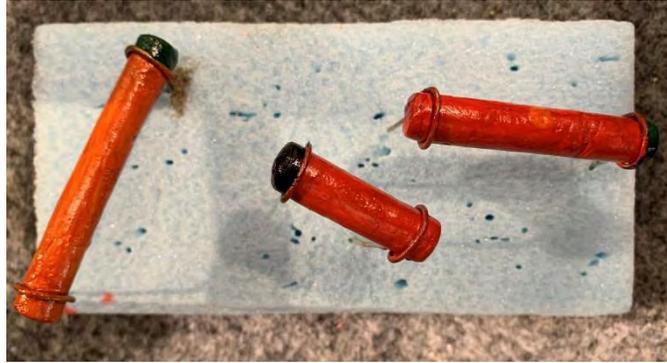
The reproduction resistors were then installed in the chassis and the operation of the set tested.

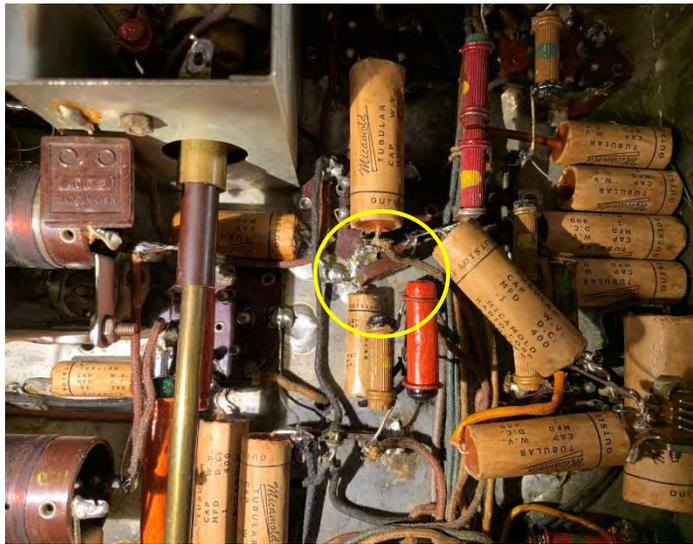
One thing I had noted once the V.I. meter was working, was that when the tone control was set for minimum treble cut, and the volume level was at around $\frac{1}{4}$ advanced (or higher), the audio stage went into supersonic oscillation, which 'pegged' the V.I. meter. I decided to investigate this and found that it was the #42 audio driver tube that was going into oscillation, producing a nice sine wave output just below 30KHz at a high level. Possible causes were a poor ground connection(s), dry joint, faulty tube, incorrect stage bias, or poor lead/component dressing.

I tried a different #42 tube and found this improved the situation such that the oscillation did not occur every time when the set was operating as noted, however, it would still occasionally break into oscillation, especially at high volume. I could not identify any dry joints or poor ground connections, and the lead dress and tube bias conditions were ok. However, I found that connecting a 1000pF capacitor from the #42 tube grid connection to ground completely cured the issue under all operating conditions, even with the original #42 tube installed. I therefore decided to make this slight (and easily reversible) mod to the circuit, using a 'period' silver mica capacitor so it was very inconspicuous (the capacitor is circled on the photo, above left).

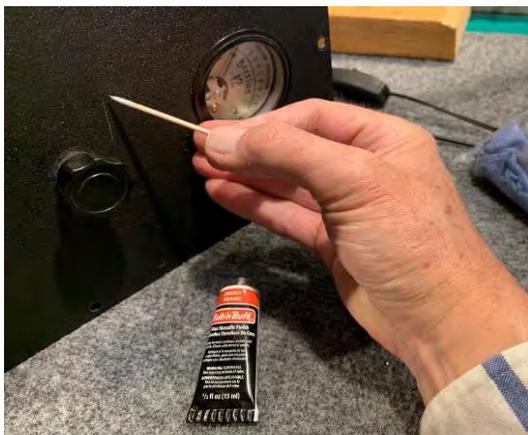
Finally, I touched up some scratches on the black wrinkle finish paint on the front panel using a little 'Ebony Rub 'n Buff' applied with a toothpick (photo, below left), followed by a polish with Novus #1.

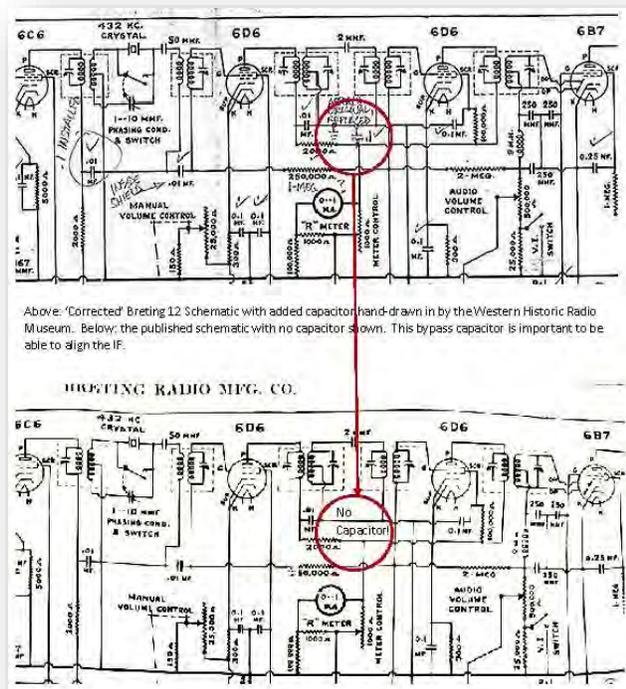
The IF alignment went fairly smoothly except one of the mica dielectric compression trimmers in the 4th IF transformer (primary winding) would not peak fully: instead, it started to 'click', indicating it had likely reached the end of its travel, ie. minimum capacitance. To confirm this and to check it looked ok physically, I removed the screening can and found that this was indeed the case - the trimmer was in good shape, but the adjustment screw was at the end of its travel. But why? I suspected a poor (signal) ground at the 'cold' end of the transformer secondary.

Careful examination of the schematic and the photos from the Western Historic Radio Museum revealed yet another error - the signal bypass capacitor at this node of the circuit was missing from the original schematic and was not fitted to this chassis when I received it (figure, above). However, the photos of

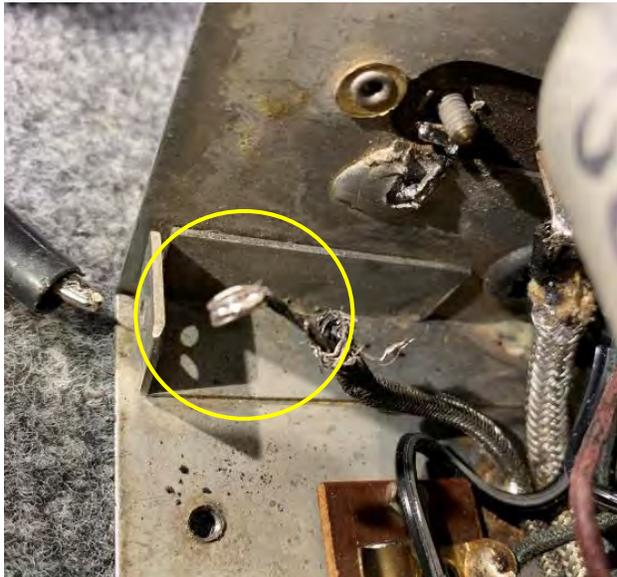
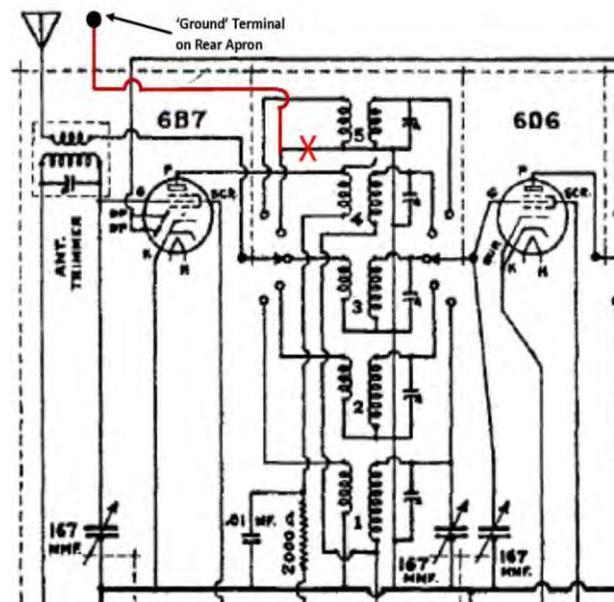
I had noticed some intermittent crackling noises during the soak testing sessions of the chassis that I had concluded was originating in the RF section of the chassis. I decided to locate the cause before I started the RF alignment process. I soon found the problem: the ground connection on the rear of the receiver is not wired directly to ground, rather, a screened wire runs from this terminal to the antenna wafer of the band change switch. This is a modification to the original circuit as shown in red

on the diagram, above, ie. it allows for a balanced antenna (dipole/doublet, etc) on Band 4 only¹⁵. The reason for the crackling noise was that the internal (rubber) insulation in this screened wire was completely perished and the internal wire was making intermittent contact with the outer braid (circled in the photo, left).

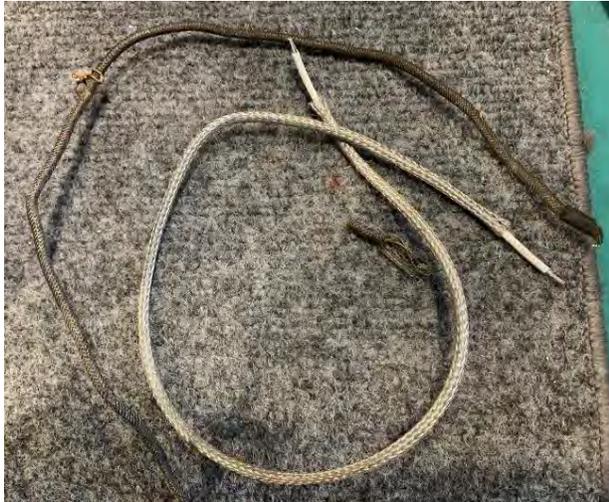
original wire and fabricating a new piece of braided-covered wire (photo, left). With this installed, the cracking noises were gone.

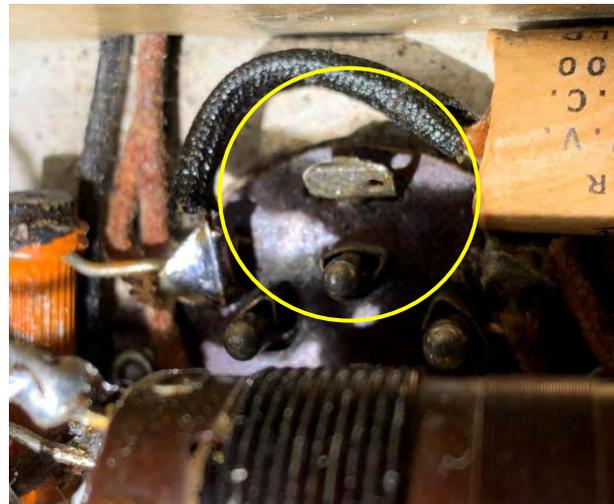
While I was undertaking the RF alignment, I found one more fault in the circuit while checking to see if I could squeeze any more performance out of the set – the suppressor grid of the 2nd RF tube, a 6D6, was not connected (circled in photo, right) - it had been at some point in the past, but someone had removed the connection (it should connect to the cathode). Why would anyone do that? Fixing this improved things, giving significantly more gain, however, I was surprised that the stage remained stable with the suppressor grid disconnected – I would have expected a tendency to oscillate, however it did not do so.

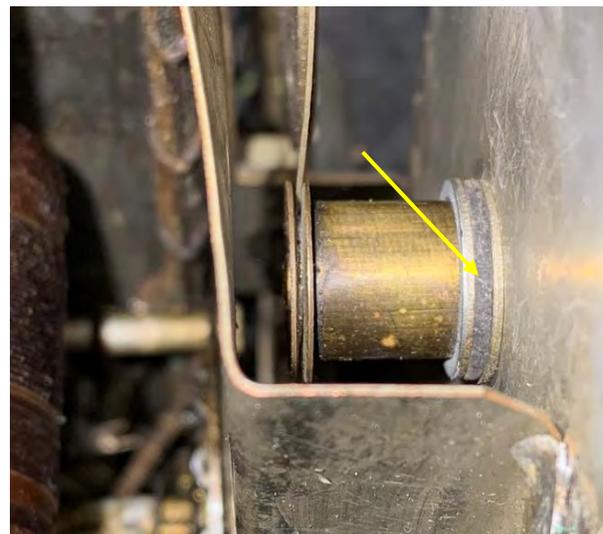
While running the tuning back and forward during the alignment process, I noticed that there was still some occasional slippage in the friction drive. I spent some time cleaning and adjusting this again, this time removing the front panel to provide better access to the pinch wheel and the phenolic logging scale that it engages with. I also installed a rubber washer onto the inside of the tuning shaft between two thin metal washers such that the pinch wheel is pushed slightly harder against the side of the phenolic logging scale (tip of arrow in photo, below right). The 'give' in the rubber washer allows the tension to be set optimally to compensate for

decades of wear on the mechanism by tightening/loosening the shaft bushing retaining nut. This has made the tuning mechanism much more reliable and the feel is now 'right'. I also installed a couple of rubber spacers between the front panel and the front apron of the chassis such that it was better supported and not rubbing on the tuning knob shaft.

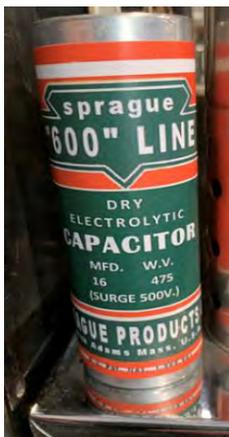
I printed the electrolytic capacitor labels on a colour laser printer and replaced the temporary monochrome-printed ones with these (photo, left) – a definite improvement!

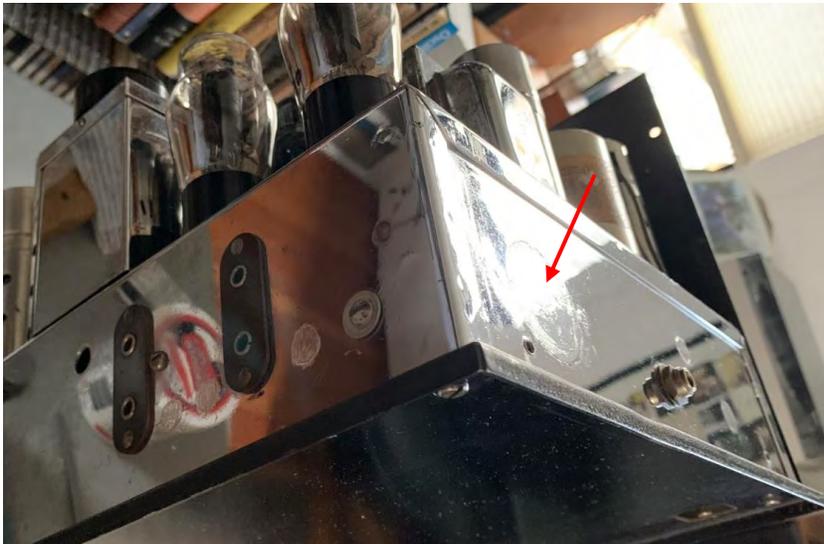
After dusting and wiping the areas clean with an IPA-soaked cloth, I applied a coat of the 'Mirror' paint with a soft (sable) brush. I was disappointed with the result - it was not much better than the regular 'silver' paint I had used previously. So, I lightly sanded and wiped the areas with IPA again, and this time applied two, thicker, coats of the paint, allowing the first coat to dry first before applying the second coat. The result was much better, with a glimmer of a reflection appearing, though hardly a true 'mirror' finish. So, I tried a third coat and finally a definite, though somewhat 'murky', reflection could be seen in the paint finish on the larger filled area (tip of red arrow in photo, left).

I concluded that if this paint was applied to a perfectly smooth surface, then it may be possible to have an (almost) mirror finish - but likely not if applied with a brush. I categorize this painting exercise to be in the experimental class - my conclusion being that although it does effect a definite improvement over the use of regular silver paint, unless expert car body repair techniques are used to fill and prepare holes in a chassis, 'perfect' results will not be obtained. Even then, highly reflective surfaces such as chrome and the 'Mirror' paint tend to show every miniscule blemish. Anyway, the result here was definitely better than the regular 'silver' paint - much more 'chrome looking'.
