Restoring a 'Breting 12' Communications Receiver – Gerry O'Hara

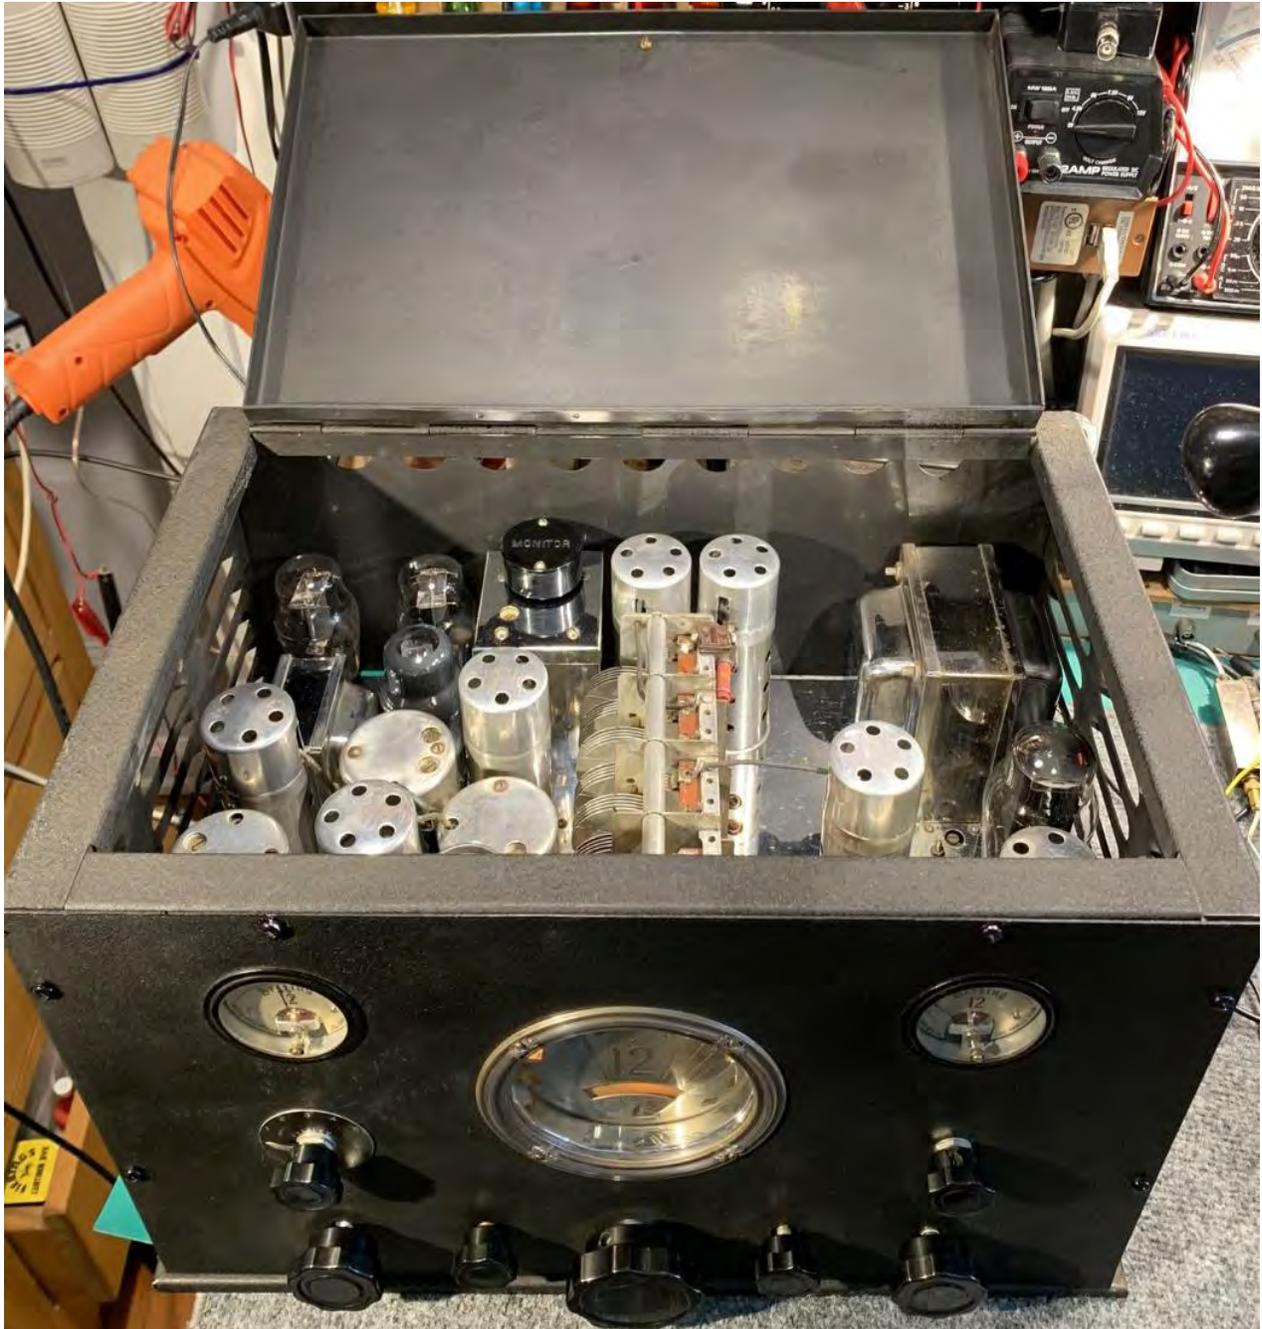
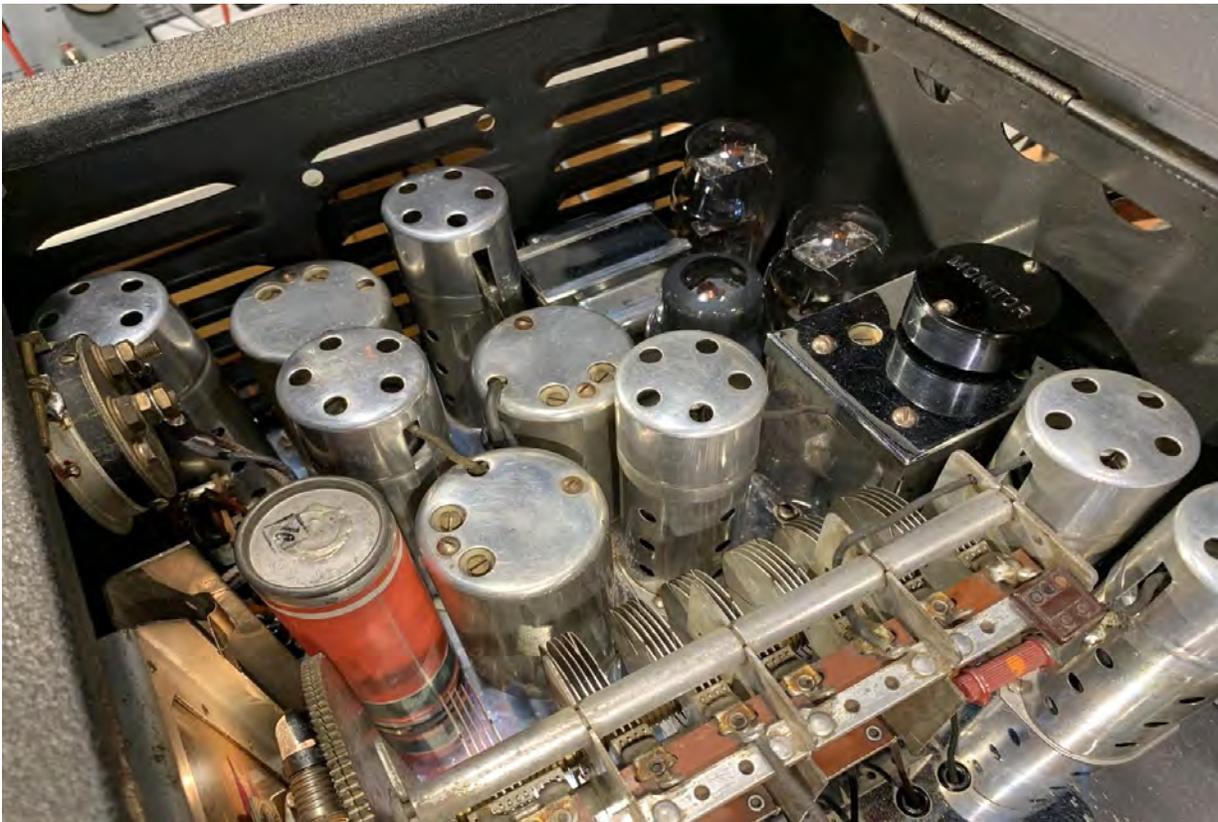
'Peek-a-Boo' views of the restored chassis through the opened cabinet lid. Above: IF/AF section of the chassis. Below: Power supply and RF section of the chassis

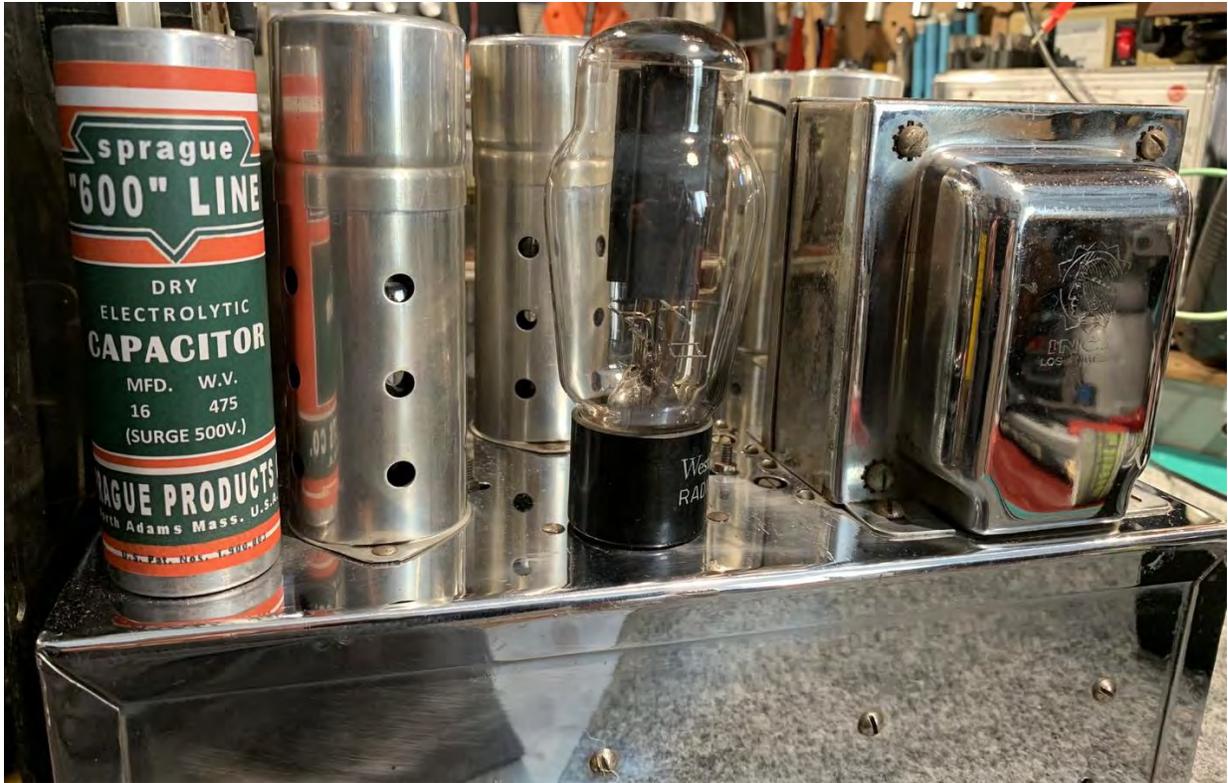
Above: One of the repro 'Sprague' brand (re-stuffed) can capacitors installed on the chassis. Below: the chrome-plated 'INCA' brand transformer shrouds are a work of art

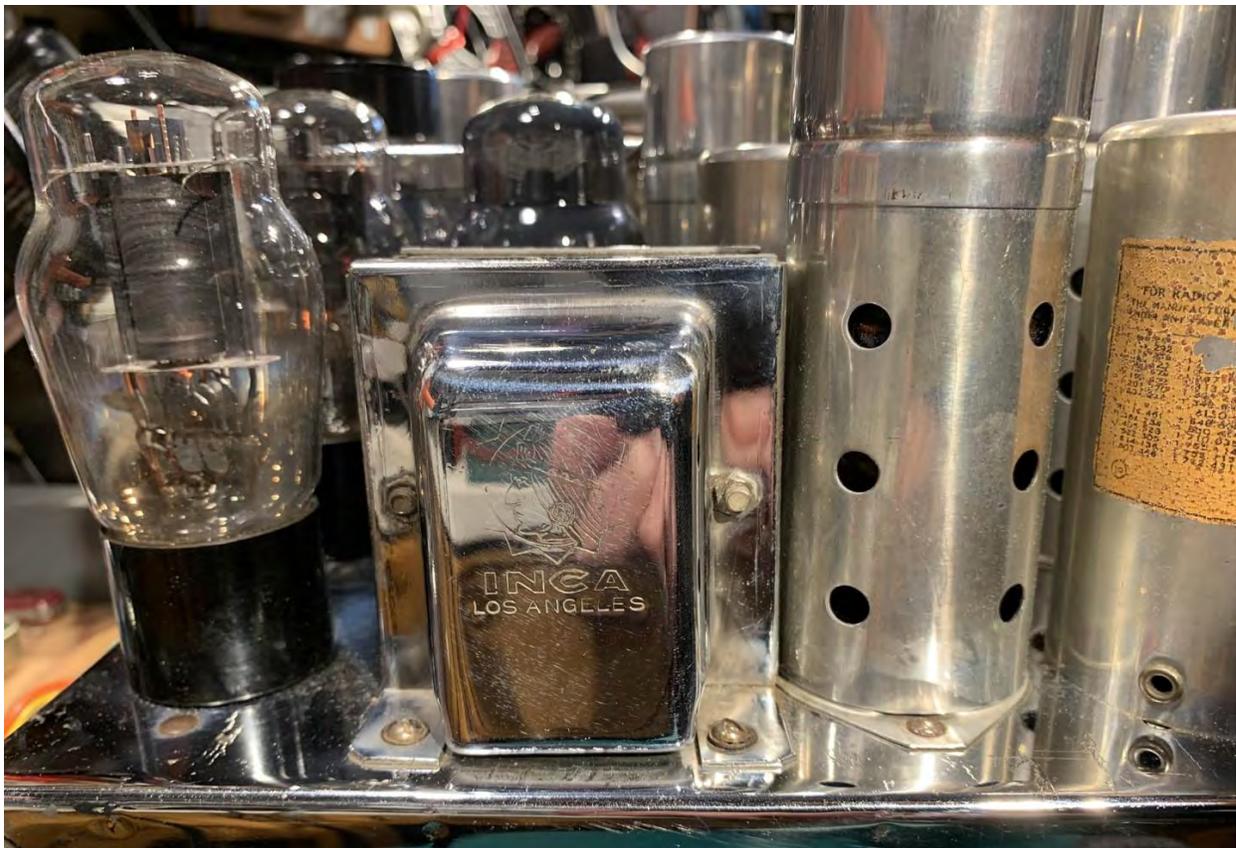
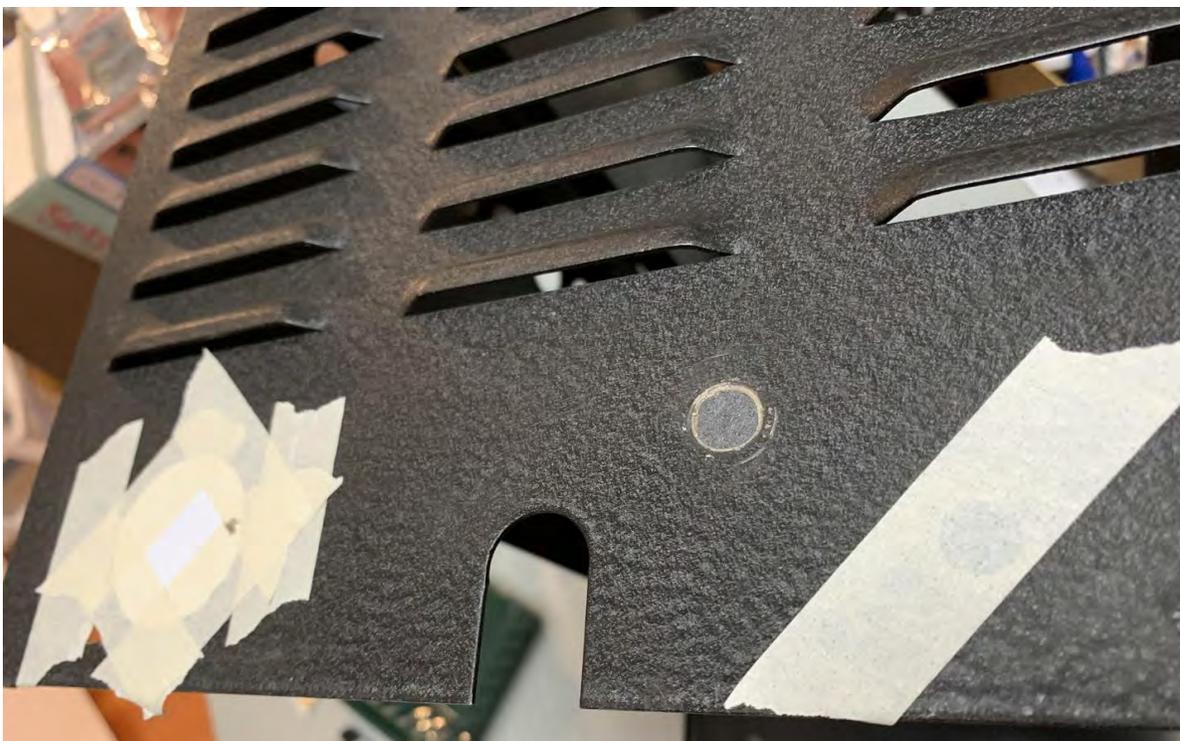
Above: patching the 'butchered' cabinet side. Below: patched areas after touch-up painting

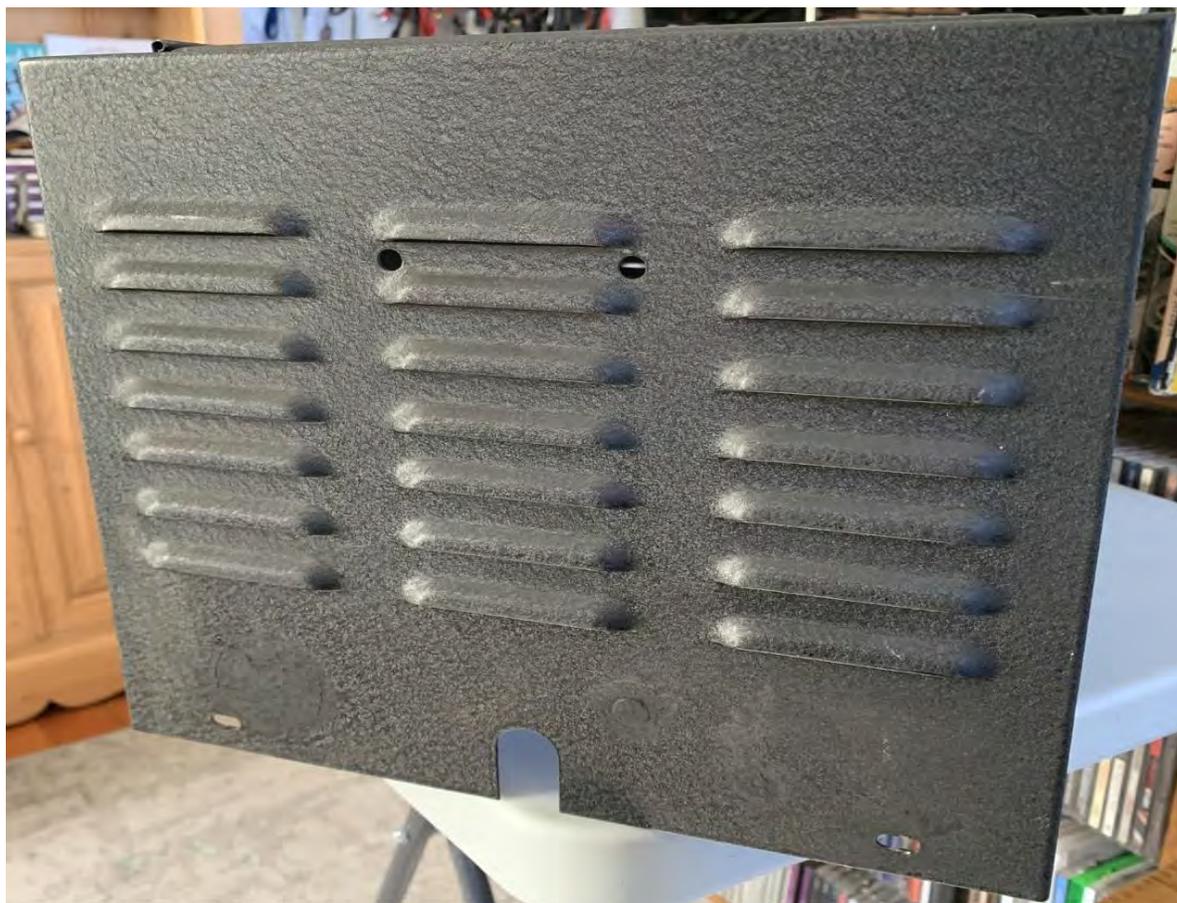
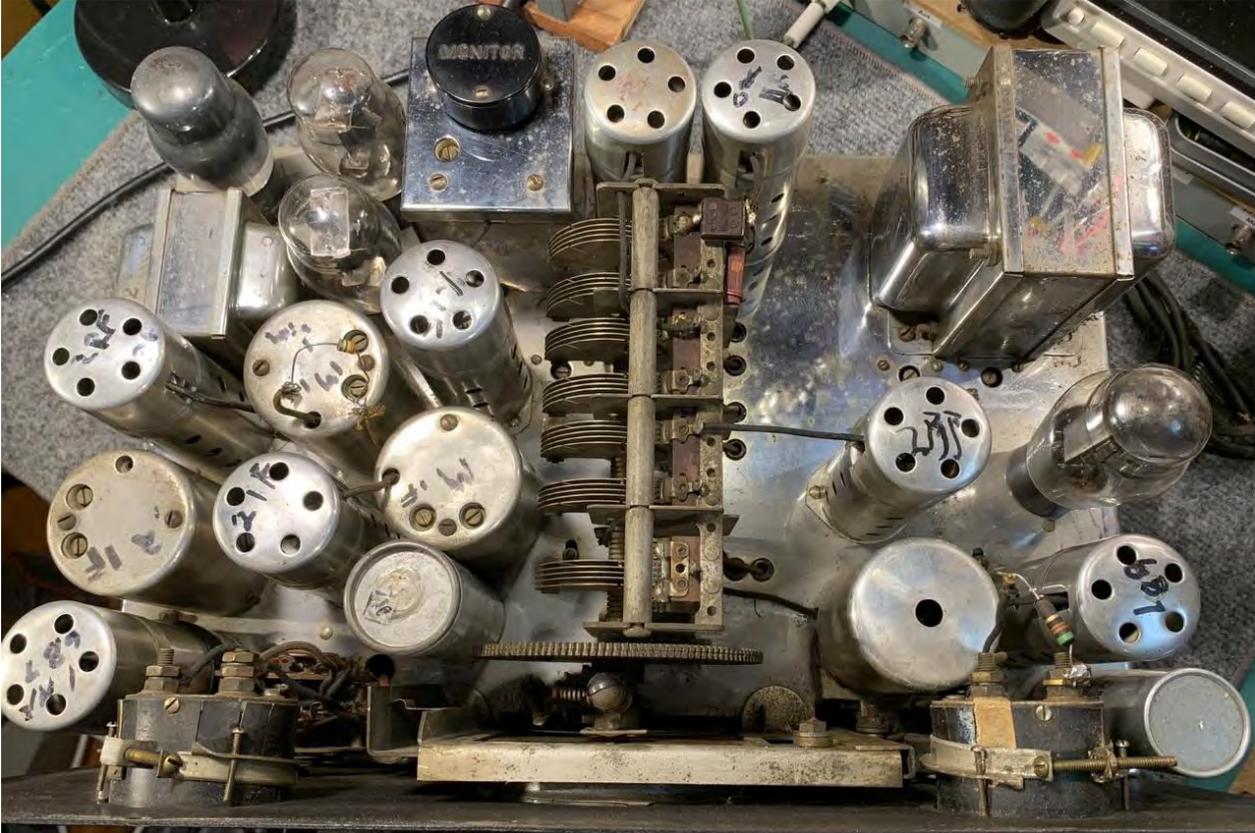
Above: top of chassis before restoration. Below: top of chassis after restoration

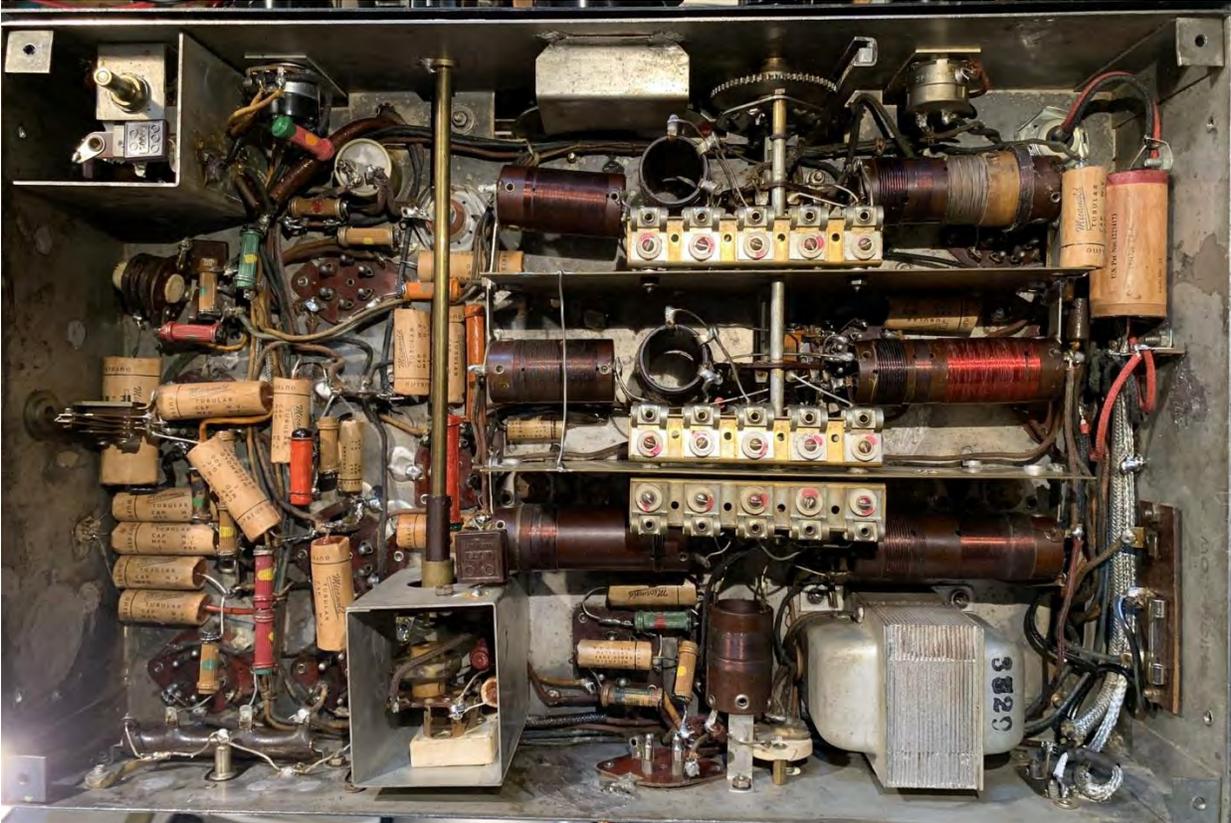
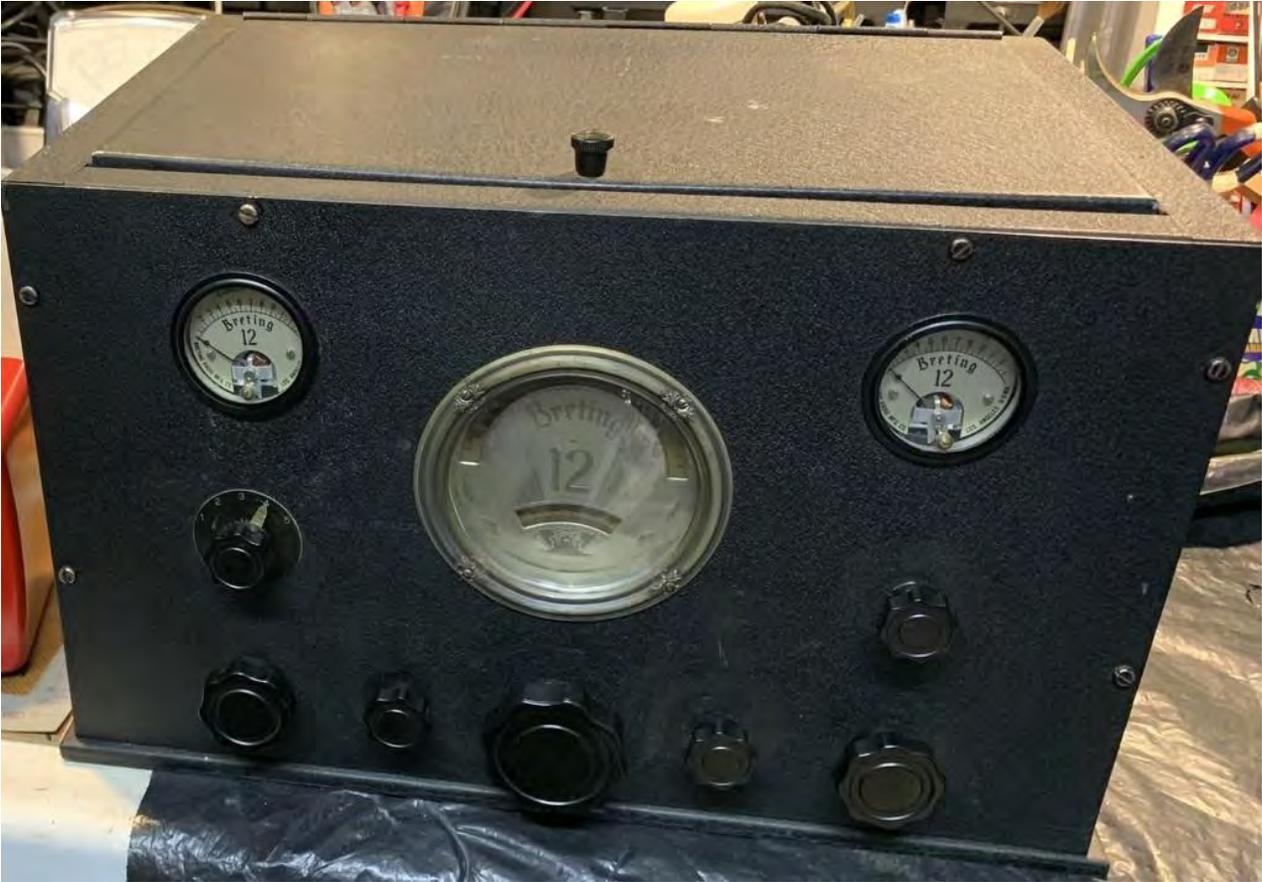
Above: receiver before restoration. Below: receiver after restoration

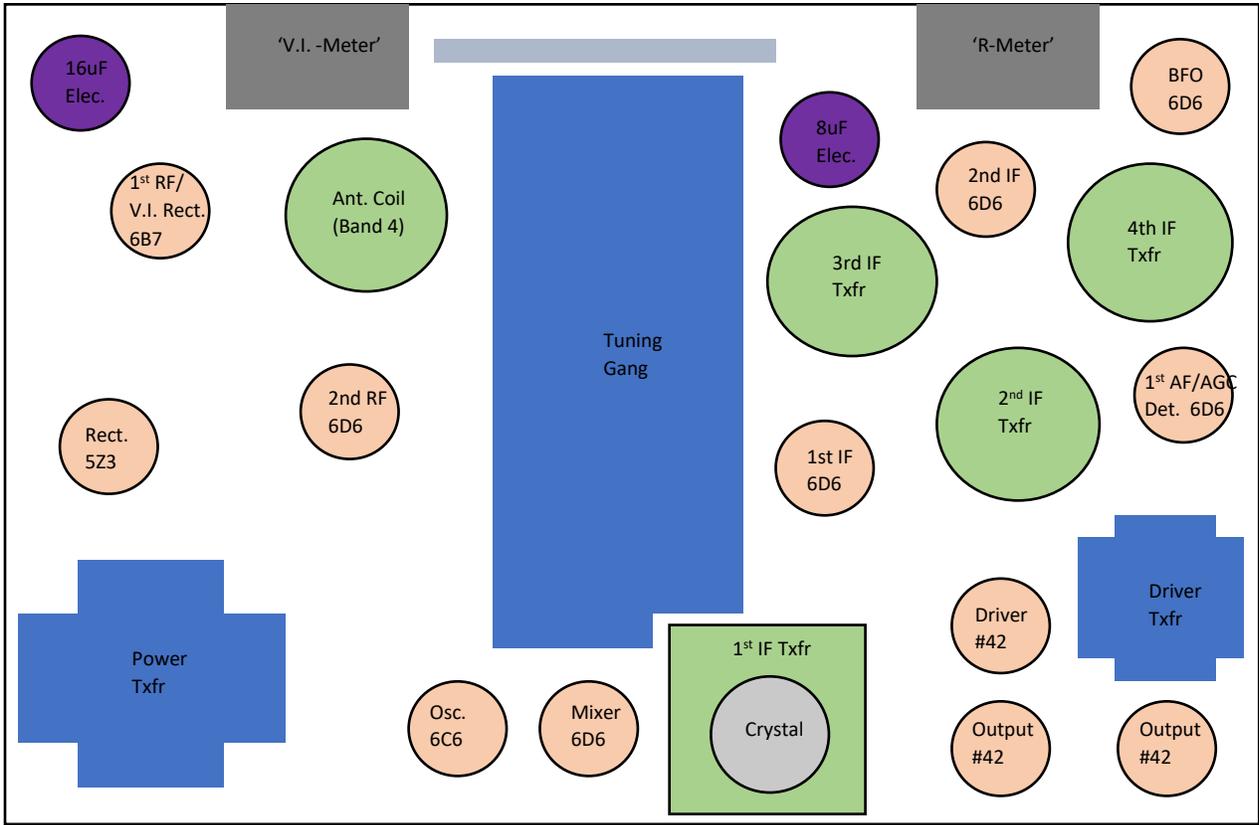
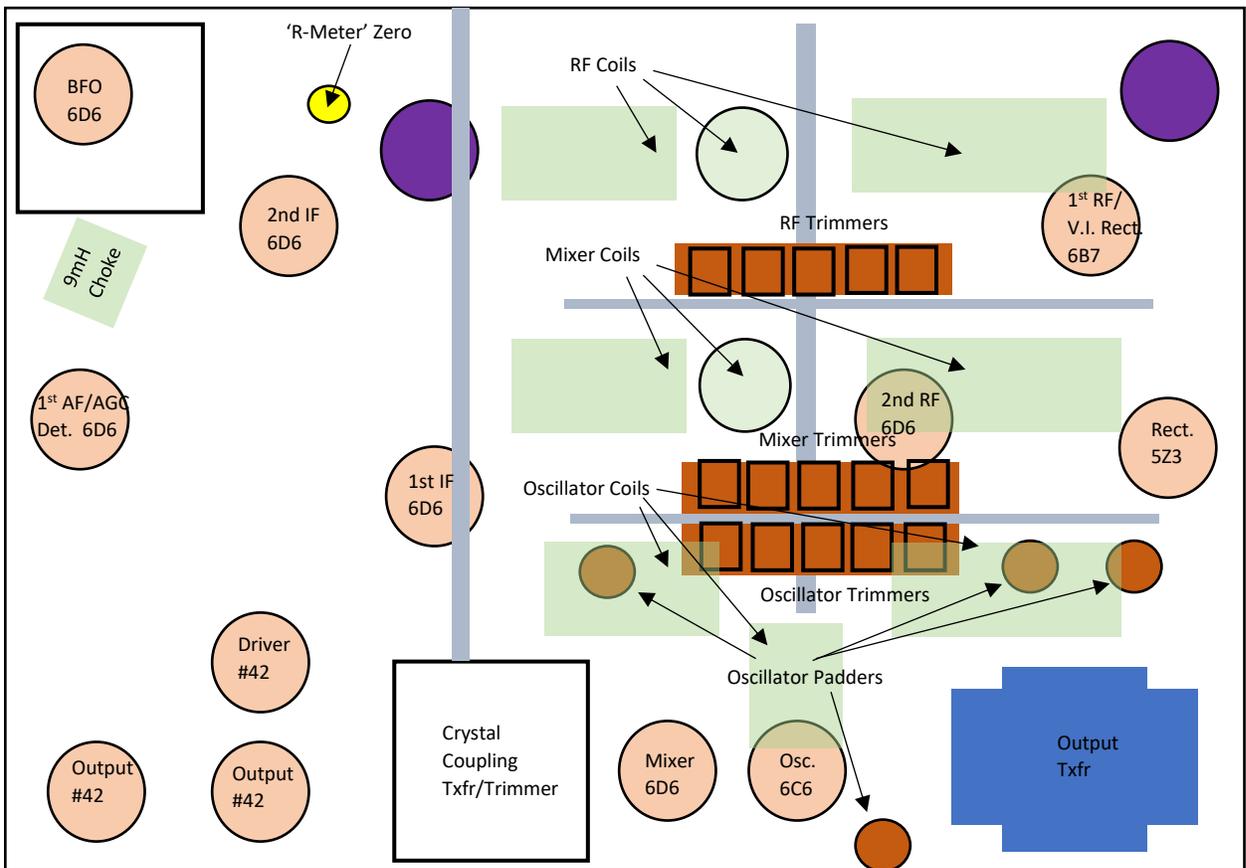
Above: Breting 12 chassis layout (above chassis). Below: Breting 12 chassis layout (below chassis)
