Restoration of an RCA ACR-175: a mid-1930's 'Classic' – Gerry O'Hara

I was recently asked to work on a couple of mid-1930's RCA communication receivers: an ACR-111 (fairly rare) and an ACR-175 – the latter lower cost and hence more popular/common. The owner also has a much-rarer RCA AVC-11A to refurbish – that will make for an RCA communications set 'hat trick' this year! (and its only August...). The photo, above, shows the ACR-175 on the day it arrived at my workshop.

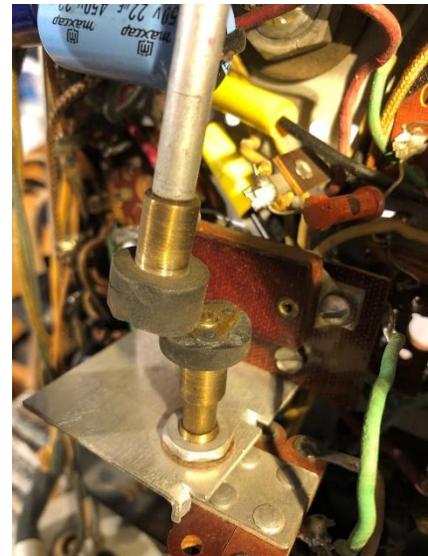
Preliminary inspection of the chassis showed that someone had done some recapping work previously - some electrolytics and a few paper capacitors have been replaced (photo, top of next page). The rubber isolation coupling on the crystal phasing control shaft was broken (photo, right) – easily fixed with a drop of Duco cement, but otherwise things looked in reasonable physical shape under the chassis. The speaker driver looked ok too, this being mounted on a simple wooden baffle stand, and is thought to be the original as supplied with the set.

- Reversing the 'obvious' repairs, eg. using re-stuffed capacitor shells recovered from the work on the ACR-111 chassis to install in place of the 'modern' replacements, and removal of the 'modern' under-chassis electrolytics and re-stuffing the original electrolytic capacitor cans;

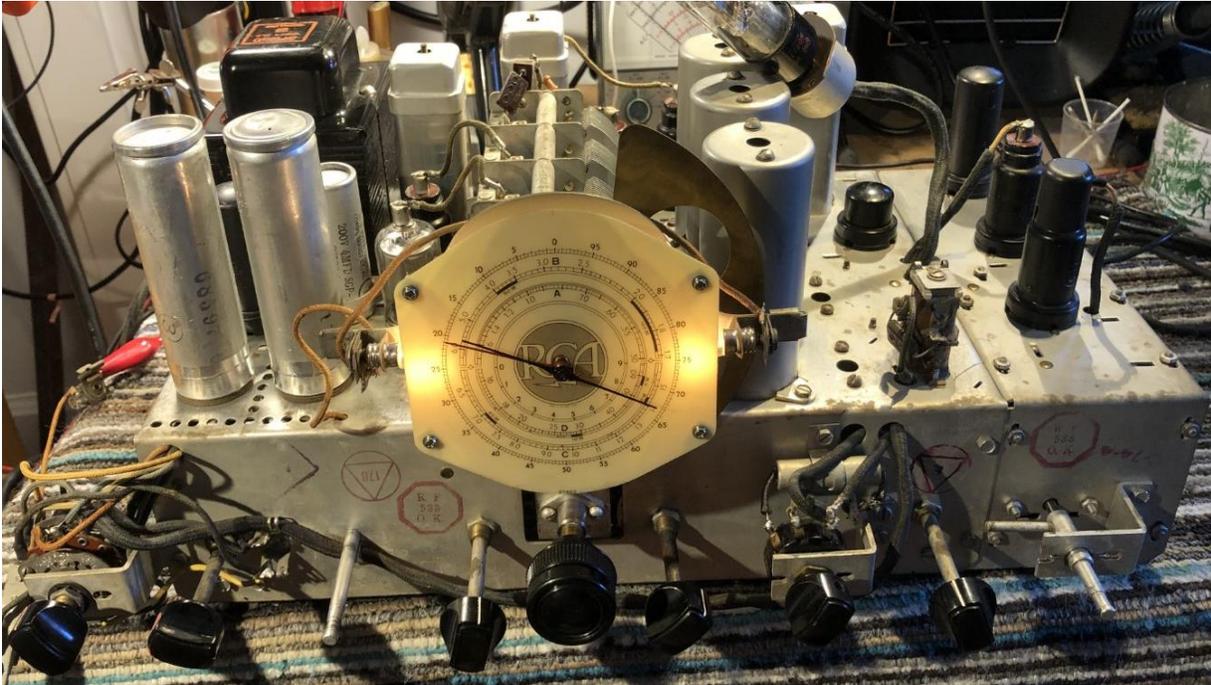
Above: completed ACR-175 chassis on final soak test. Below: 'birds-eye' view of the restored chassis

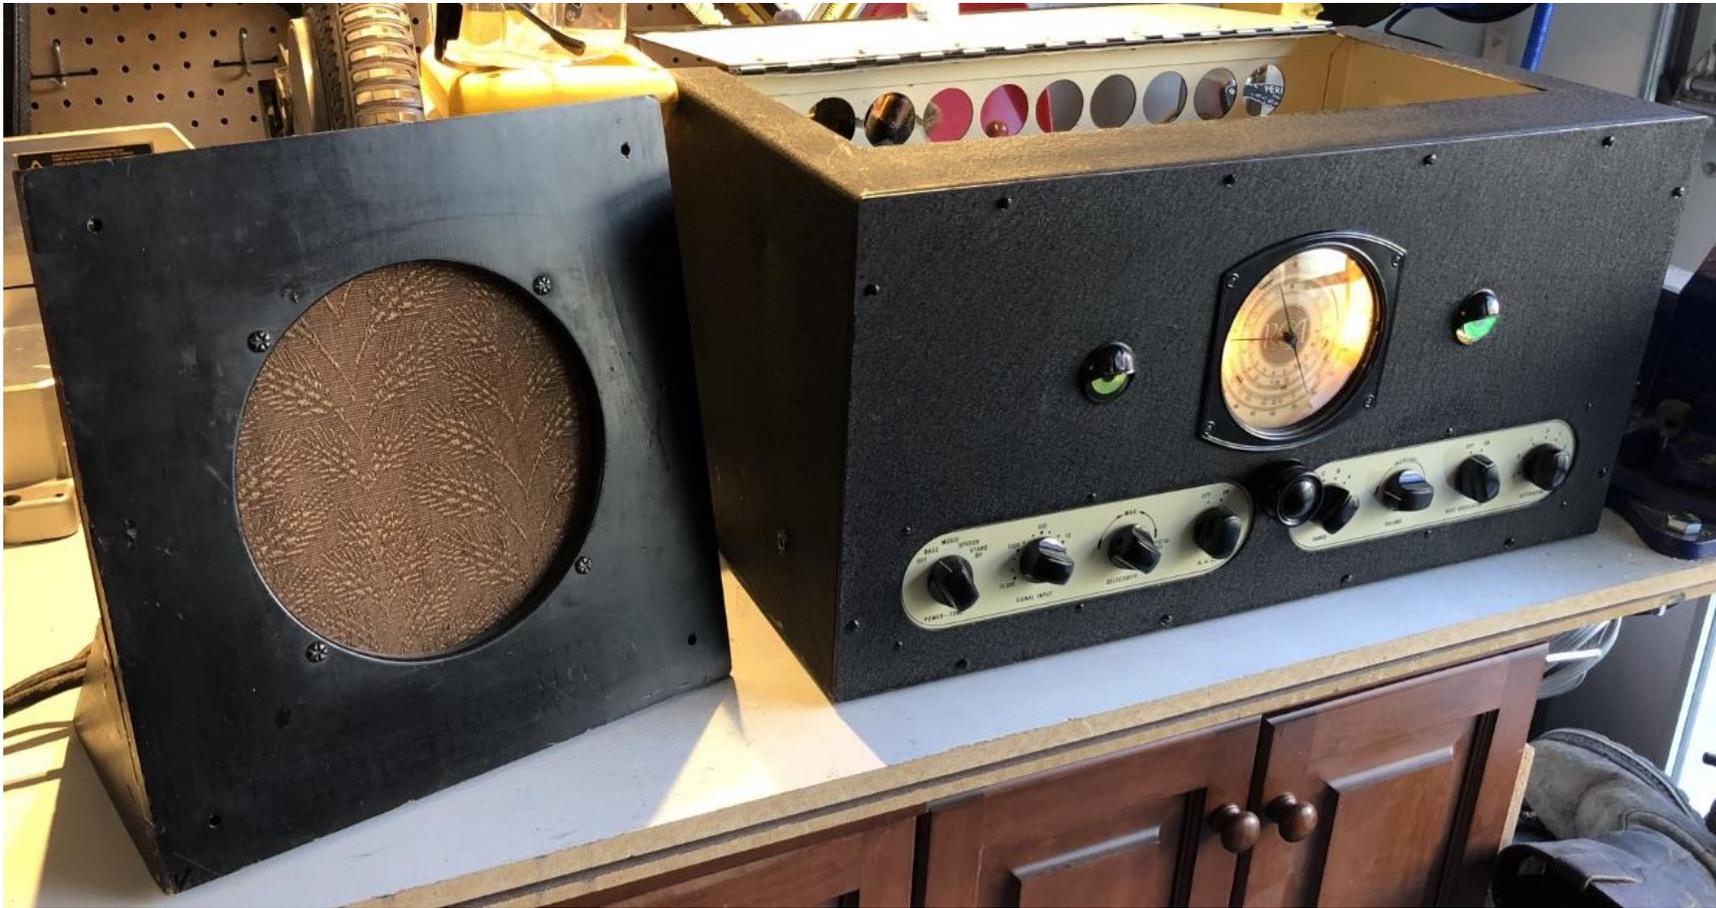
The finished ACR-175 receiver with its 'matching' speaker during its final workout – a real mid-1930's 'classic' communications receiver. The dummy eye tube on the left is the 'standby' indicator lamp. The cabinet is several inches too wide for the chassis – was this meant to impart more 'gravitas' to the owner's reception bench? (see the photo of the chassis mounted in the cabinet without the front panel fitted on Page 11), or maybe it was meant to store headphones in, or spare tubes, or lunch... it would certainly keep a pasty nice and warm next to the transformer and rectifier tube.
