# Collins

Collector's Quarterly Magazine

Volume 1 Issue 4

# The care and feeding of your KWS-1 and other pertinent trivia

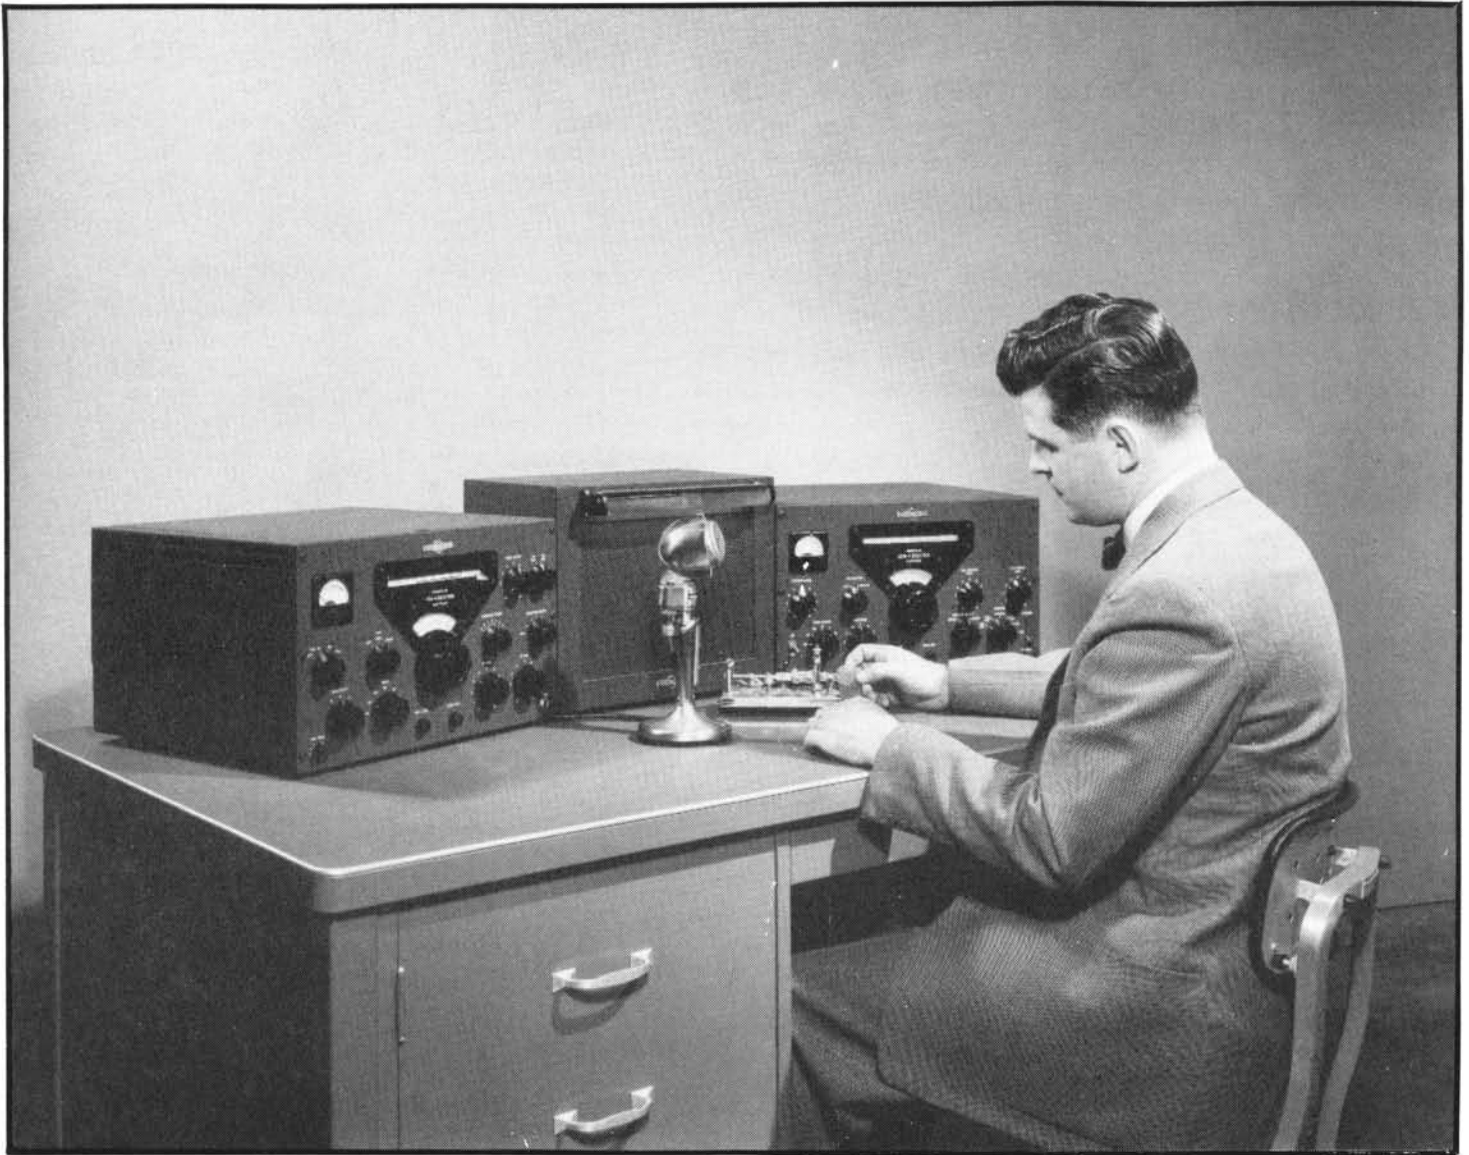
**Figure 4.**

*Collins public relations photo of 32W-1 mock-up or prototype - none were produced. Robert C. Miedke, Engineering Group Head, shown seated.*

Note the difference in front panel control configuration between the 32W-1 prototype in Figure 4 and the intro model pictured in the QST advertisement. There was also a power supply location difference. It is evident that the marketing strategy for this version was never clear.

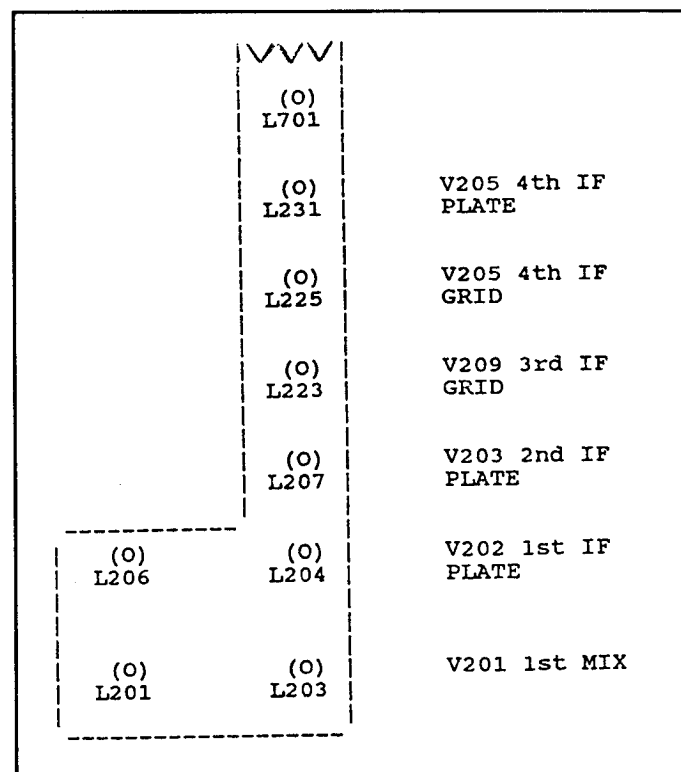
**Figure 8.**  
Top view of slug rack tuning inductors labeled by function.

I have included a top view location diagram, see Figure 8, for the tuning inductors called out in the alignment procedure. This will save a lot of hunting around. I suggest making a copy and putting it with your manual. Also, included is a table of typical AC (both audio and RF) signal levels encountered throughout a good unit.

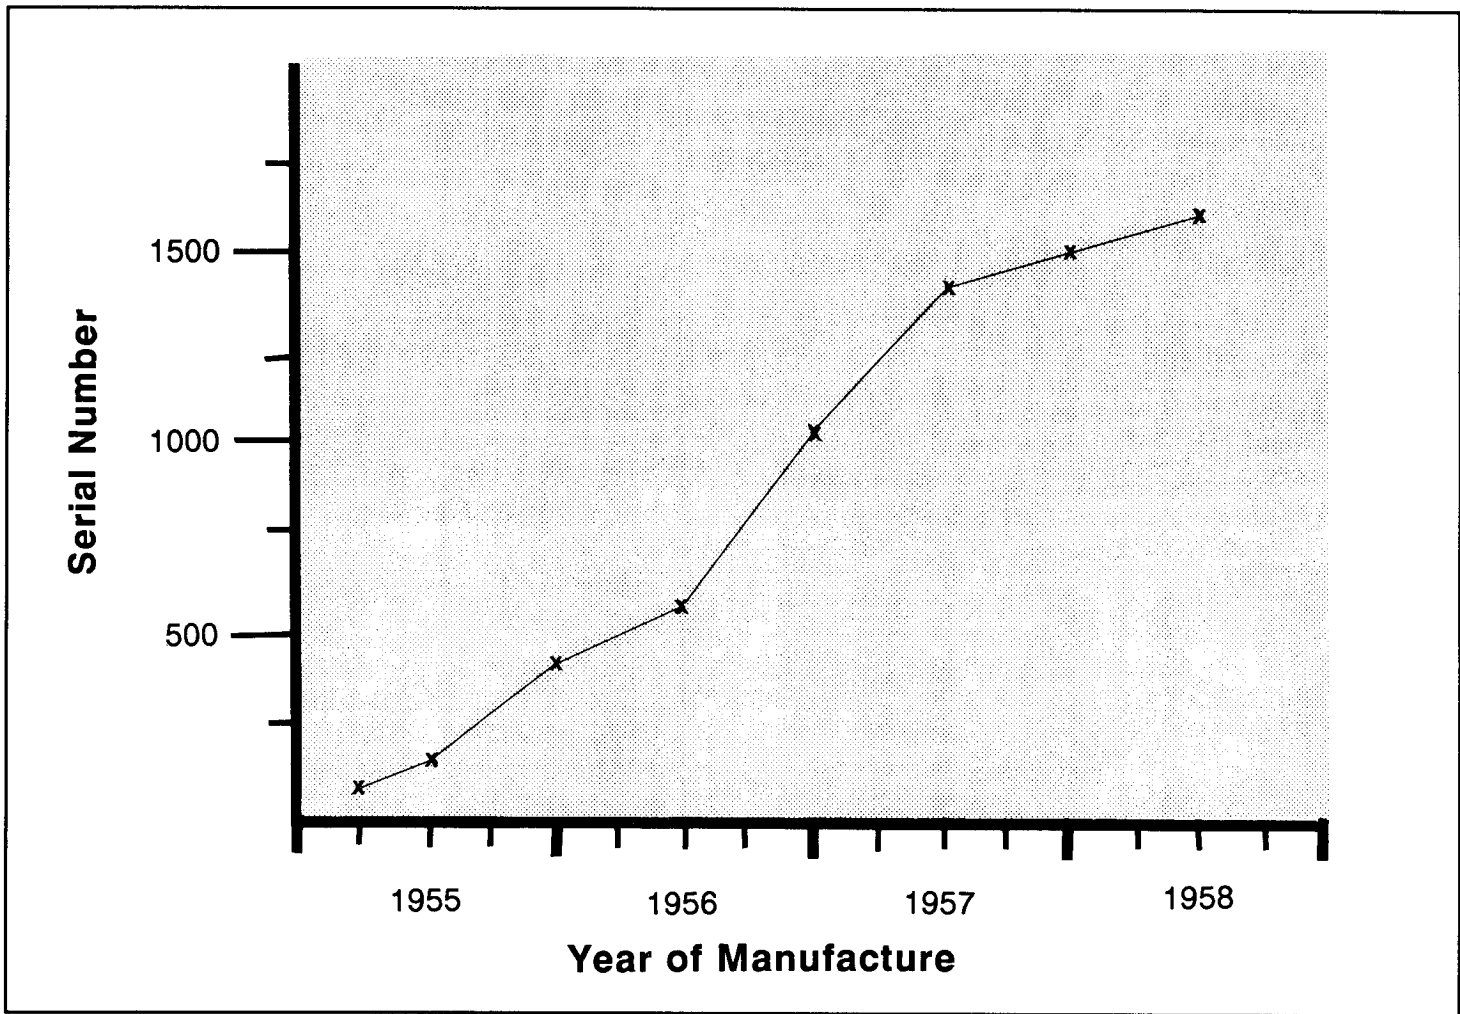
**Figure 9.**  
*Estimated KWS-1 serial number vs. manufactured date.*

At the end of this article is a plot of estimated date of manufacture vs. serial number. This estimate is based on a combination of date code information supplied by owners and serial number data contained in service bulletins and inferred from owners manual revision dates. See Figure 9.

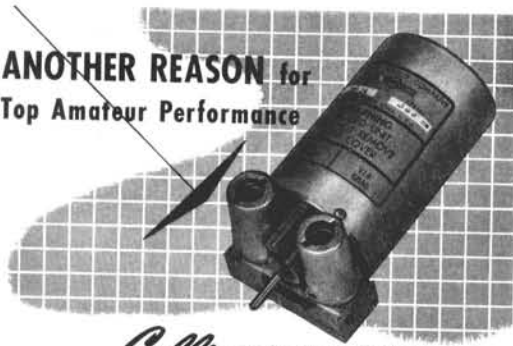
## Collins PRECISION VFO

Another reason for the superior performance of Collins KWS-1 Transmitter and 75A-4 Receiver is the use of Collins Variable Frequency Oscillator — famous for its linear calibration and stable output. The units in the KWS-1 and 75A-4 are designed specifically for Amateur operations and are 100% tested under lab conditions to rigid specifications.

- An average of 24-hour stability of .003% or better is achieved under normal operating conditions.
- Precision ball-bearing construction allows single-knob, permeability tuning with rock-steady vibration stability.
- Each unit is hermetically sealed against atmospheric changes for life-long, drift-free operation.
- Each unit is individually temperature-compensated for minimum drift. Each is lubricated for life.
