# FT-902DM

Survival Guide

3th edition November 2015

## The FT-901DM and FT-902DM Survival Guide

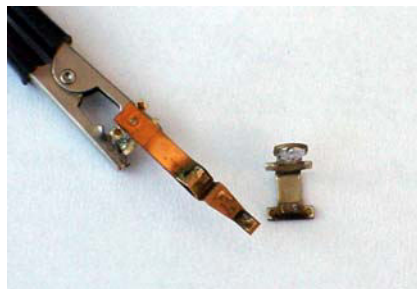
If that fails there is a third possibility: As you can see in the pictures, the switch has a NC contact, that is not used. It is the contact in the middle of the switch. By using this and the common contact, and mounting the switch upside down in the bracket when you assemble, you have actually a new switch, that will last for another 25 years or so.

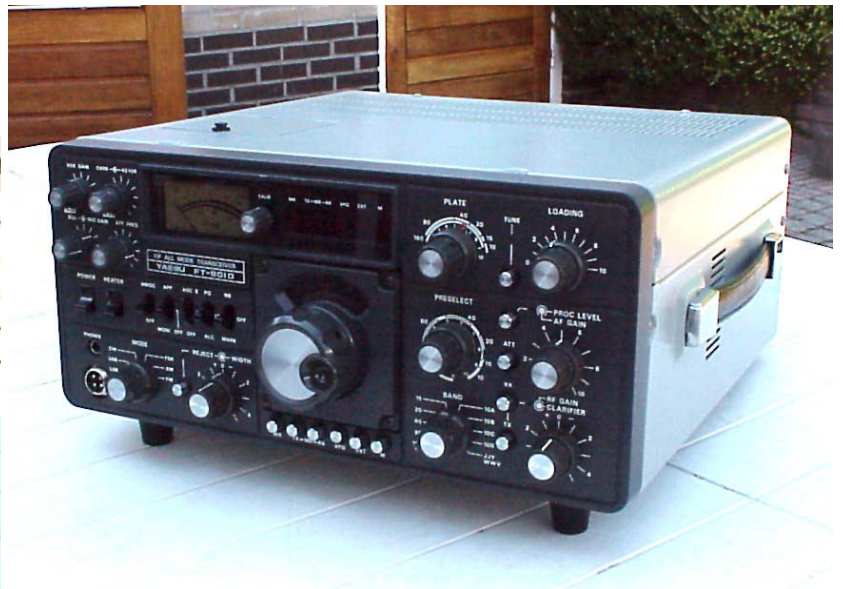
The FT-901D after restoration, a big difference !

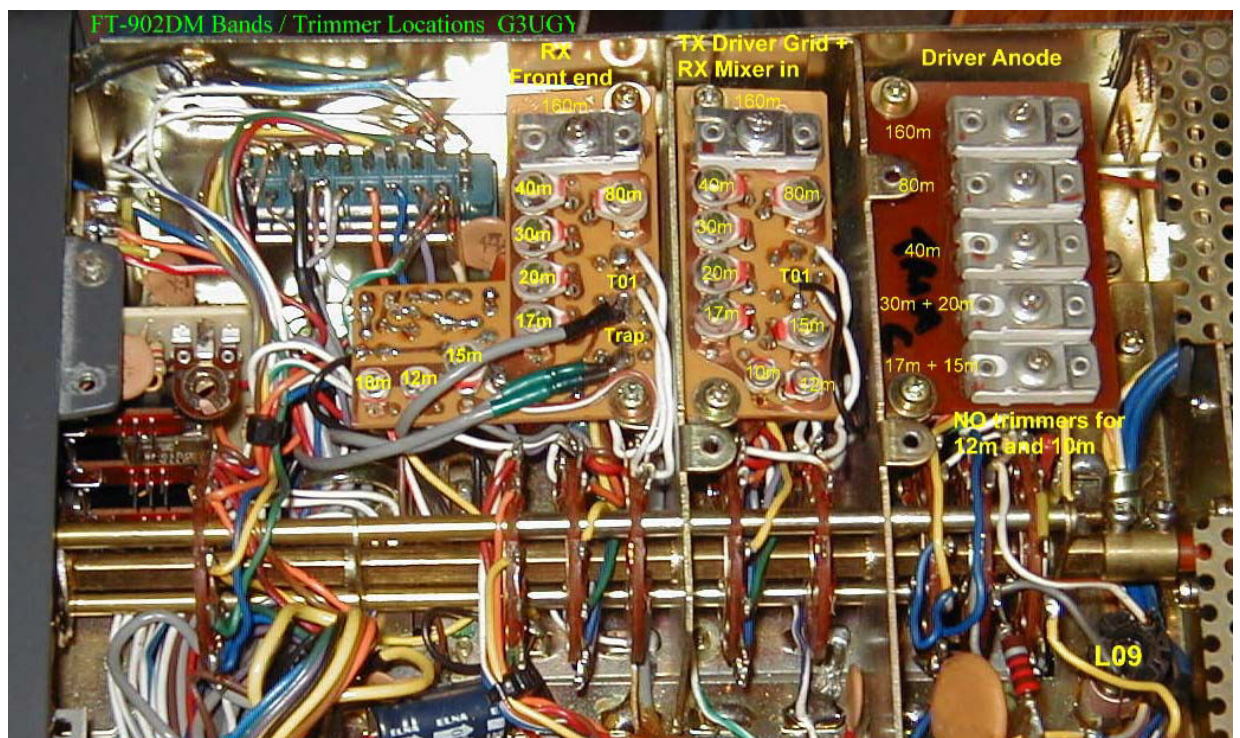
Trimmer positions on the later FT901DM and FT-902DM (below) (courtesy of G3UGY)
